## FREEDOM OF INFORMATION – LEGIONELLA

I write in response to your request for information in relation to Legionella in East Calder Health Centre.

This document relates to an ongoing programme of water quality monitoring at East Calder Health Centre, carried out by Westfield Caledonian during February 2016. As part of this visit, a review of the Water Quality Risk Assessment, relating to the domestic water systems contained within this building was carried out. This survey was carried out to satisfy the requirements of the Approved Code of Practice (L8) and guidance document HSG 274 and to determine aspects of the system design, condition and mode of operation which may compromise the quality of the water to which occupants are exposed and subsequent health risk. This assessment survey and control scheme review was carried out in a manner consistent with requirements with *BS8580:2010 Water Quality-Risk Assessment for Legionella control – code of practice*.

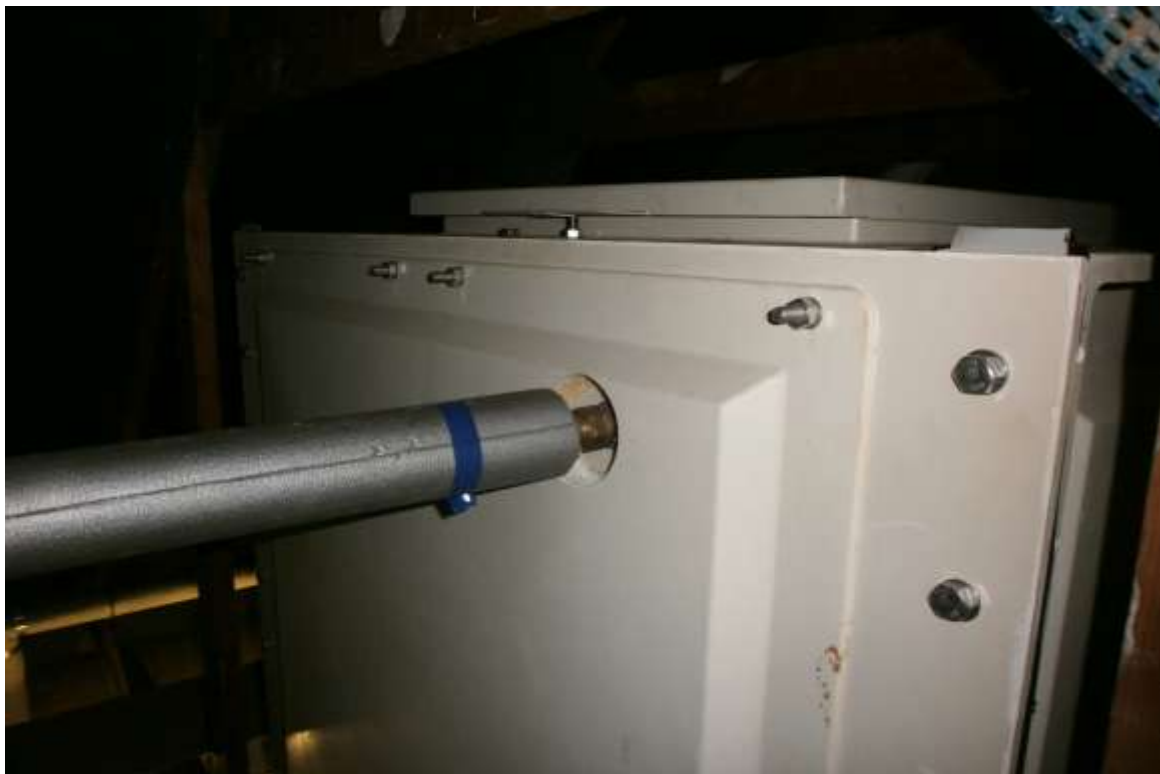
Laboratory analysis of a sample collected from this tank also returned results which are regarded as entirely satisfactory and we have no specific recommendations with regards to the CWS tanks other than that they be subject to regular control measures.

**Roofspace CWS Tank – Pre Insulated GRP Construction**

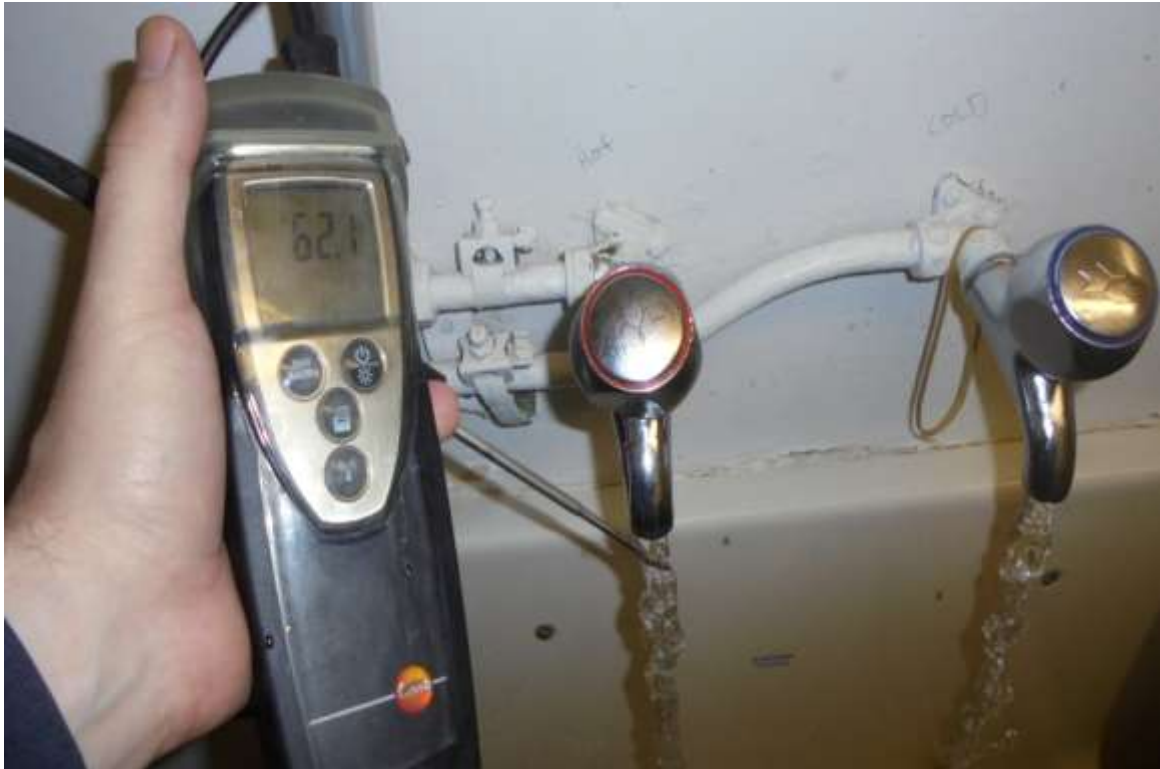
**DRS Sink – Hot Water Outlet Temperature Too High (>60°C) Scald Hazard**

Hot water outlet temperatures should be maintained at between 55°C and 60°C. The lower limit is required to ensure pasteurisation of both the water and supplying pipework, whilst the upper limit is necessary to minimise the risk of user scalding. With regard to the preceding criteria, hot water outlet temperatures recorded throughout the premises were satisfactory in that these were in excess of 55°C and sufficiently high to provide an effective thermal control regime. Temperatures were however recorded above 60°C and as such represent an increased risk of user scalding. It is recommended that the thermostatic controls on the gas fired water heaters be adjusted to lower the storage temperatures slightly and maintain outlet temperatures between 55°C and 60°C.

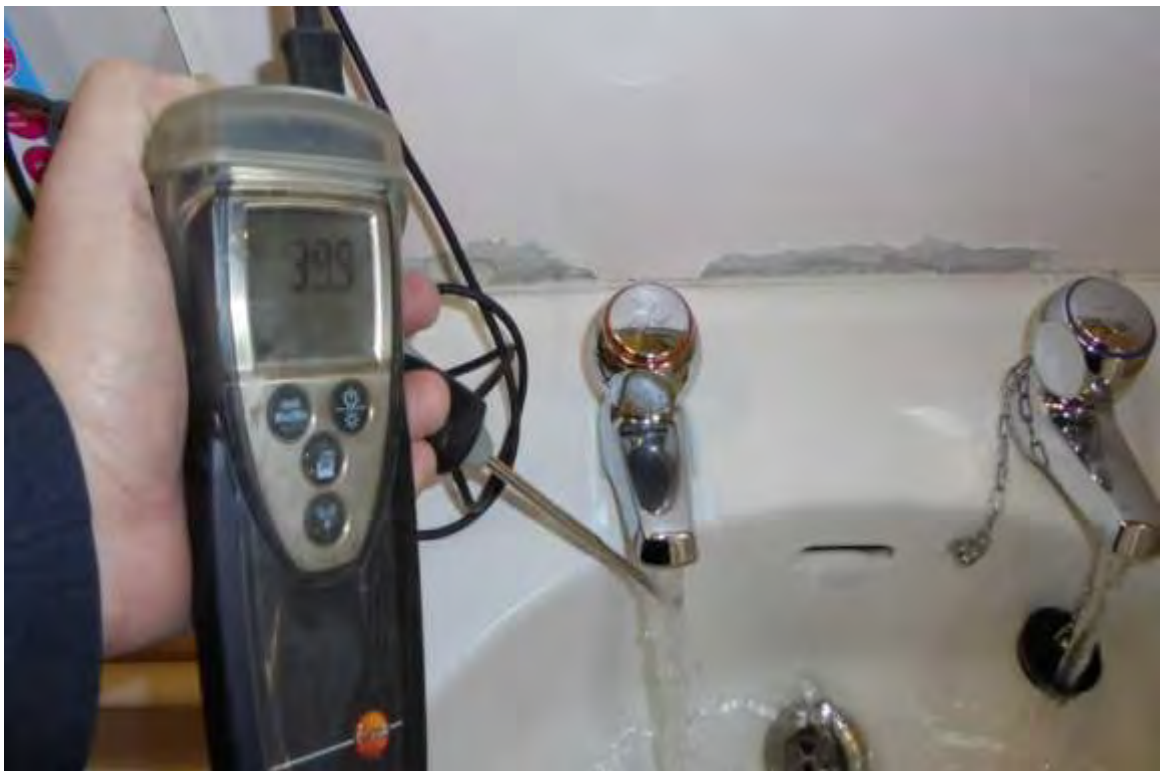
**Public Toilet WHB – Hot Water Outlet Temperature Satisfactory – Thermostatic Control**

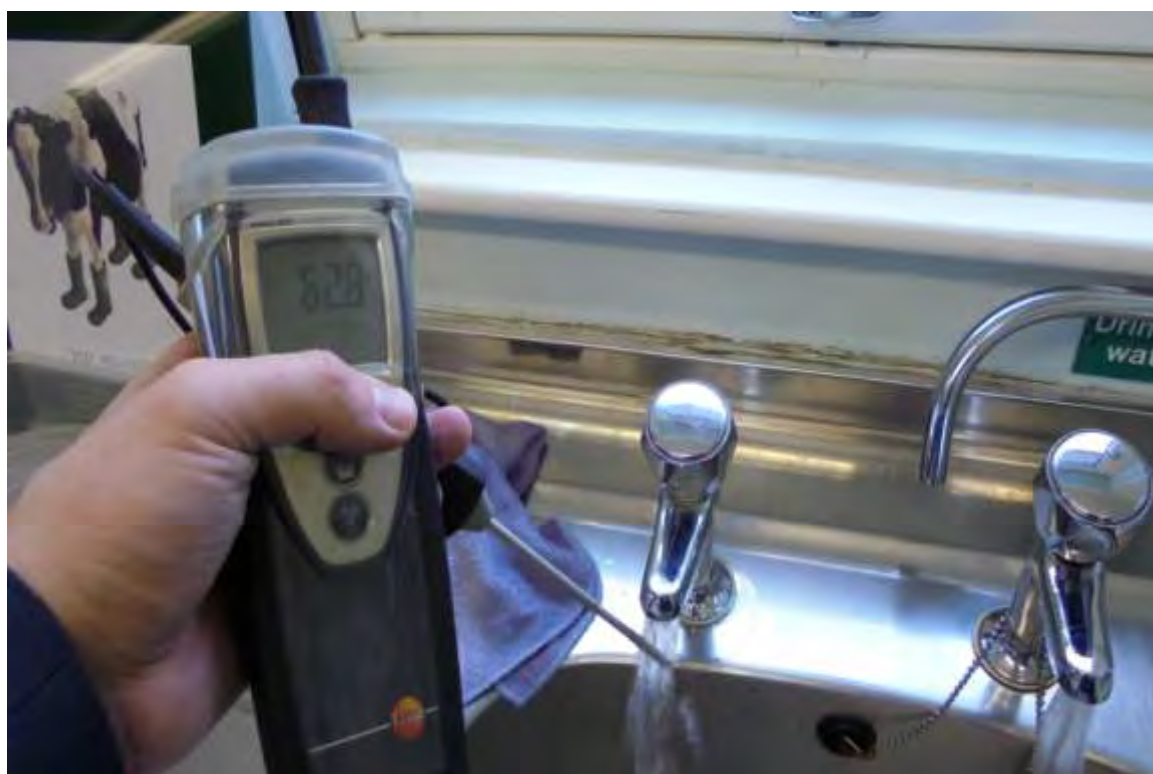
**1<sup>st</sup> Floor Staff Room Sink – Hot Water Outlet Temperature Too High (>60°C)  
Scald Hazard**

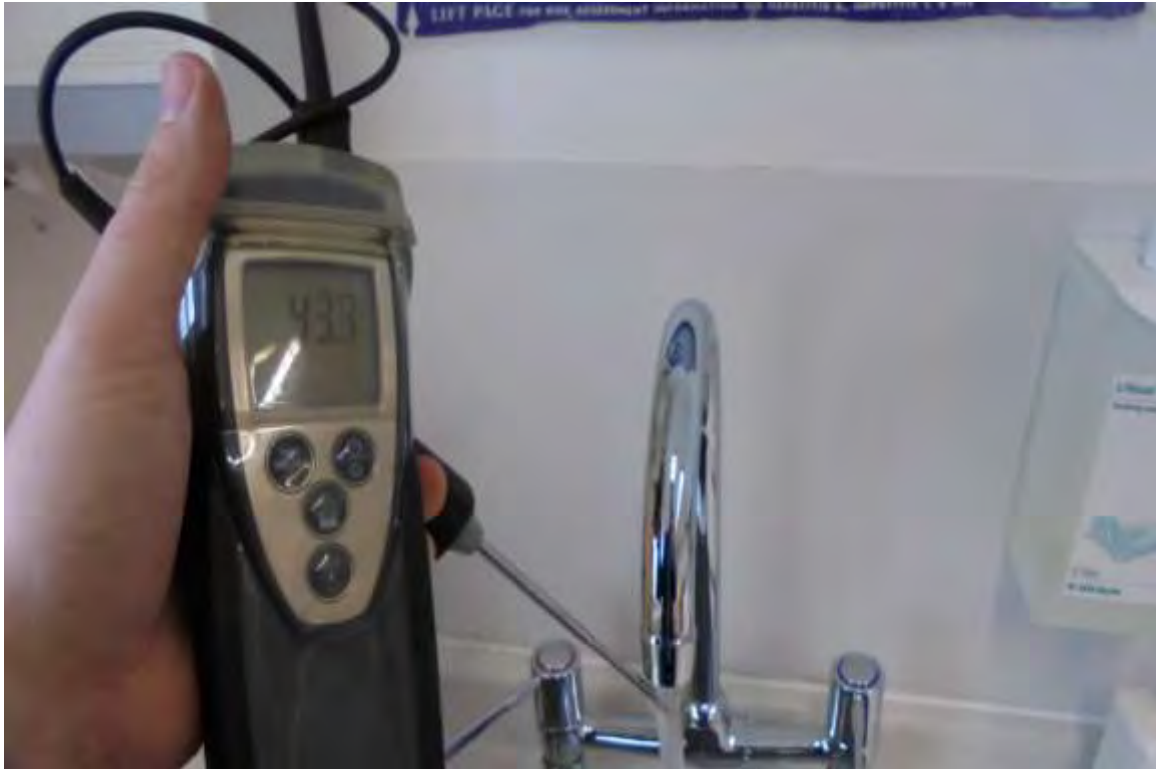
**Extension Consulting Room 3 Sink – Hot Water Outlet Temperature Too Low (<50°C) Supplied via POUH**

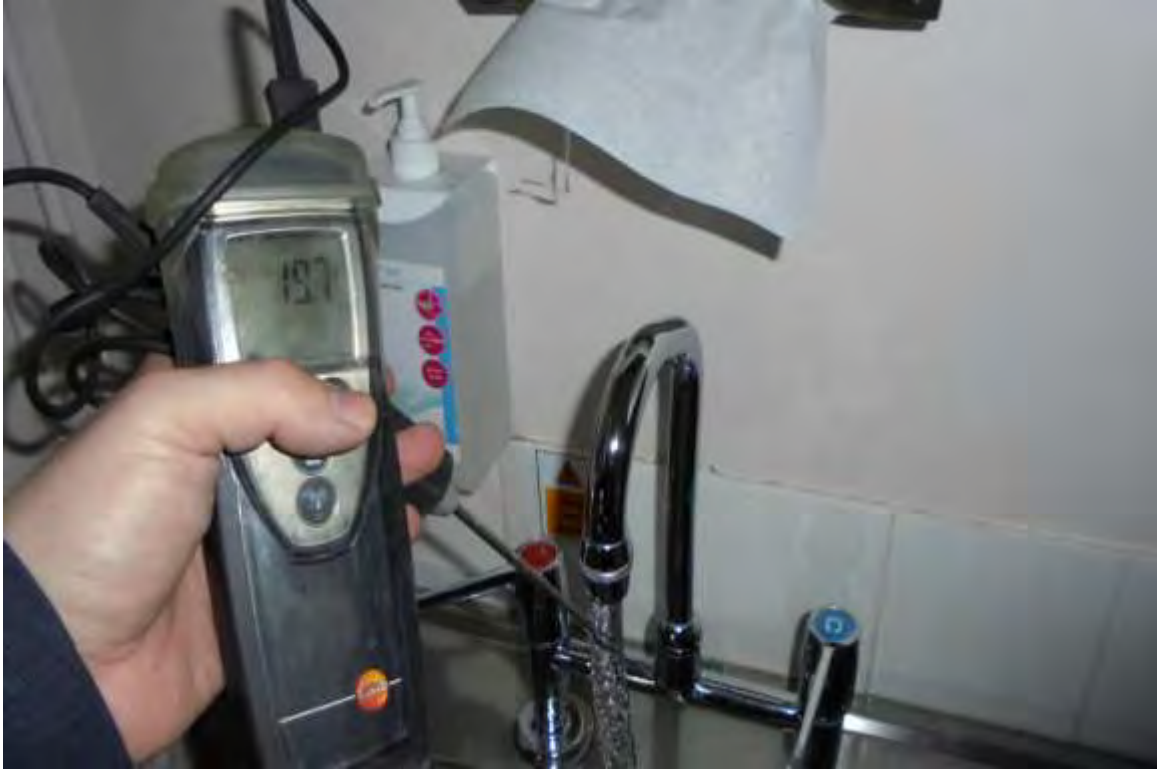
**Treatment Room G/49 Sink – Cold Water Elevated After 2 Minutes**

Westfield Caledonian recommends that cold water is distributed at temperatures <20°C as at higher temperatures micro-organisms begin to proliferate. There is further guidance which suggests that cold water temperatures should not rise by more than 2°C above that measured at the incoming Main. With regard to these guidelines, cold water outlet temperatures recorded throughout the Health Centre were generally satisfactory, although an extended flush was required at the Treatment Room G/49 Sink to achieve a temperature which compared well with the storage temperature within the CWS tank. It is recommended that this outlet be included in a twice-weekly simulated usage programme (SUP) to ensure that a fresh charge of water is drawn through the pipework to prevent heat gain, stagnation and back-contamination of the live systems. Regular temperature monitoring should be carried out to help identify any additional outlets which may be rarely used through measurement of elevated cold water temperatures and these should be included in the SUP.

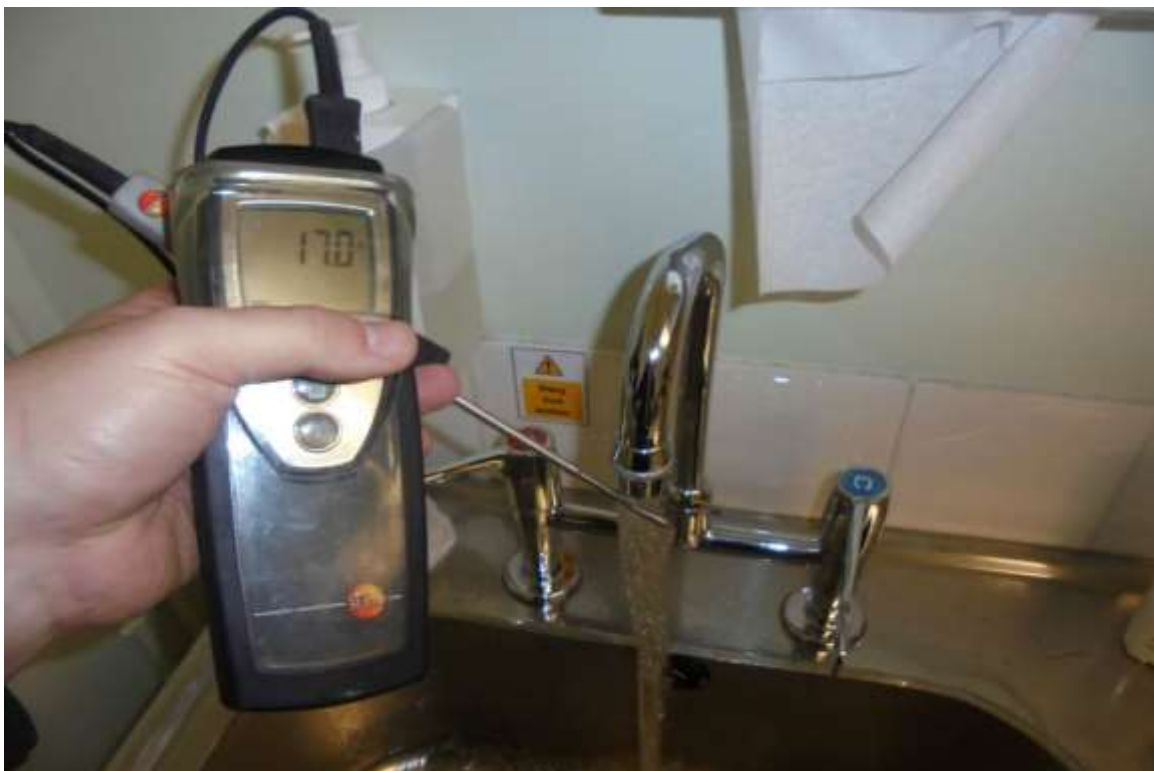
With regard to these guidelines, cold water outlet temperatures recorded throughout the Health Centre were generally satisfactory, although an extended flush was required at the Treatment Room G/49 Sink to achieve a temperature which compared well with the storage temperature within the CWS tank. It is recommended that this outlet be included in a twice-weekly simulated usage programme (SUP) to ensure that a fresh charge of water is drawn through the pipework to prevent heat gain, stagnation and back-contamination of the live systems. Regular temperature monitoring should be carried out to help identify any additional outlets which may be rarely used and these should be included in the SUP.

**Treatment Room G/49 Sink – Cold Water Elevated After 2 Minutes**

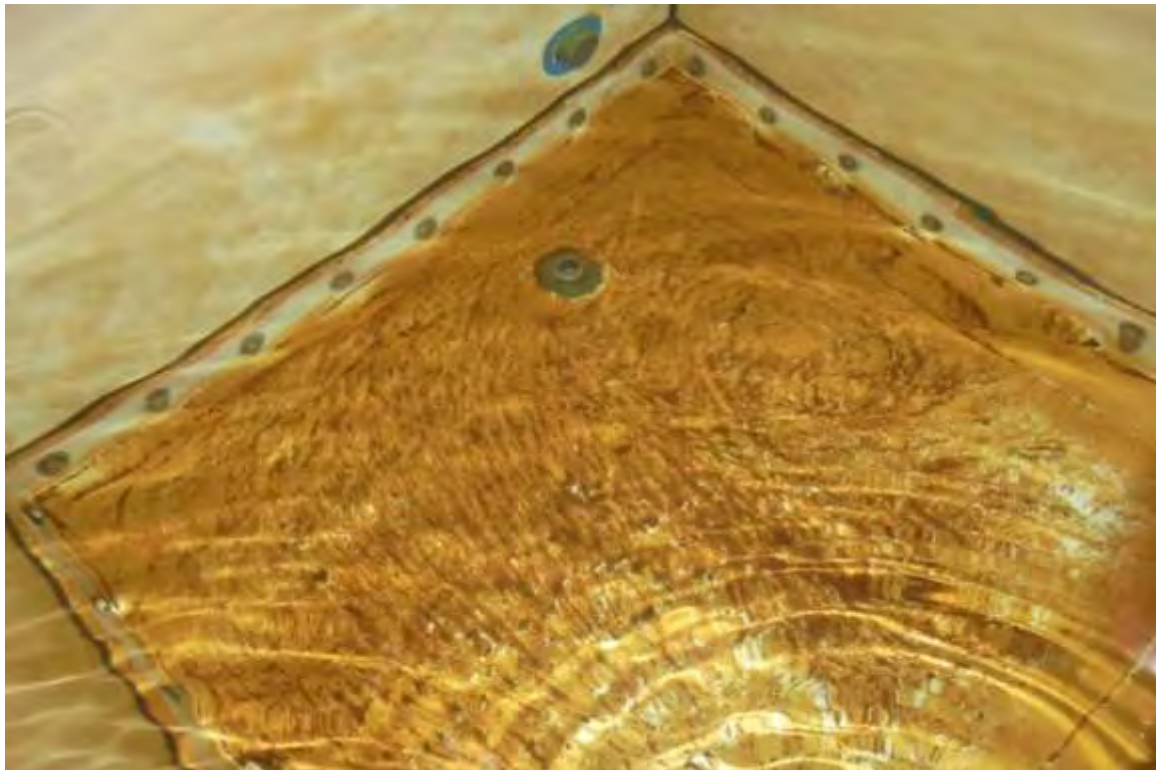
**CWS Tank No. 1 – Light Sedimental Accumulations**

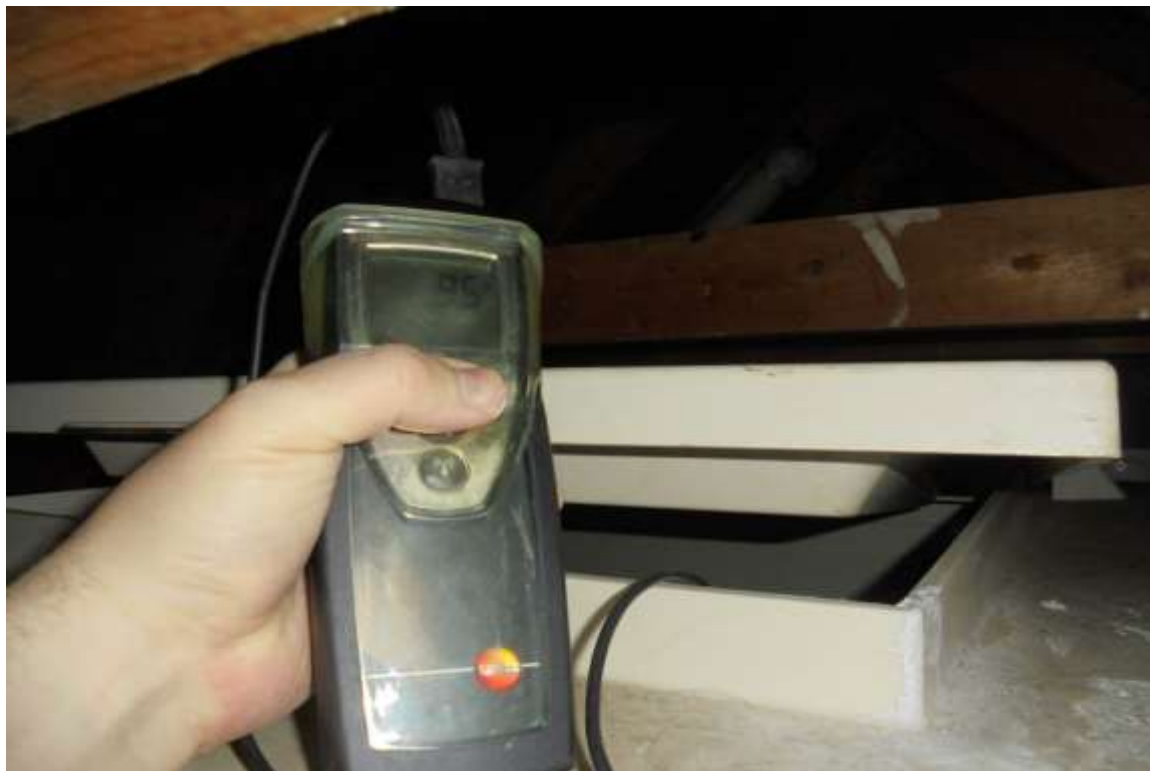
**CWS Tank No. 1 – Contents Temperature at 9.5°C**

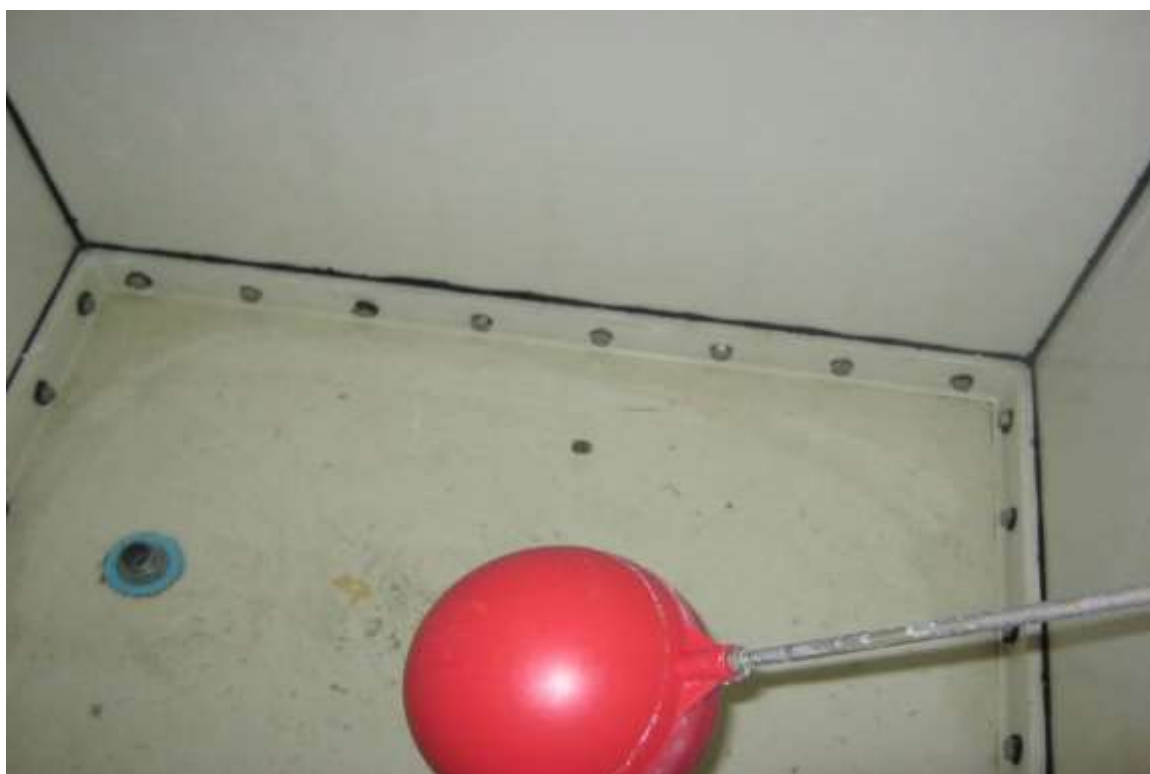
**CWS Tank No. 2 – Drained and Isolated**

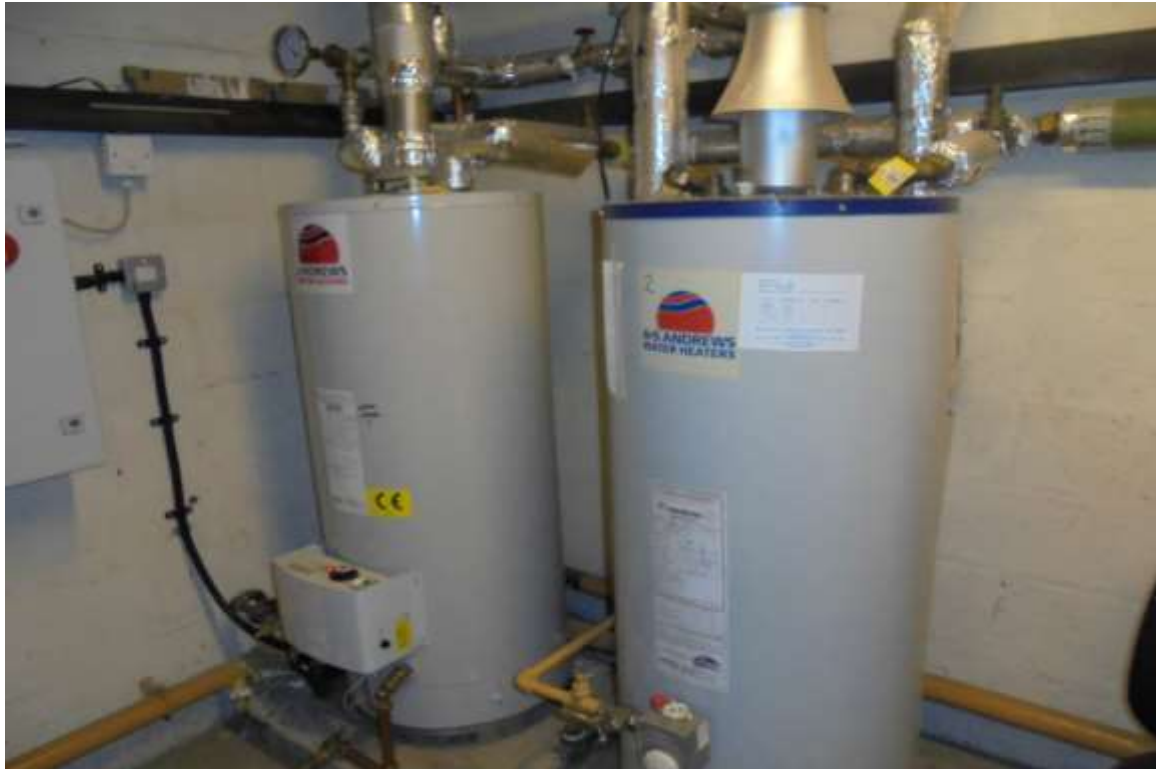
**Gas Fired Water Heaters – General Arrangement**

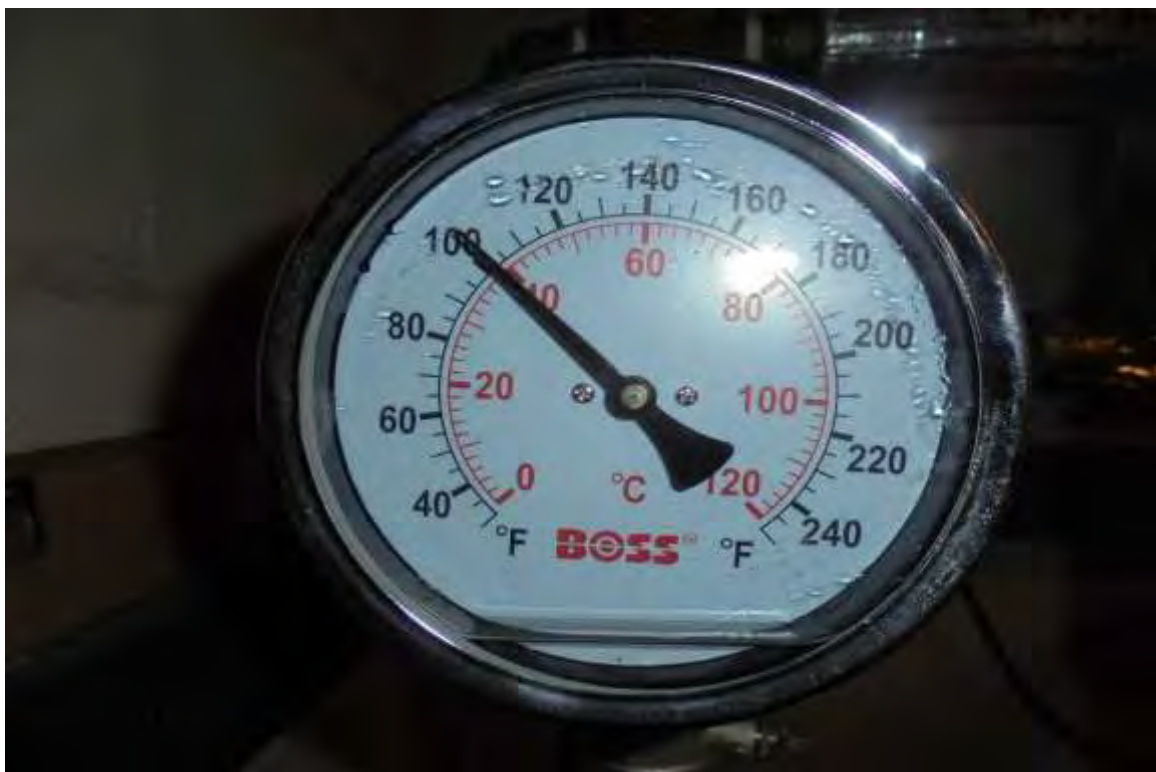
**Gas Fired Water Heater No. 1 – Contents Temperature at Approximately 40°C  
Water in Gauge – Replace**

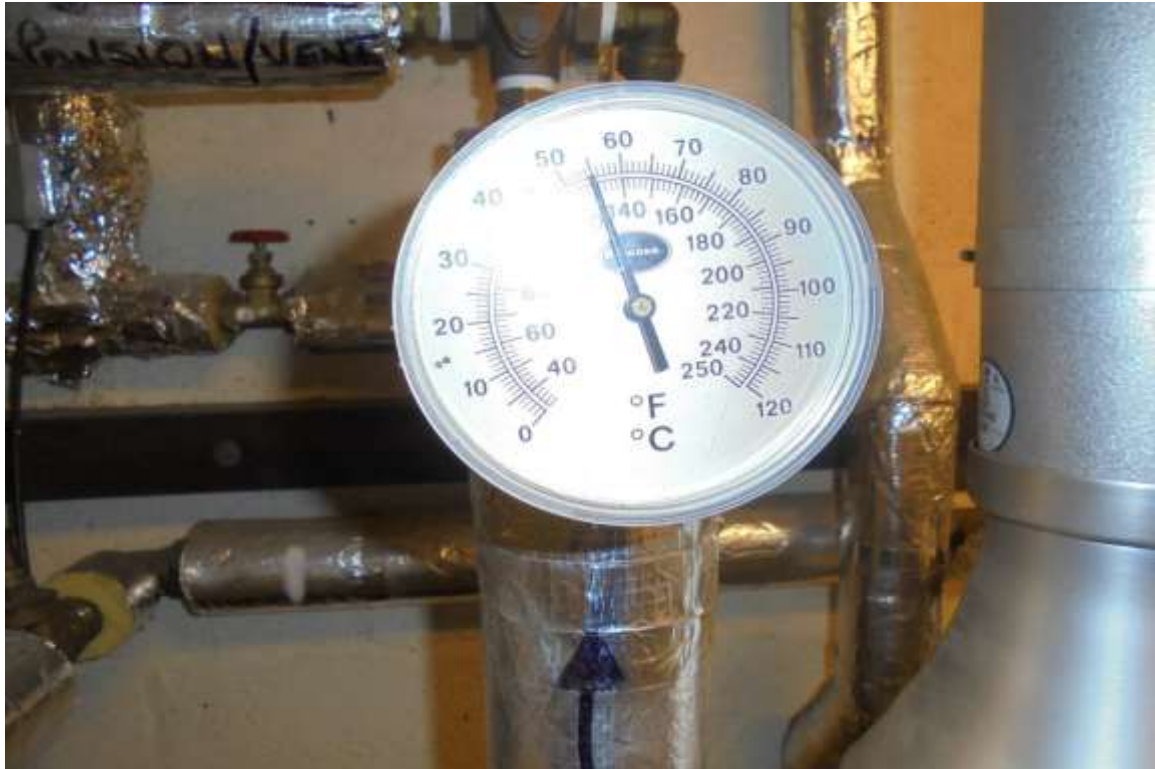
**Gas Fired Water Heater No. 2 – Contents Temperature approx. 54°C**

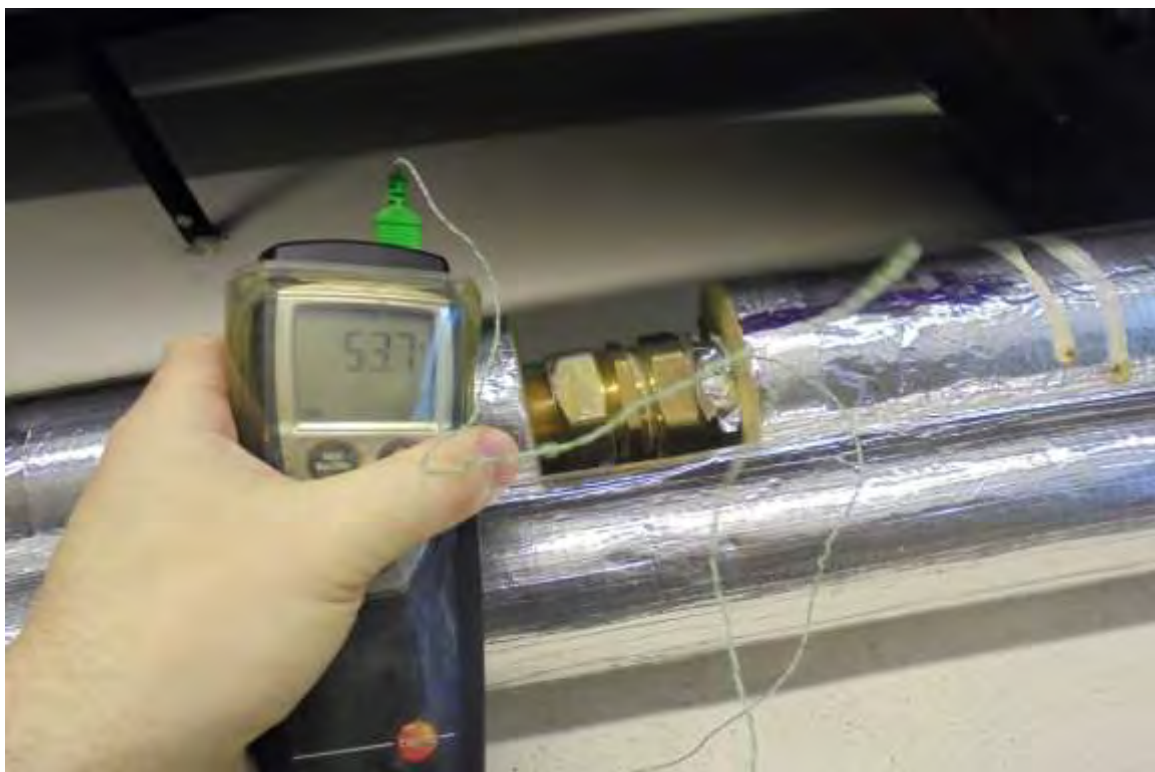
**DHWS Flow Temperature Too Low (<60°C)**

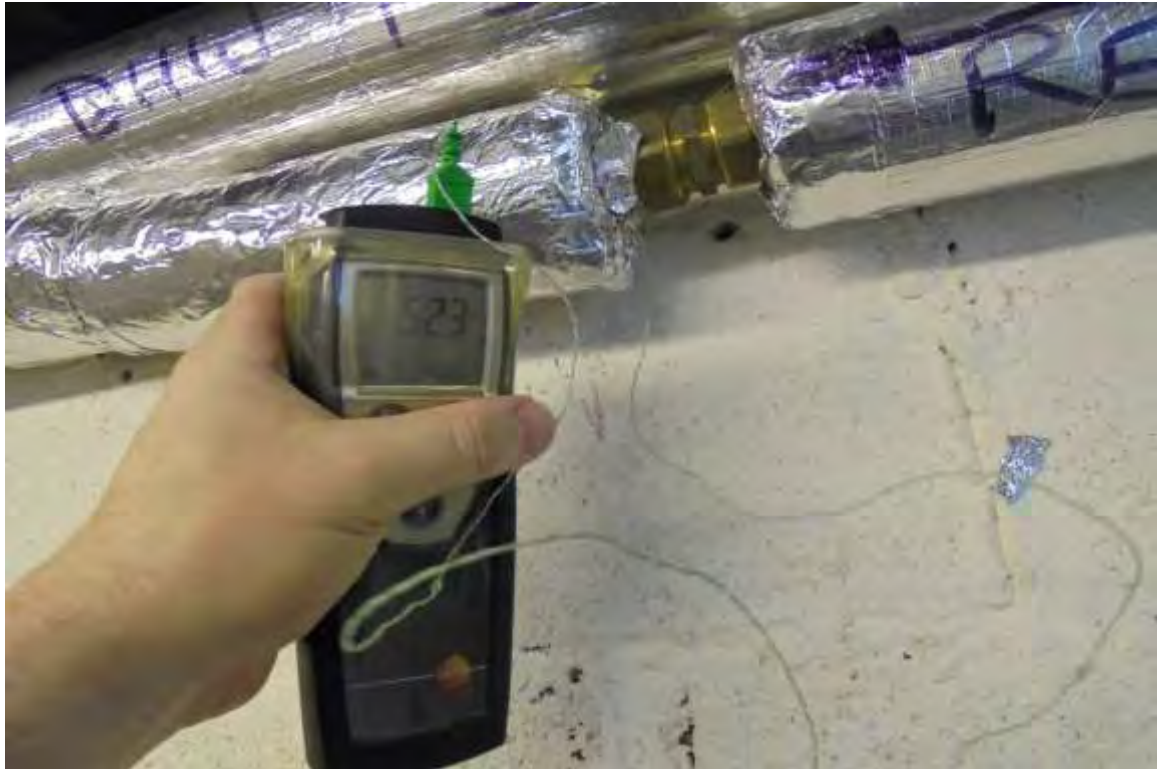
**DHWS Return Temperature Too Low (<55°C)**

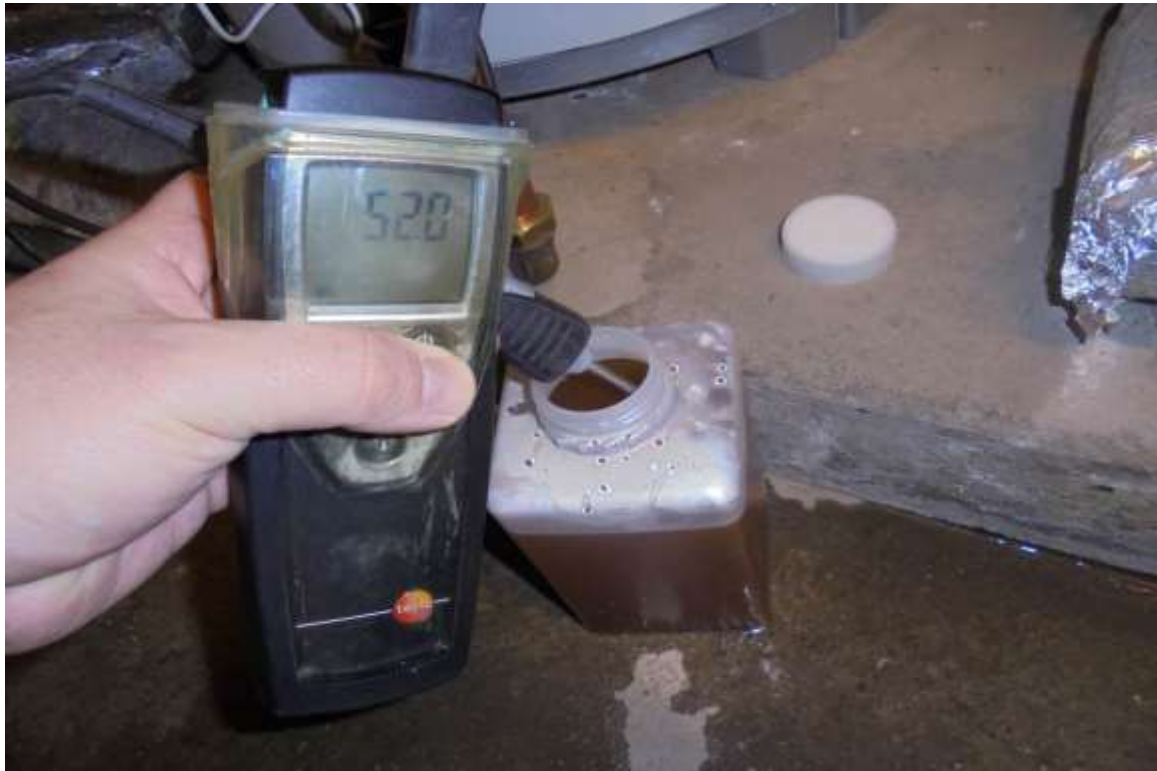
**Gas Fired Water Heater No. 1 – Drain Sample Discoloured and at Acceptable Temperature**

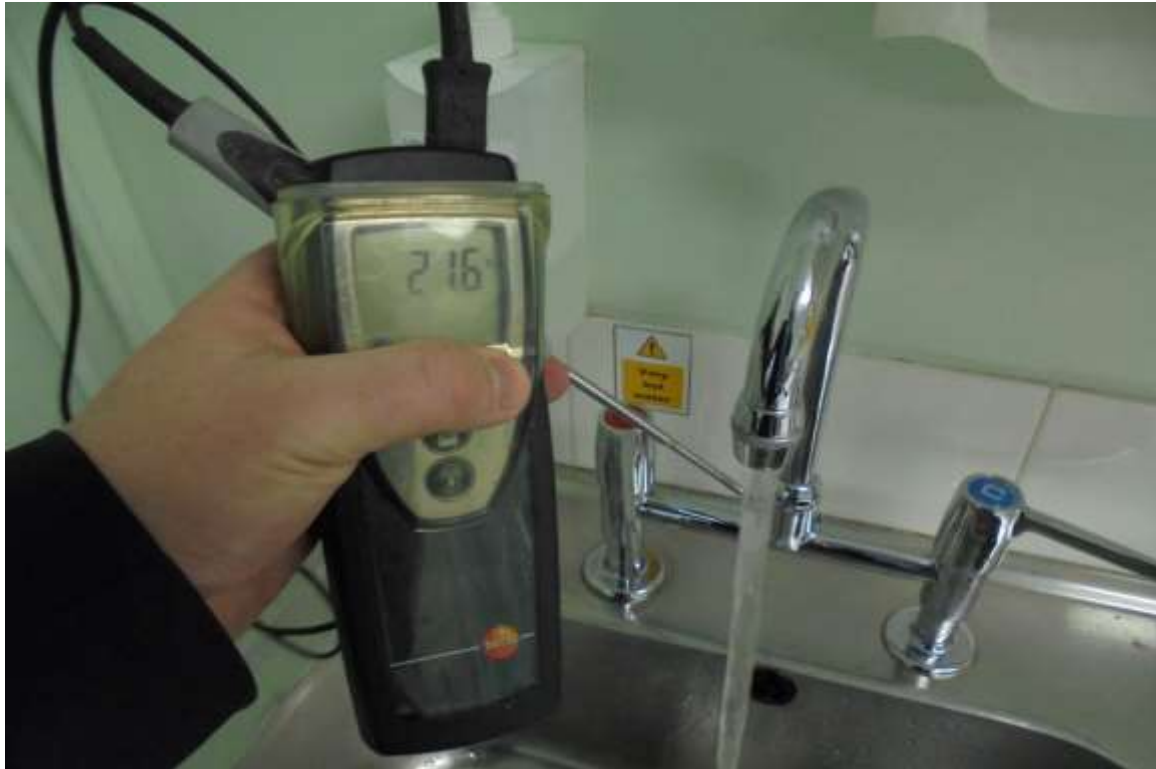
**Room 8 (G/05) Sink - Hot Water Outlet Temperature Too Cold (<50°C)**

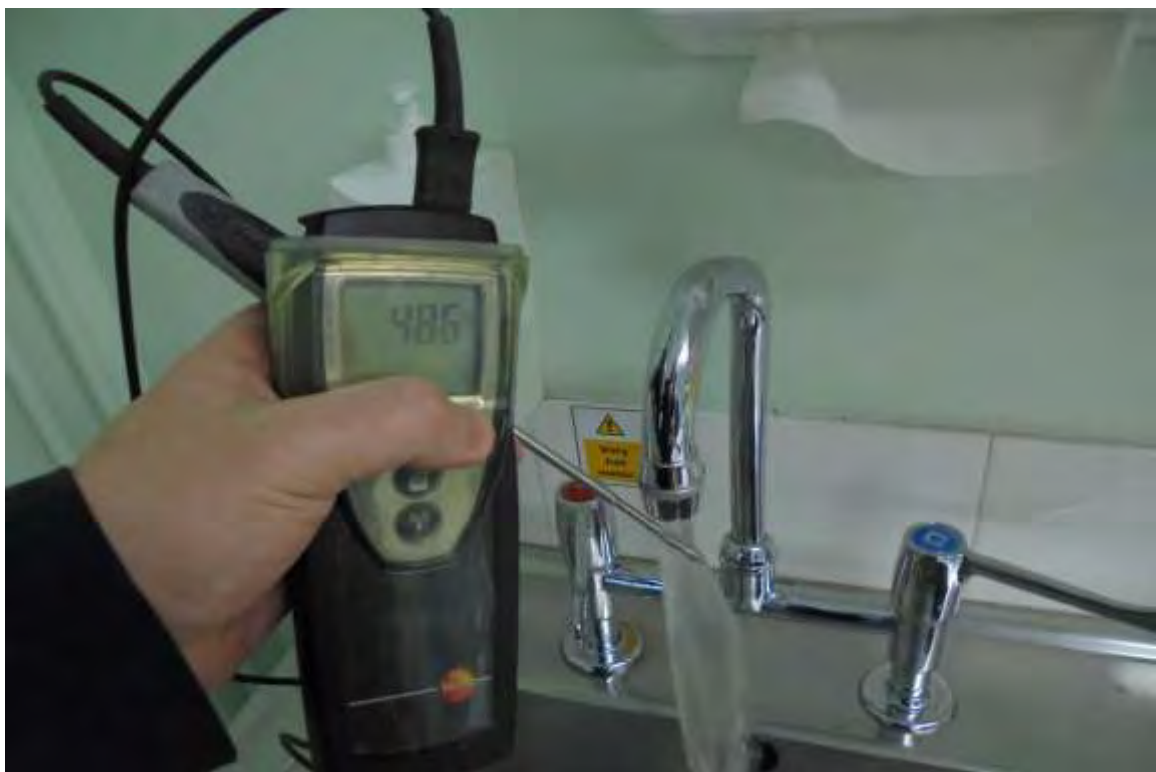
**Room 8 (G/05) Sink - Hot Water Outlet Temperature Too Low (<50°C)  
After Extended Flush (4 Minutes)**

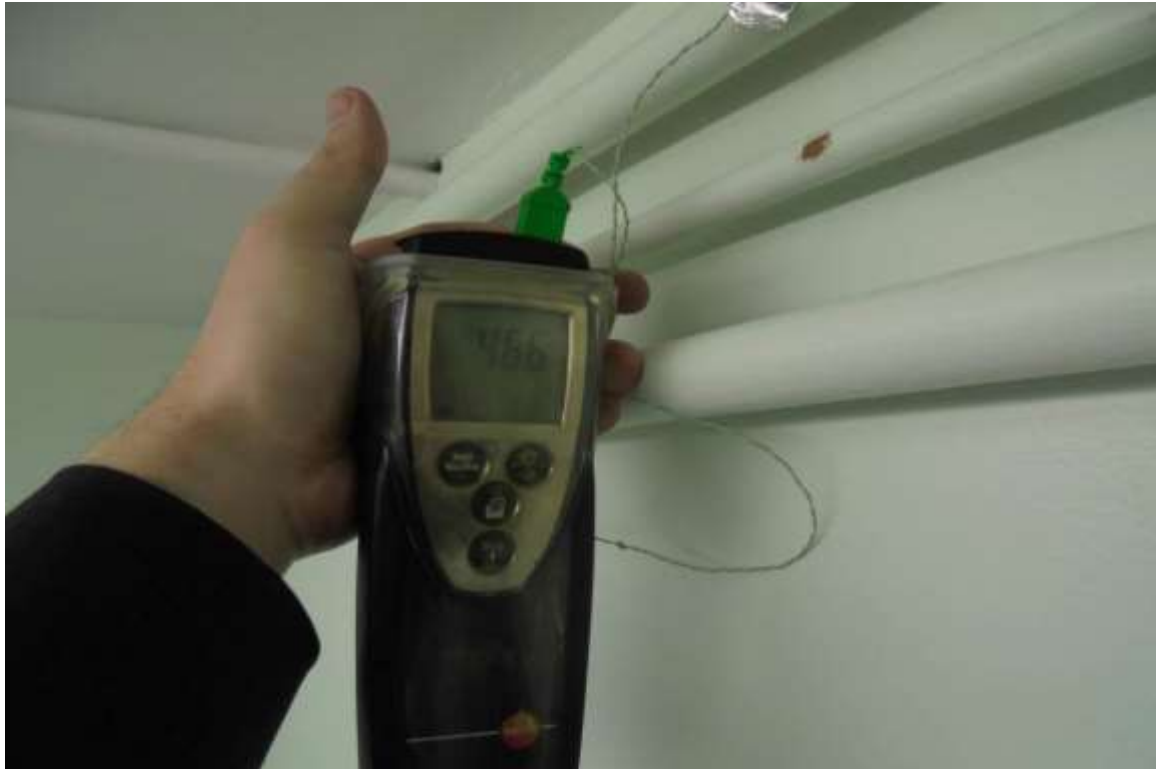
**Secretarial Office (G/09) Hot Water Flow Temperature Too Low (<55°C)**

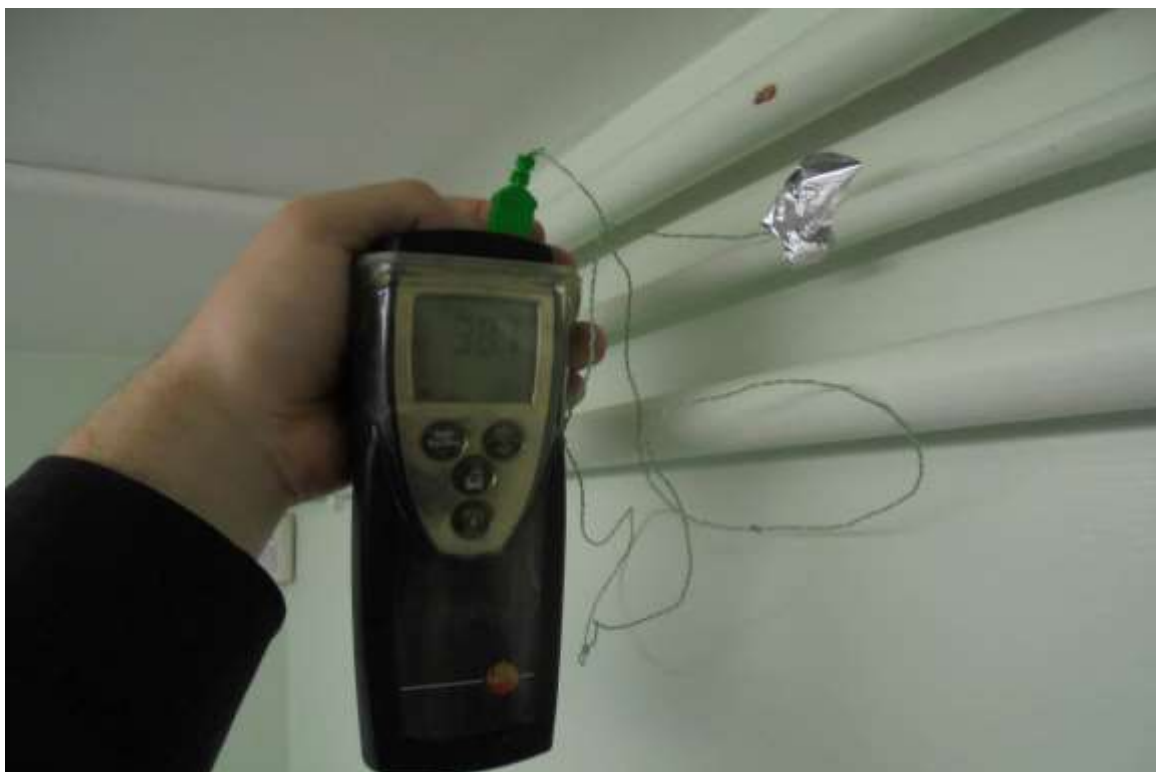
**Secretarial Office (G/09) Hot Water Return Temperature Too Low (<55°C)**

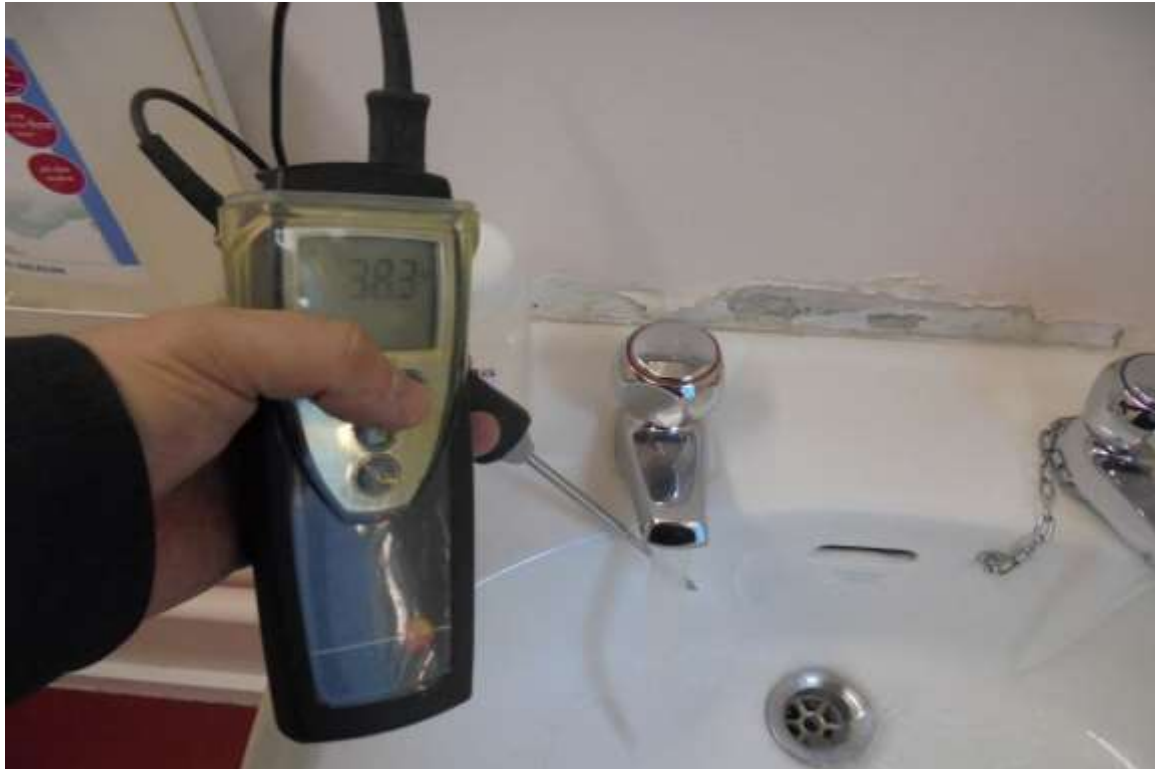
**Patients Toilet G39 WHB – Hot Water Outlet Temperature Satisfactory  
Thermostatic Control**

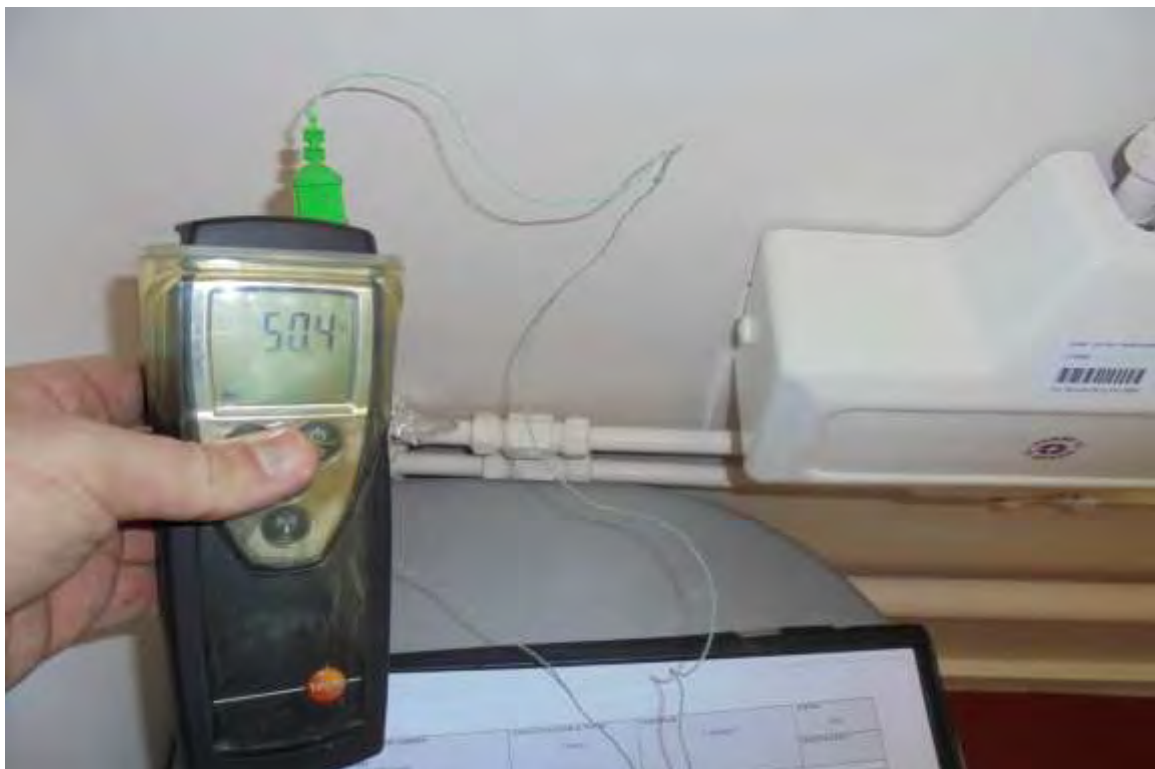
**Reception Gents Toilet WHB – Supply Temperature to TMV Too Low (<55°C)**

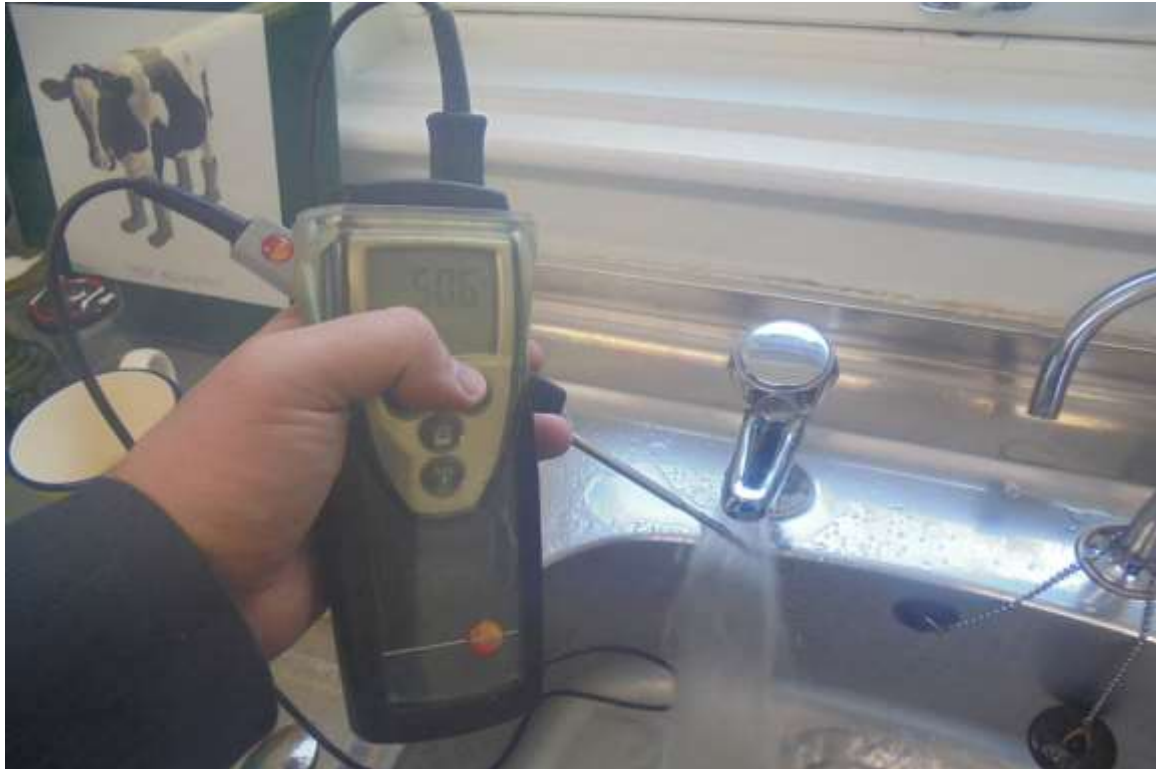
### **1<sup>st</sup> Floor Staff Room Kitchen Sink - Hot Water Outlet Temperature Too Low (<55°C)**

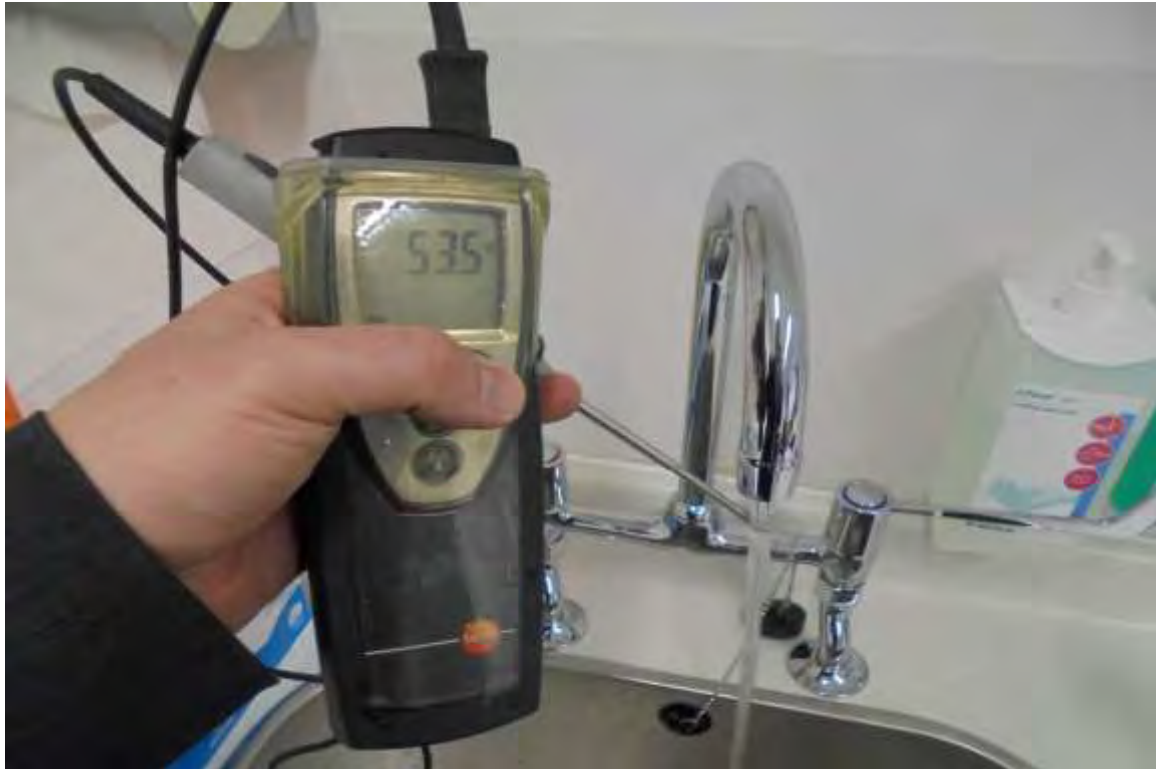
**Extension Consulting Room 3 Sink - Hot Water Outlet Slightly Low (<50°C)**
