## FREEDOM OF INFORMATION – LEGIONELLA

I write in response to your request for information in relation to Legionella in East Calder Health Centre.

This document relates to an ongoing programme of water quality monitoring at East Calder Health Centre, carried out by Westfield Caledonian during February 2016. As part of this visit, a review of the Water Quality Risk Assessment, relating to the domestic water systems contained within this building was carried out. This survey was carried out to satisfy the requirements of the Approved Code of Practice (L8) and guidance document HSG 274 and to determine aspects of the system design, condition and mode of operation which may compromise the quality of the water to which occupants are exposed and subsequent health risk. This assessment survey and control scheme review was carried out in a manner consistent with requirements with *BS8580:2010 Water Quality-Risk Assessment for Legionella control – code of practice*.

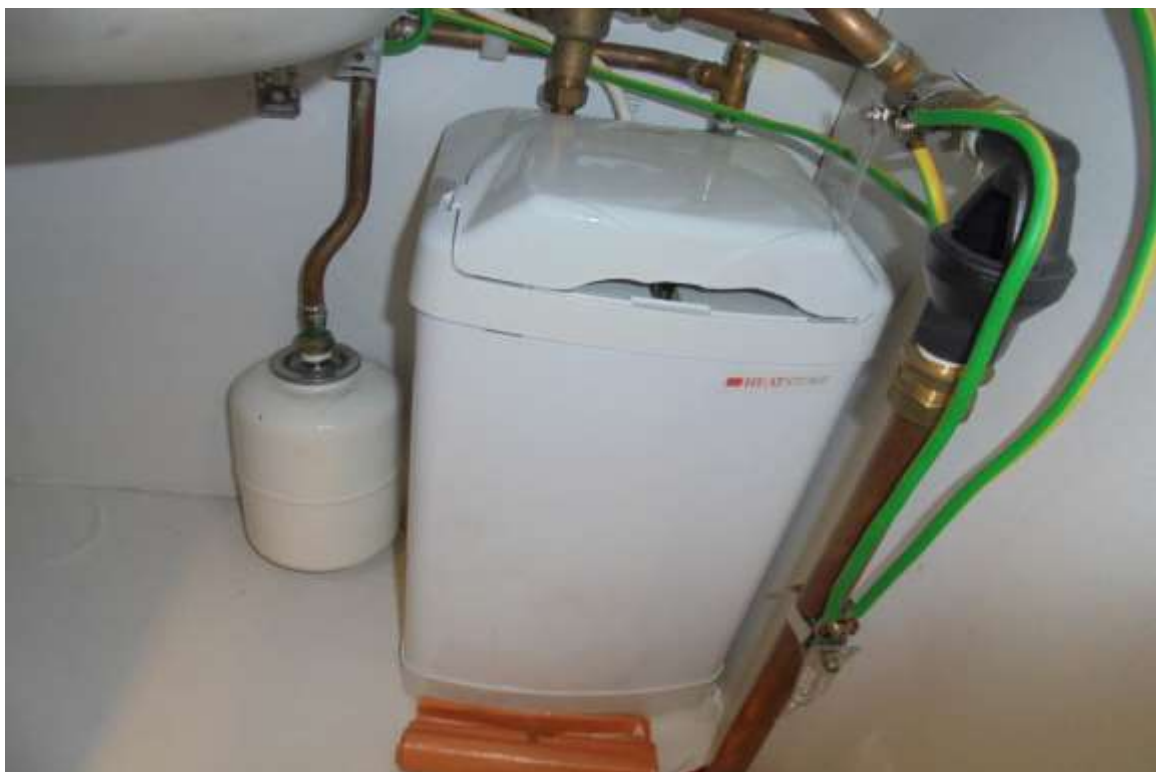
**Extension Consulting Room 3 Sink – Electric Point of Use Water Heater**

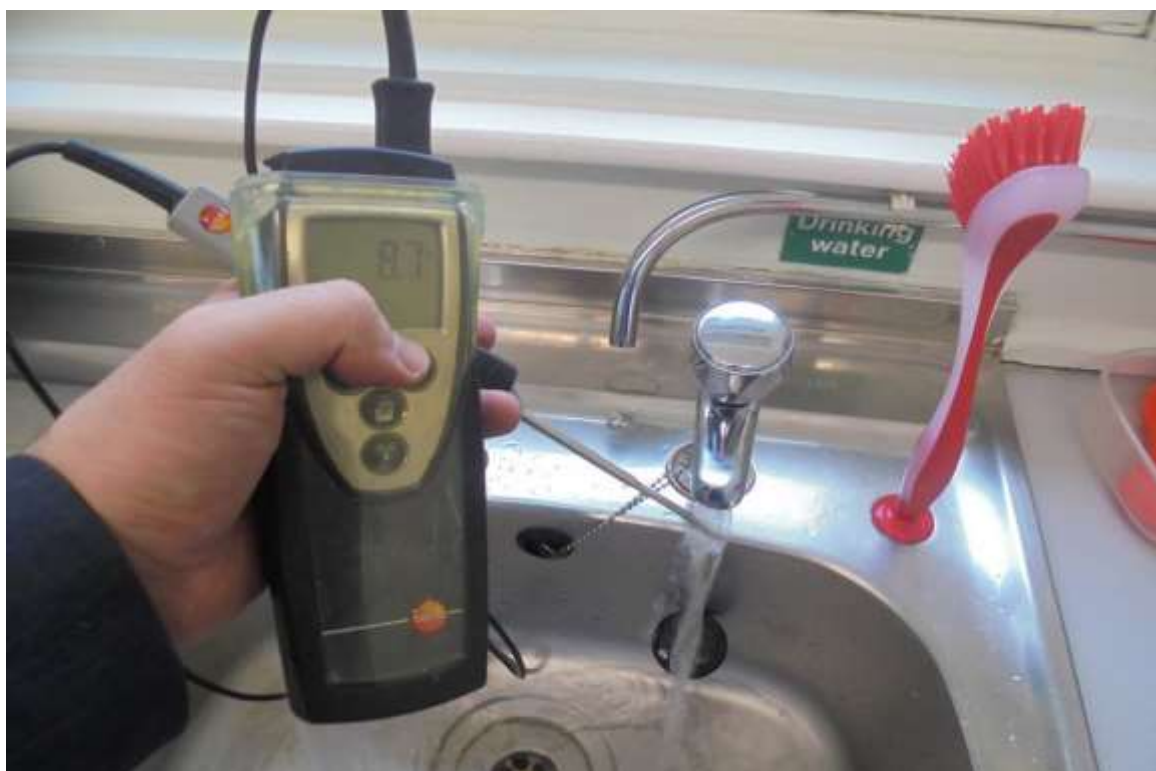
**1<sup>st</sup> Floor Staff Room Kitchen Sink - Cold Water Outlet Temperature Satisfactory**

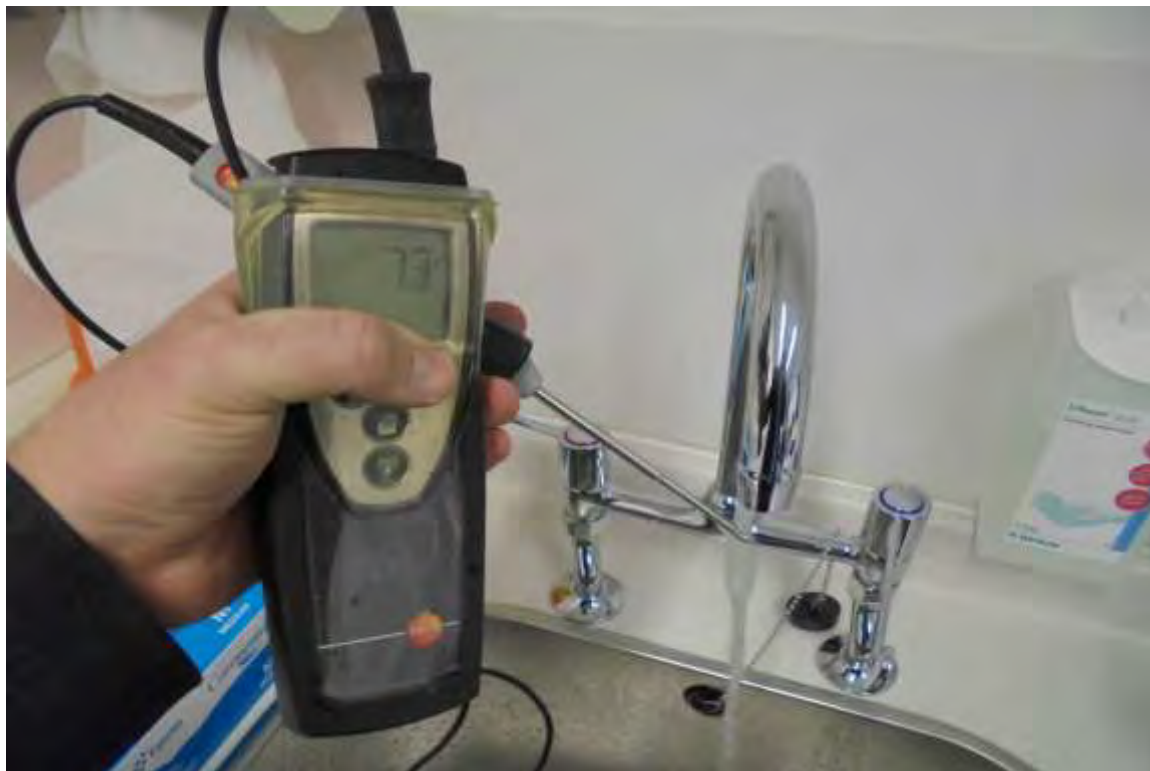
**Extension Consulting Room 3 Sink - Cold Water Outlet Temperature Satisfactory**

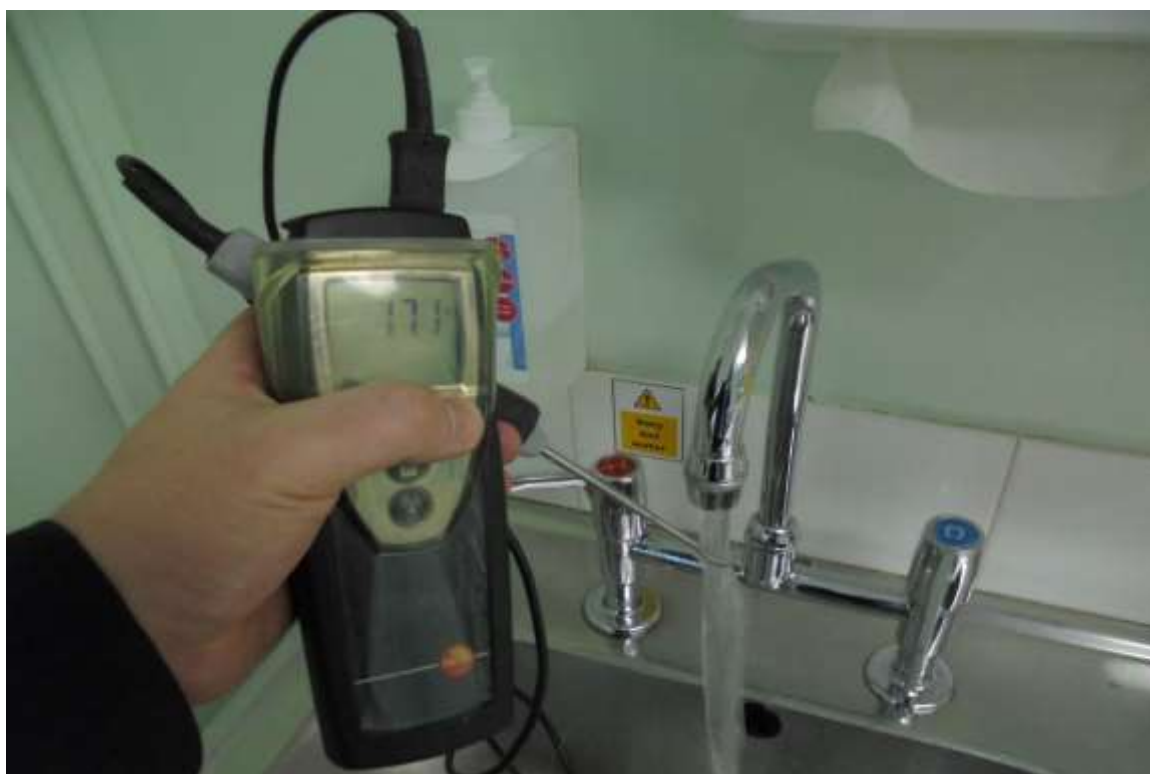
**Room 8 (G/05) Sink - Cold Water Outlet Temperature Too Warm ( $>20^{\circ}\text{C}$ )**

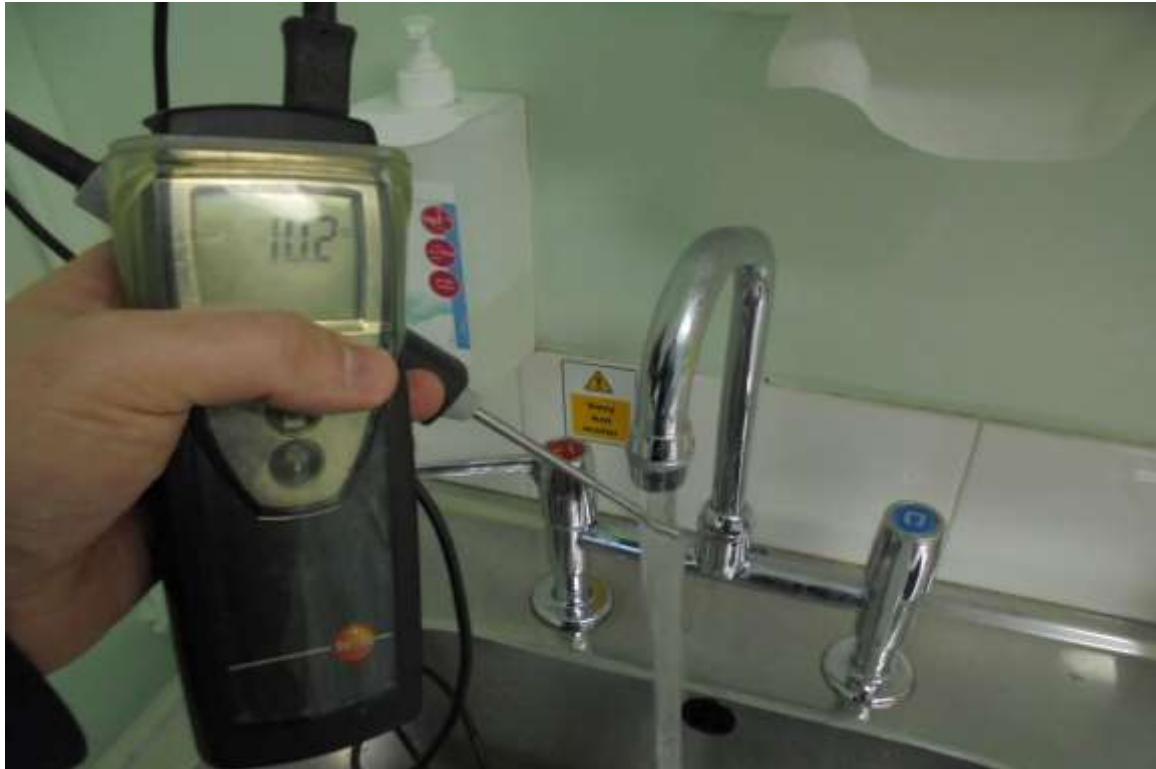
**Room 8 (G/05) Sink - Cold Water Outlet Temperature Satisfactory After Extended Flush (4 Minutes)**

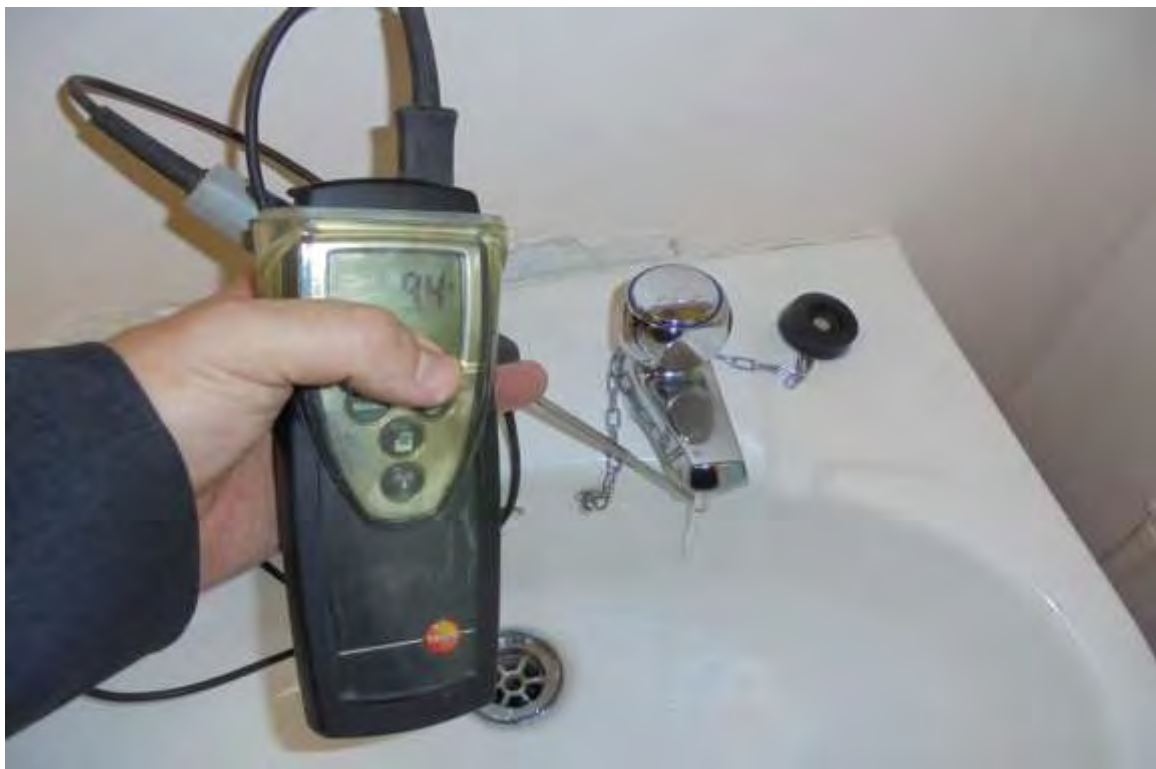
**Reception Gents Toilet WHB - Cold Water Outlet Temperature Satisfactory**

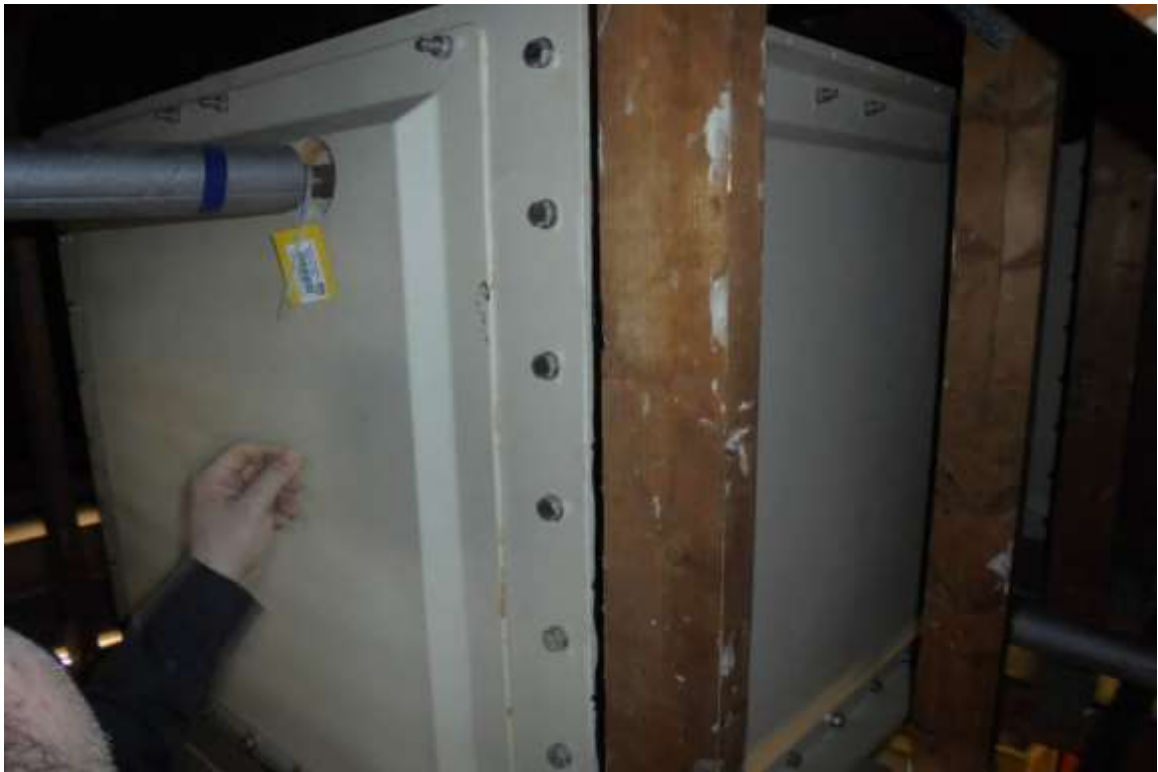
**Roofspace CWS Tank – Pre-Insulated Sectional Construction**

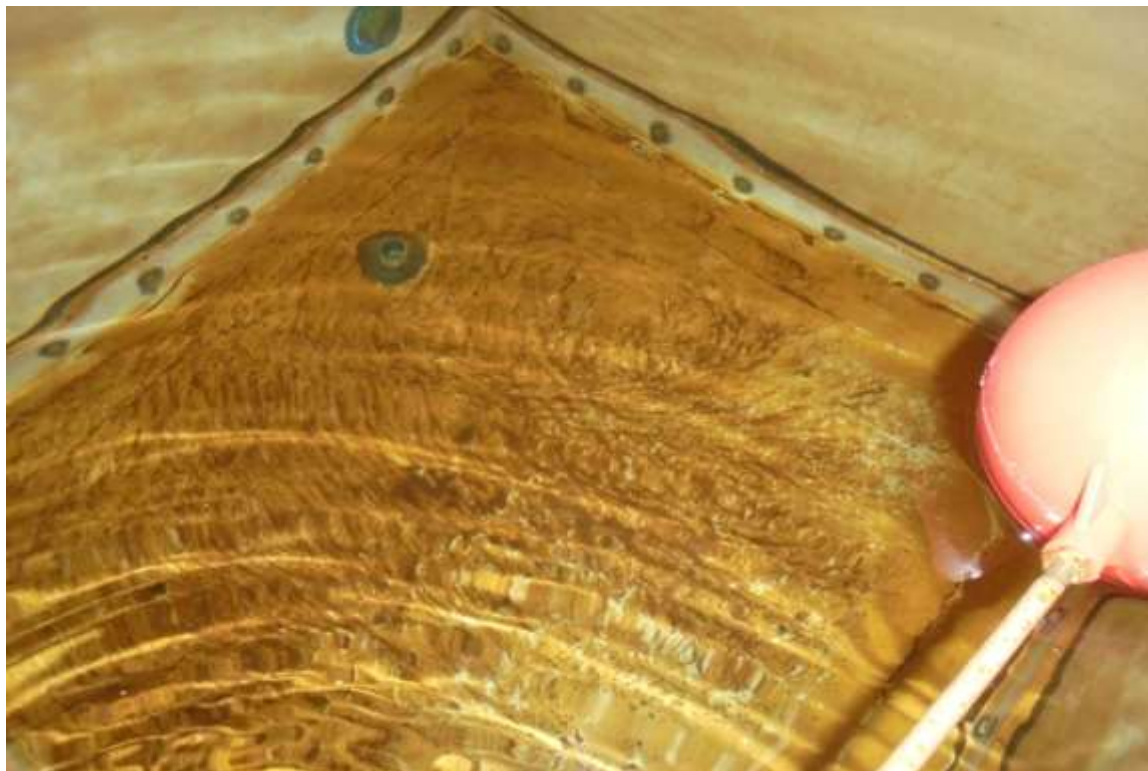
**CWS Tank No.1 – Acceptable Condition with Moderate Sediment at Base**

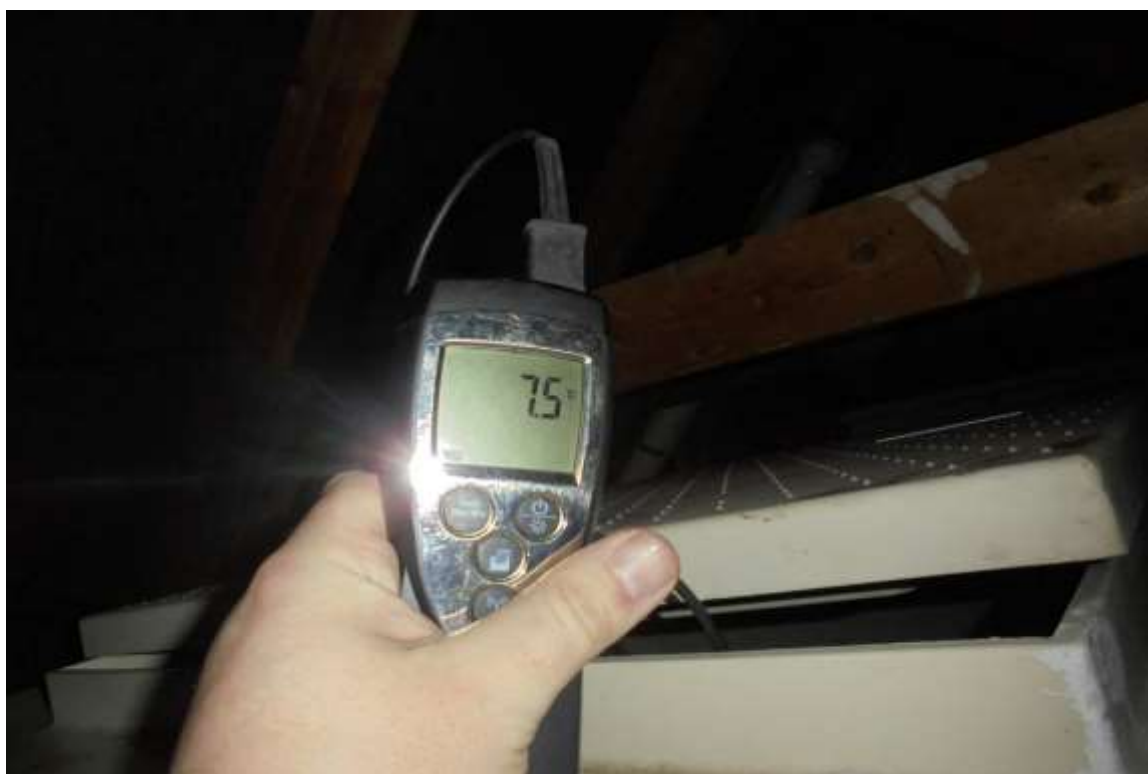
**CWS Tank No.1 – Contents Temperature 7.5°C**

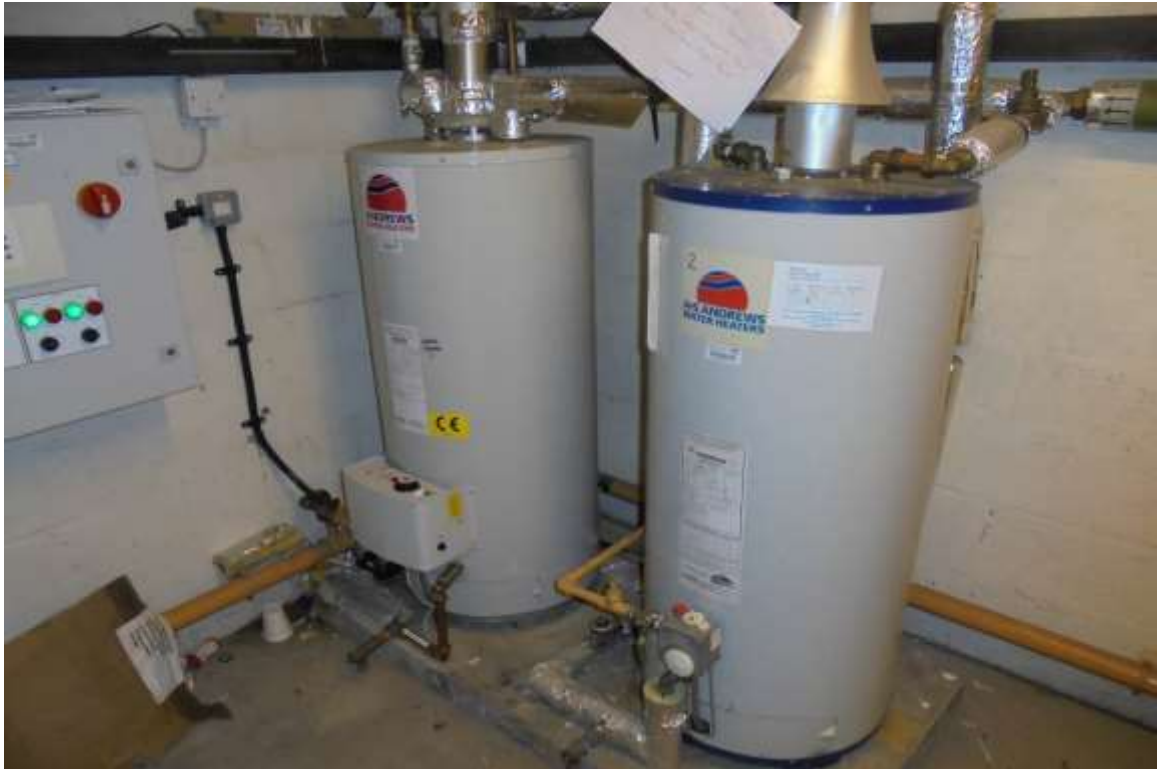
**Plantroom DHWS Gas Fired Water Heaters – General Arrangement**

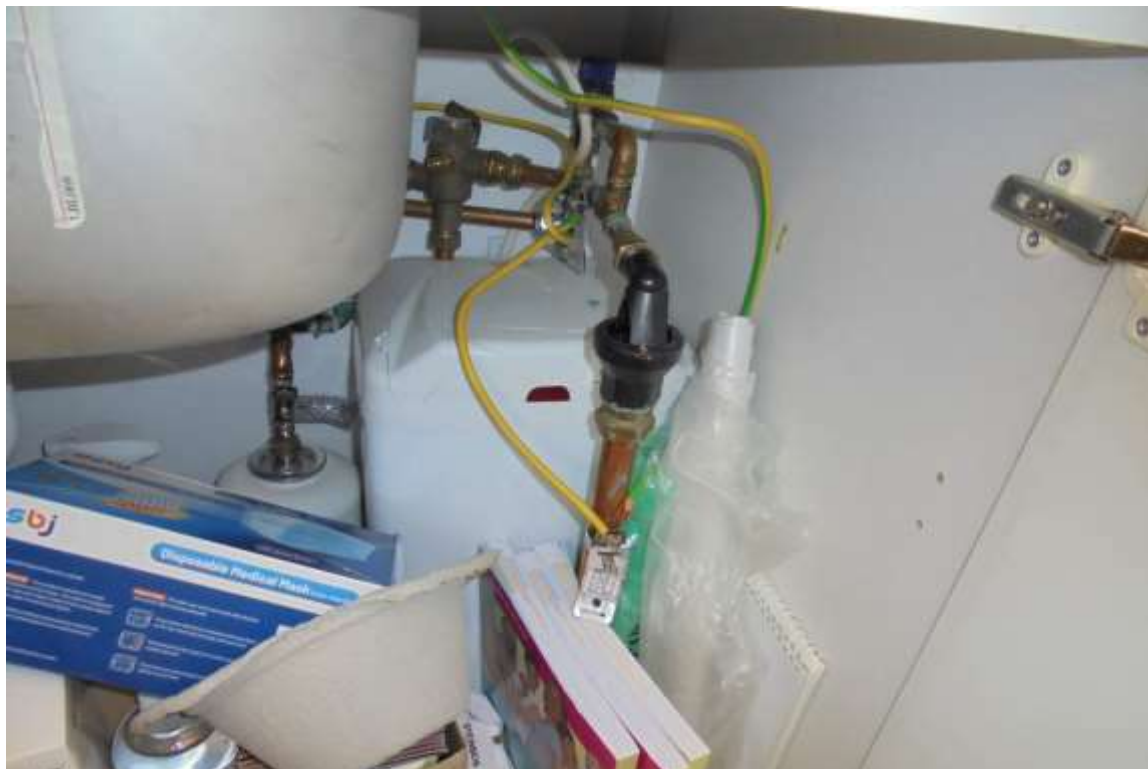
**Extension Consultant Room 2 Under-Sink Electric Water Heater Provided**

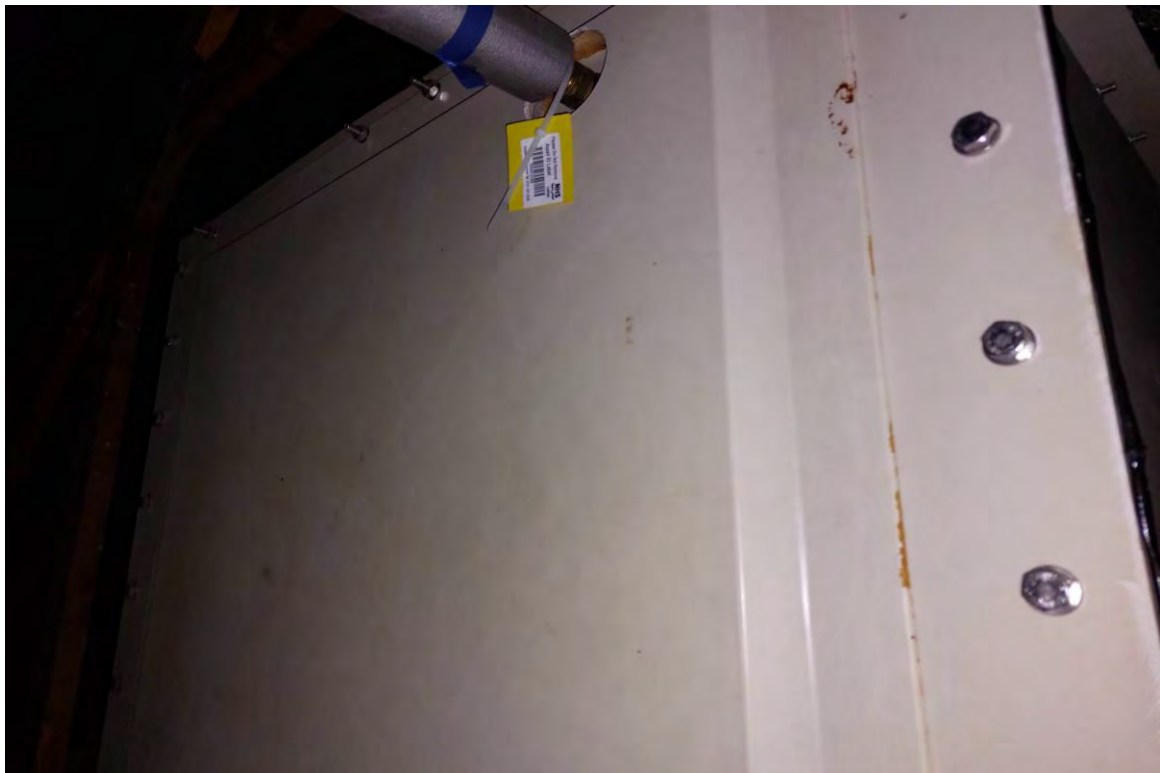
**Roofspace CWS Tank – Pre-Insulated Sectional Construction**

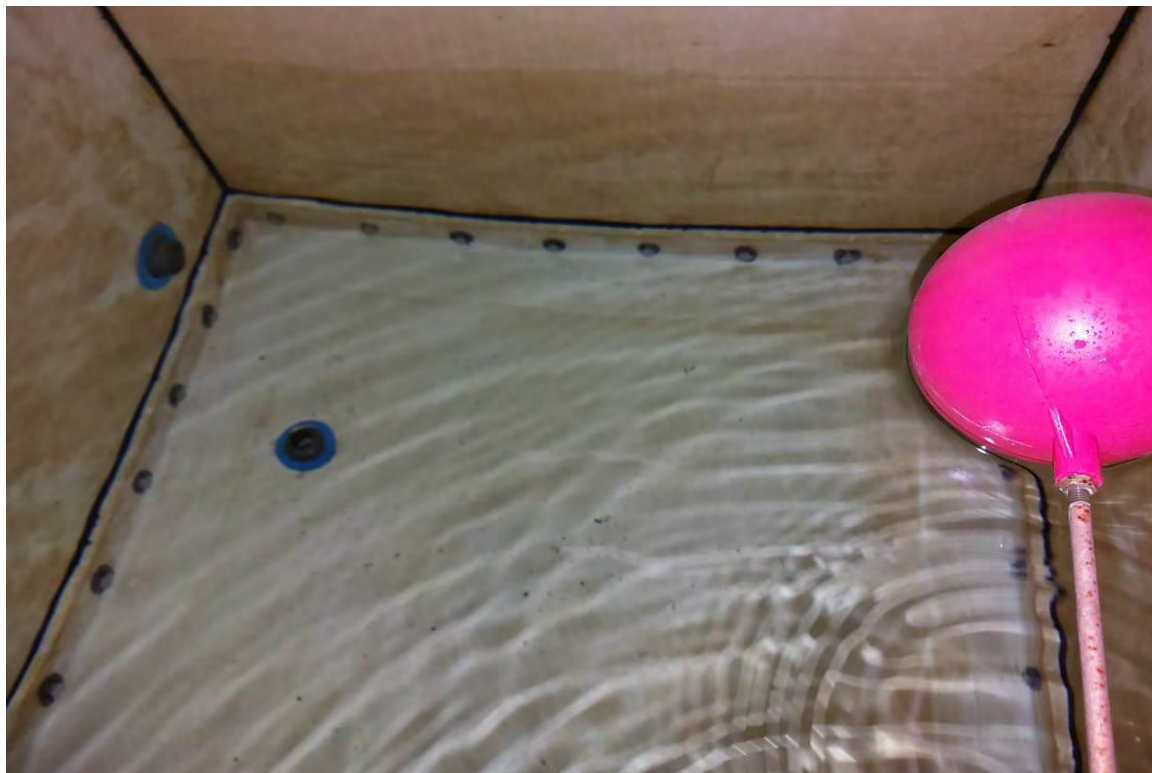
**CWS Tank No.1 – Acceptable Condition with Moderate Sediment at Base**

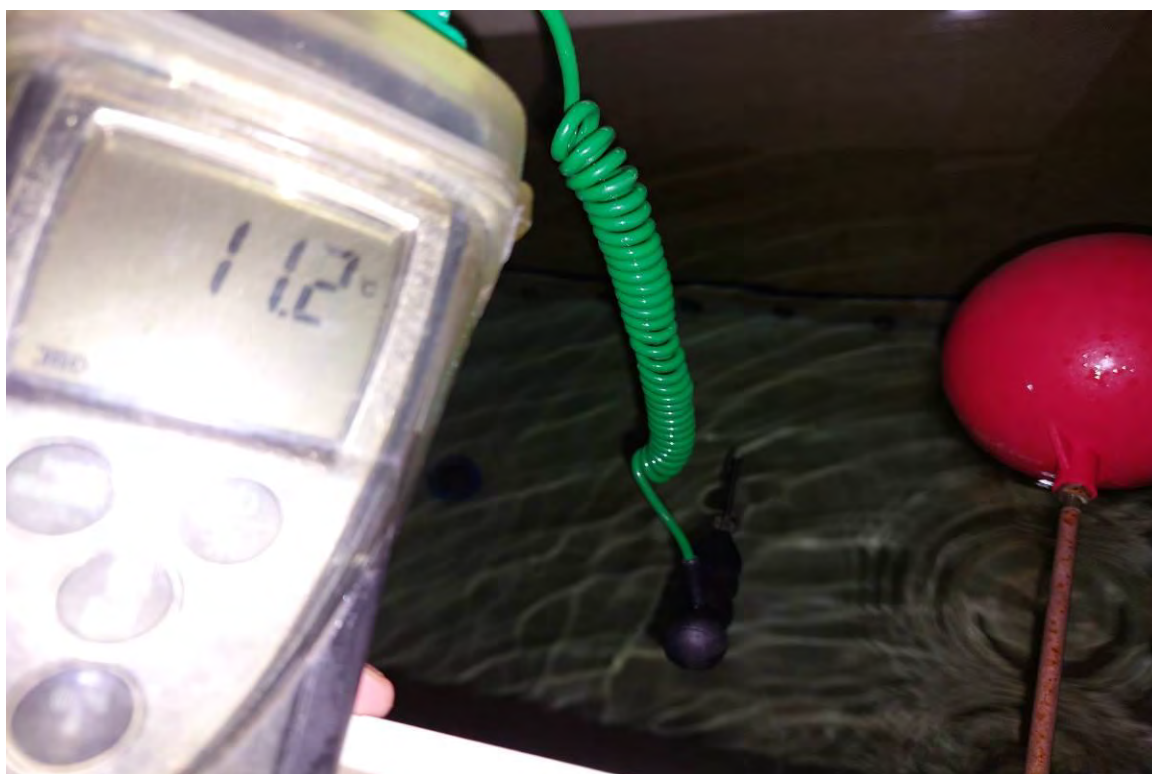
**CWS Tank No.1 – Contents Temperature 11.2°C**

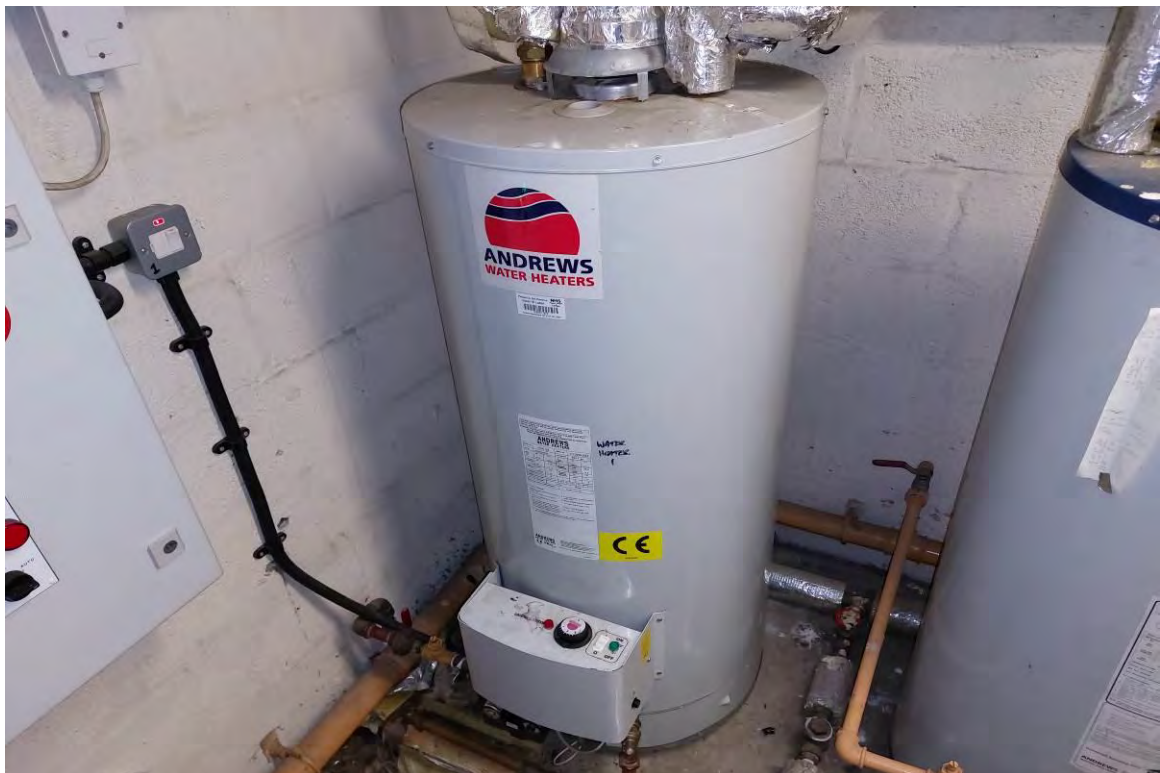
**Plantroom DHWS Gas Fired Water Heaters – General Arrangement**

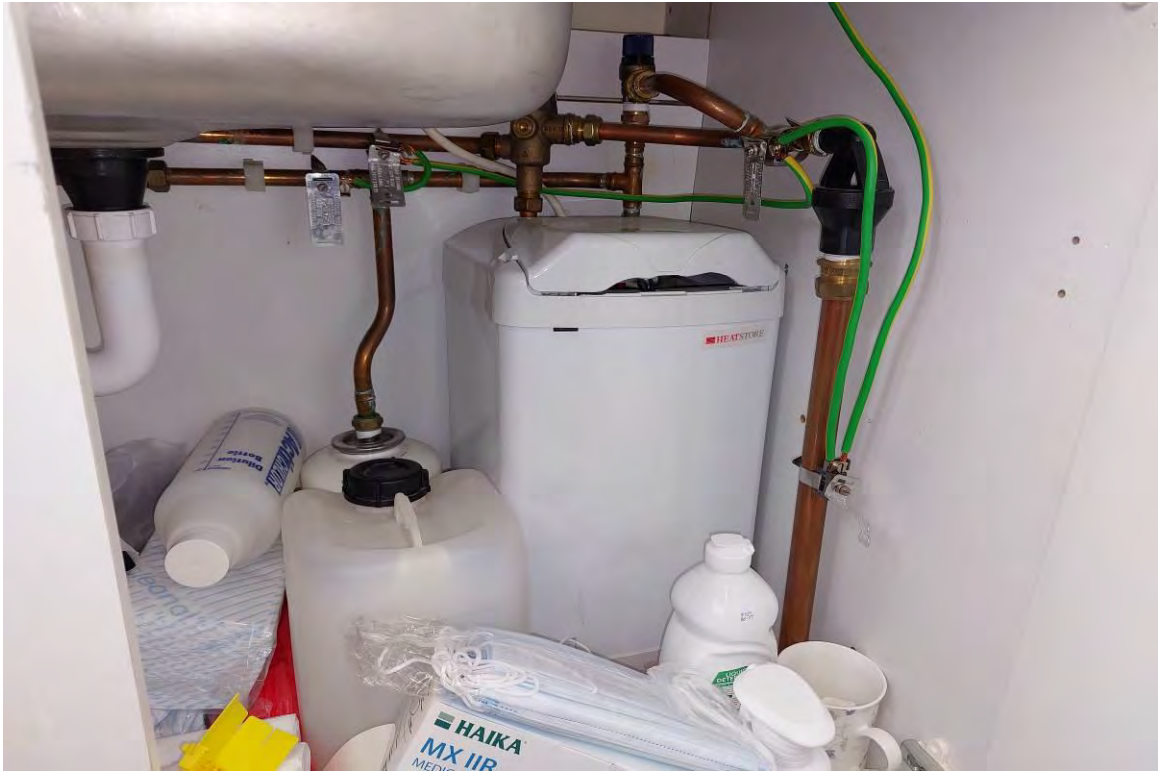
**Extension Consultant Room 3 Under-Sink Electric Water Heater Provided**
