## FREEDOM OF INFORMATION – LEGIONELLA

I write in response to your request for information in relation to Legionella in East Calder Health Centre.

This document relates to an ongoing programme of water quality monitoring at East Calder Health Centre, carried out by Westfield Caledonian during February 2016. As part of this visit, a review of the Water Quality Risk Assessment, relating to the domestic water systems contained within this building was carried out. This survey was carried out to satisfy the requirements of the Approved Code of Practice (L8) and guidance document HSG 274 and to determine aspects of the system design, condition and mode of operation which may compromise the quality of the water to which occupants are exposed and subsequent health risk. This assessment survey and control scheme review was carried out in a manner consistent with requirements with *BS8580:2010 Water Quality-Risk Assessment for Legionella control – code of practice*.

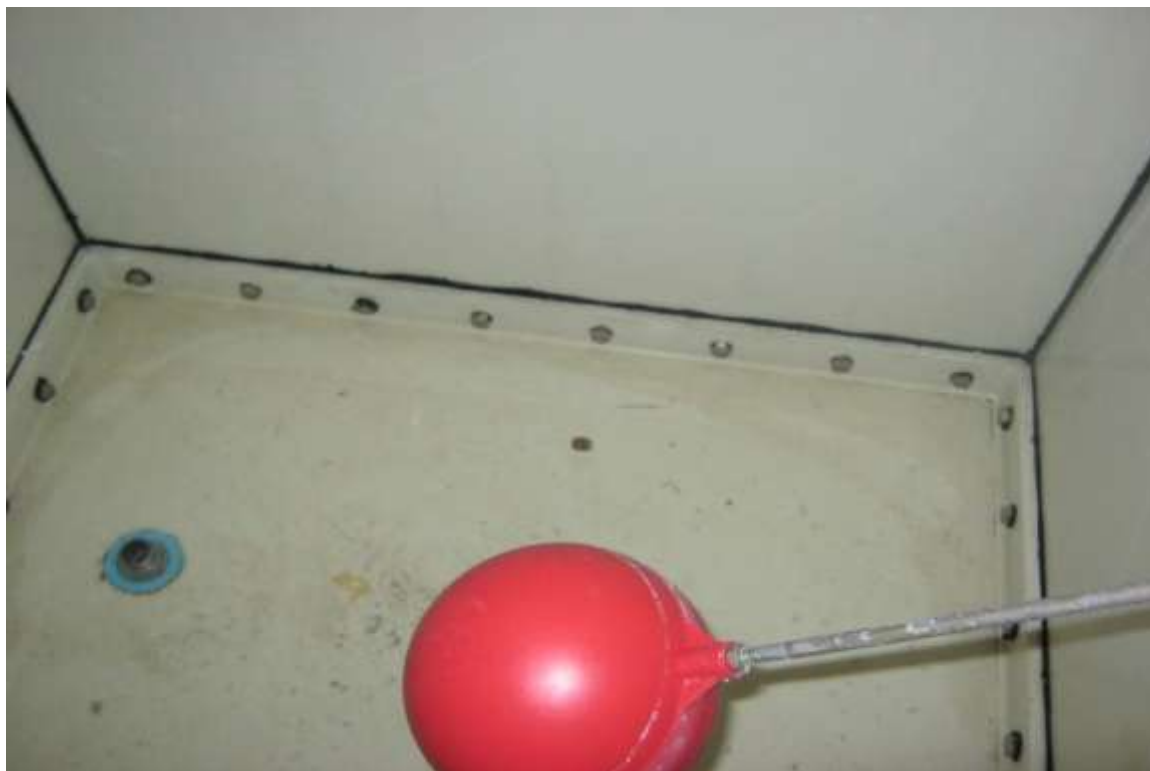
**CWS Tank No. 2 – Drained and Isolated**

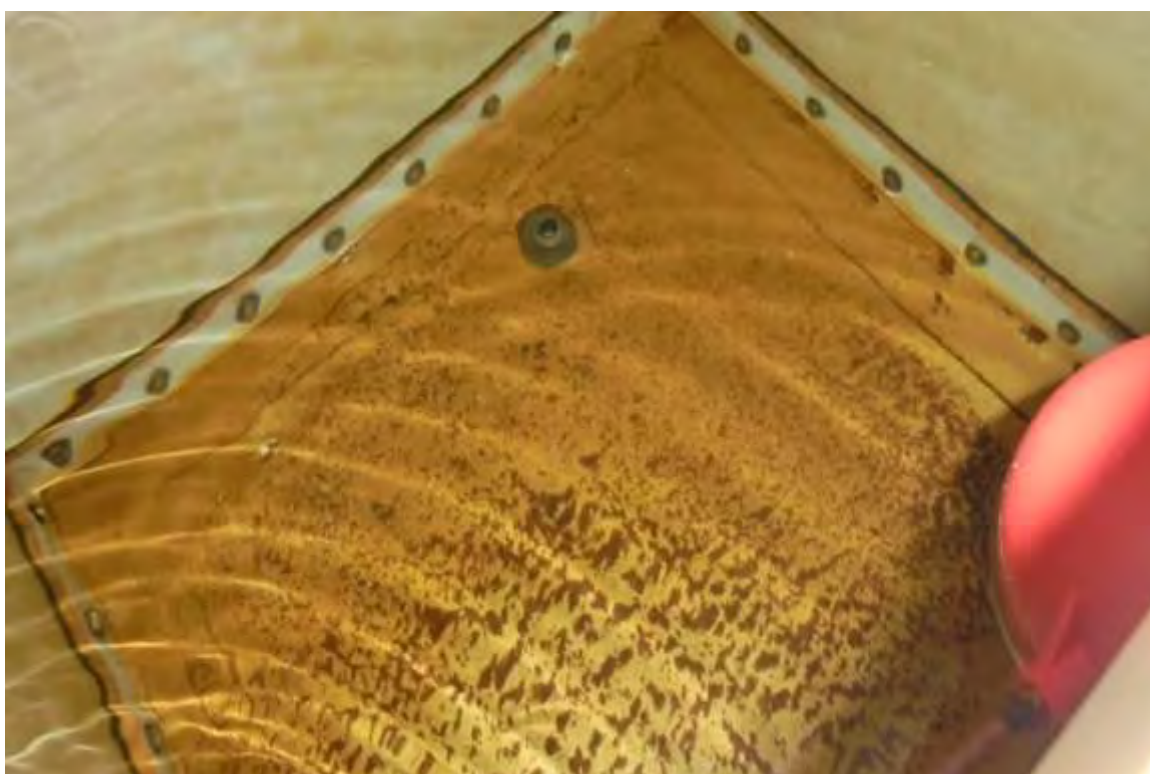
**CWS Tank No. 1 – Light Sedimental Accumulations**

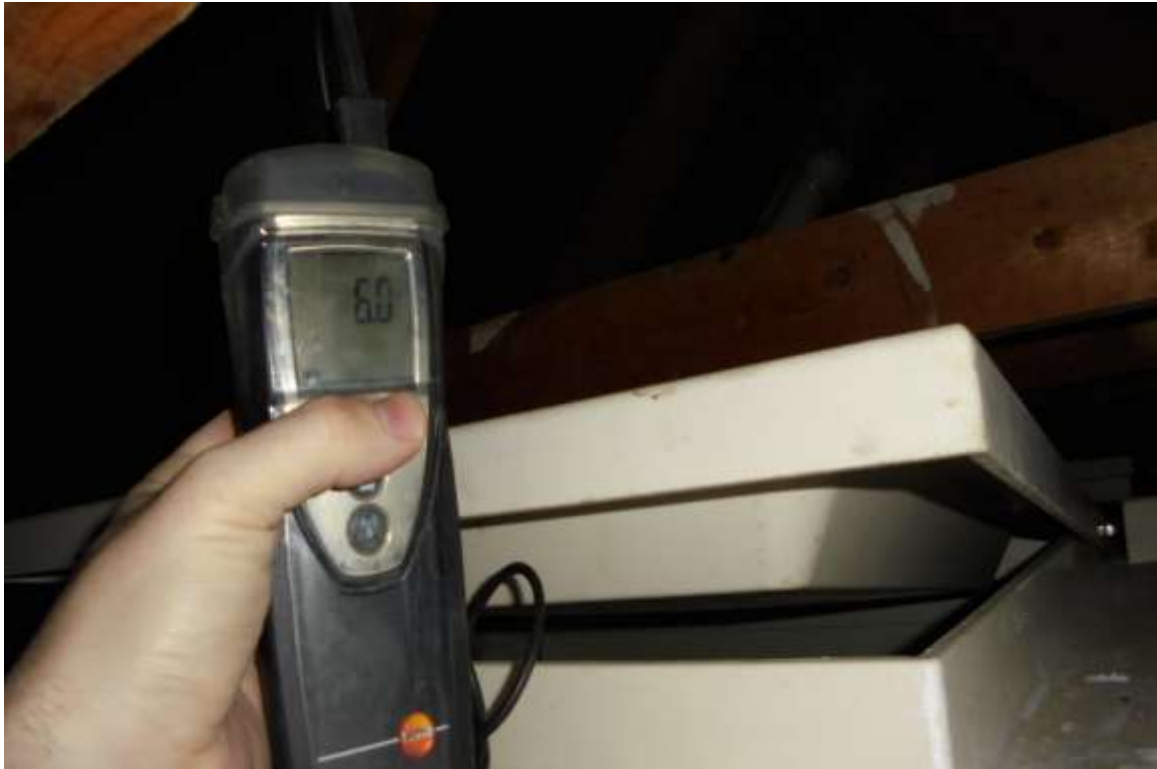
**CWS Tank No. 1 – Contents Temperature Satisfactory**

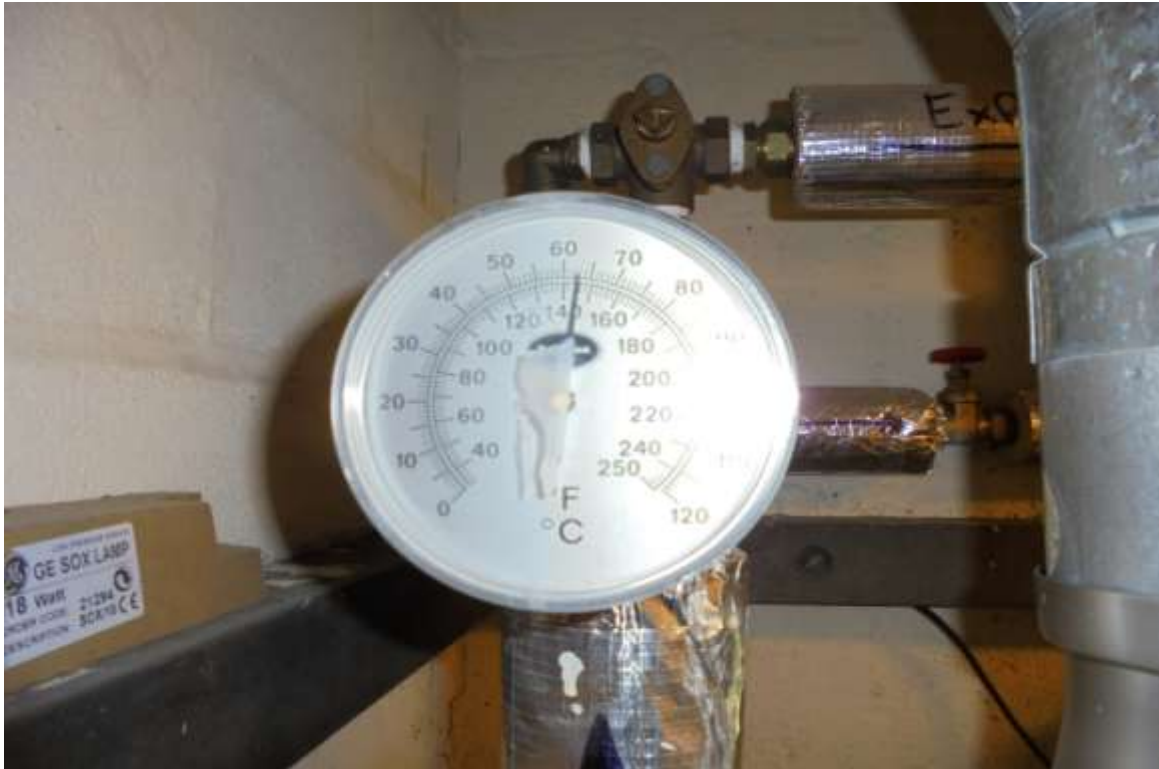
**Gas Fired Water Heater No. 1 – Contents Gauge at 62°C**

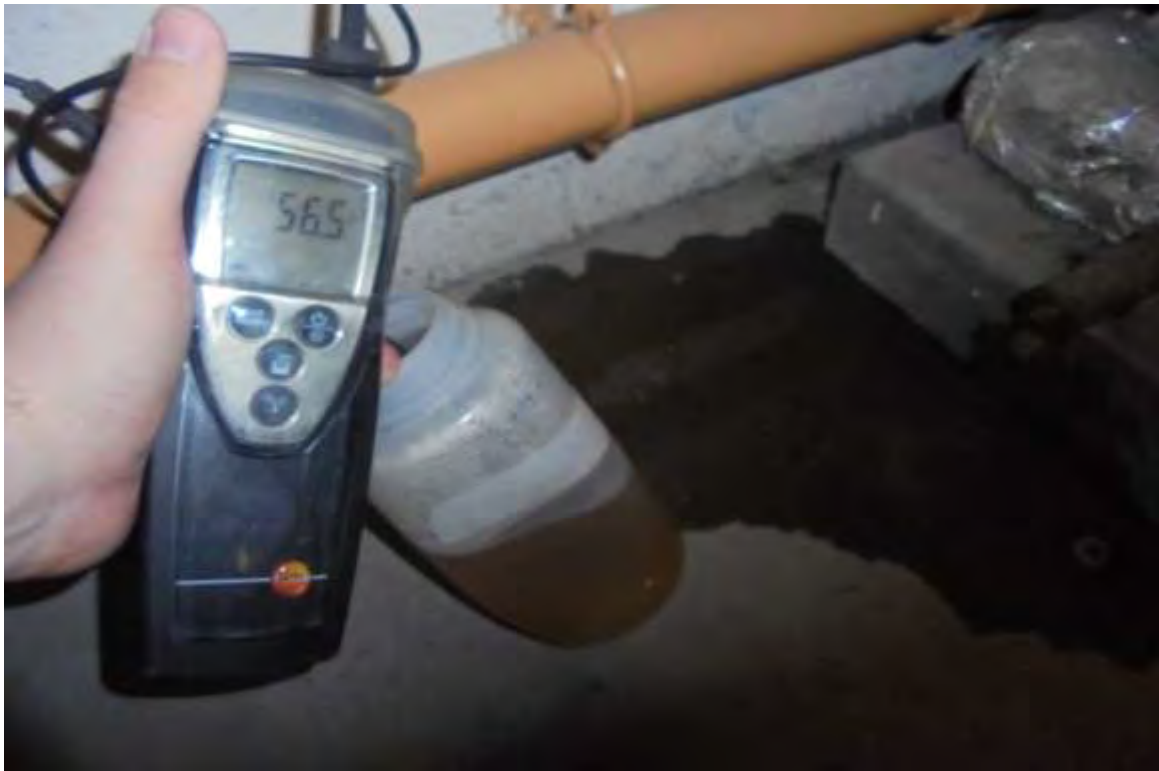
**Gas Fired Water Heater No. 1 – Drain Sample Discoloured and at Satisfactory Temperature**

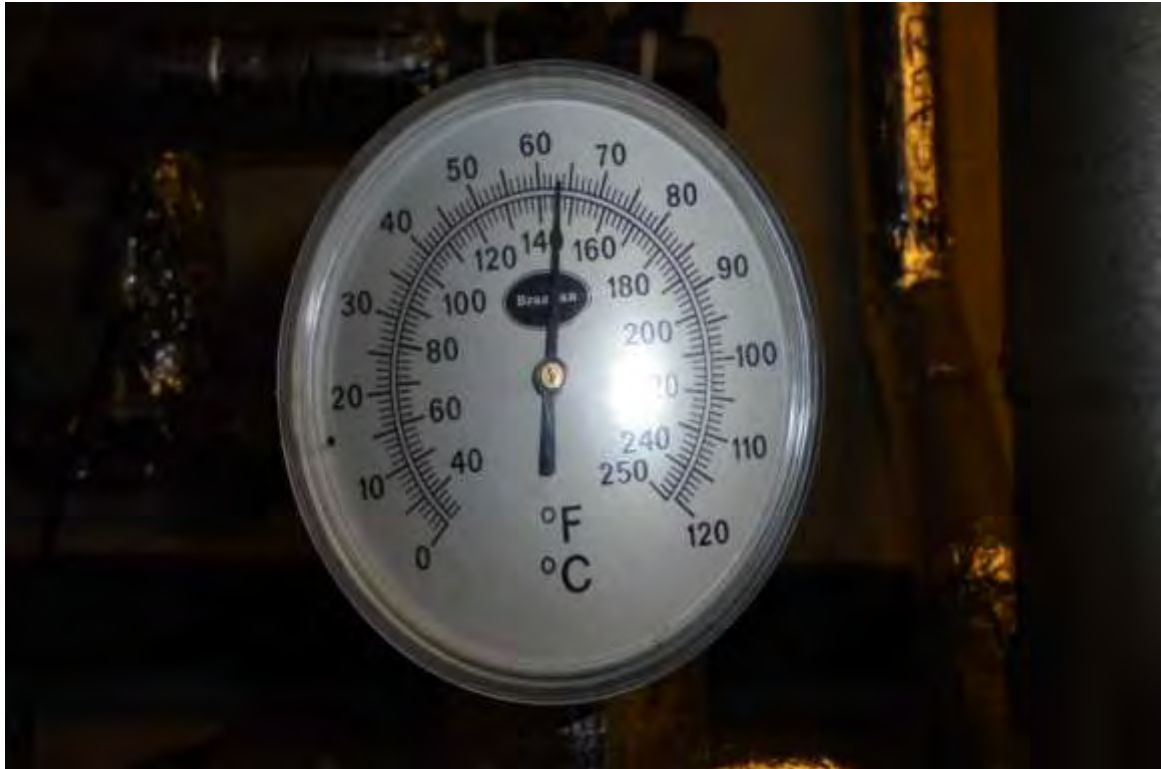
**Gas Fired Water Heater No. 2 – Contents Gauge at 62°C**

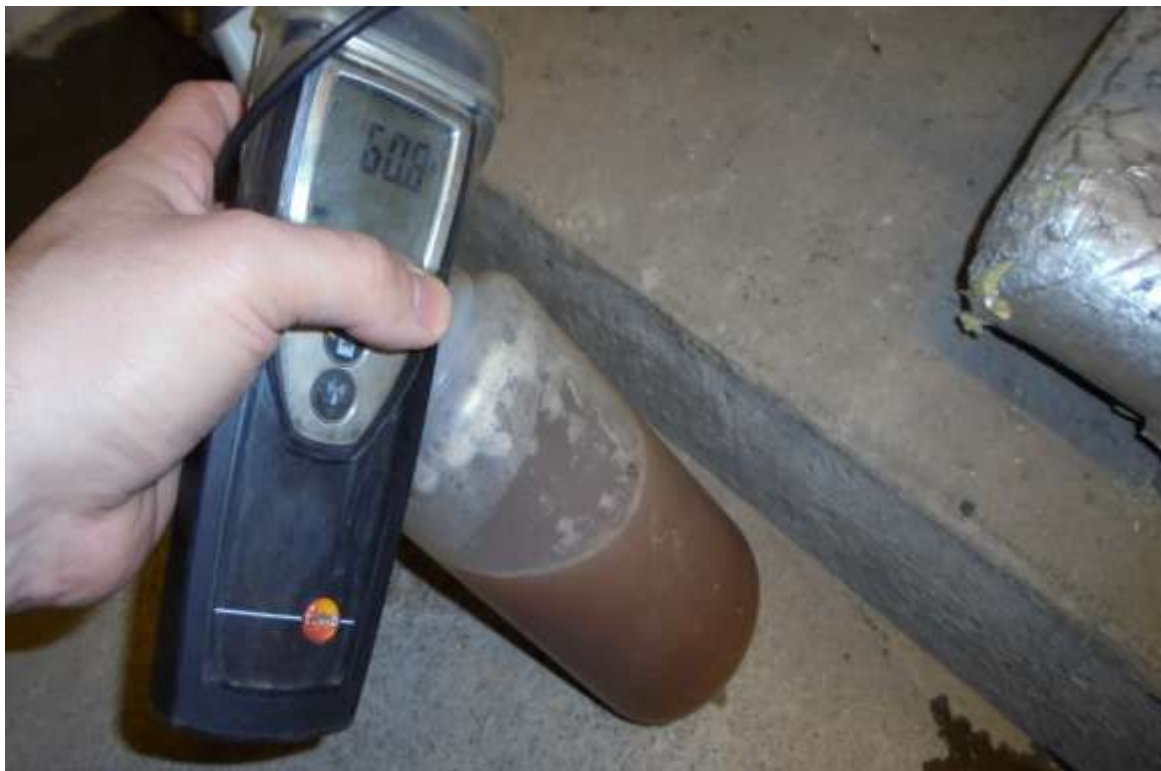
**Gas Fired Water Heater No. 2 – Drain Sample Discoloured and at Satisfactory Temperature**

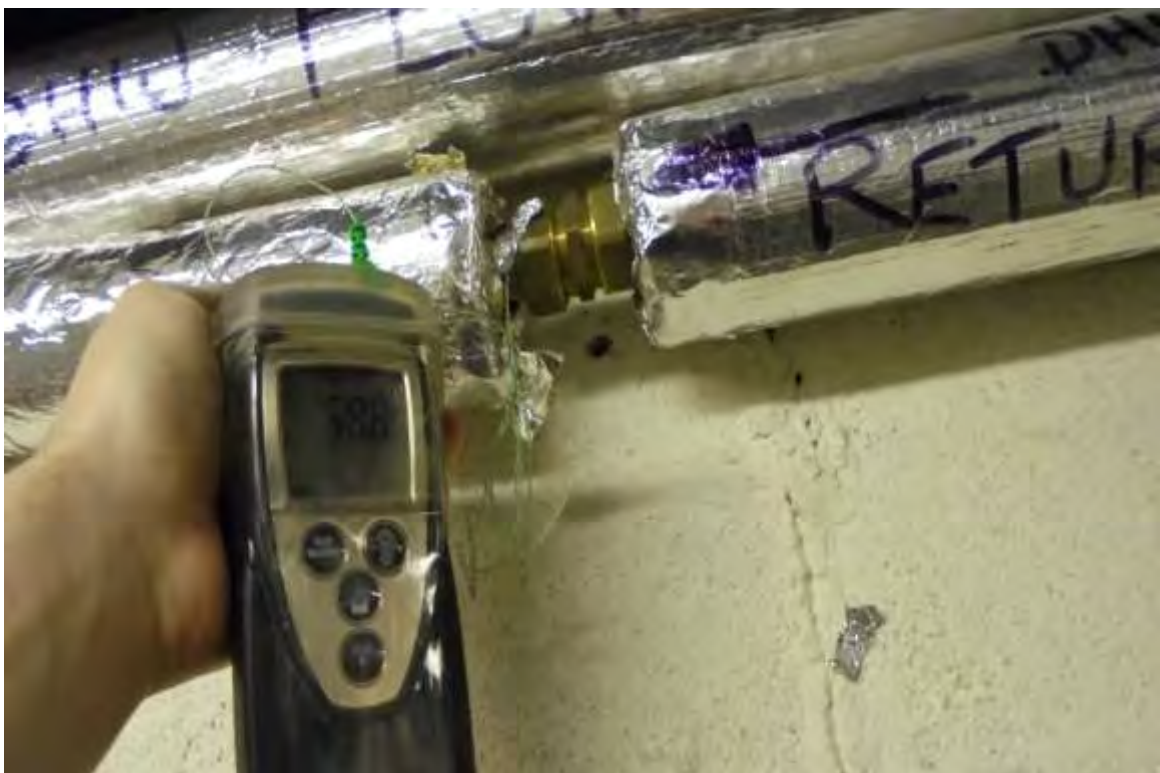
**DHWS Return Temperature Satisfactory (>55°C)**

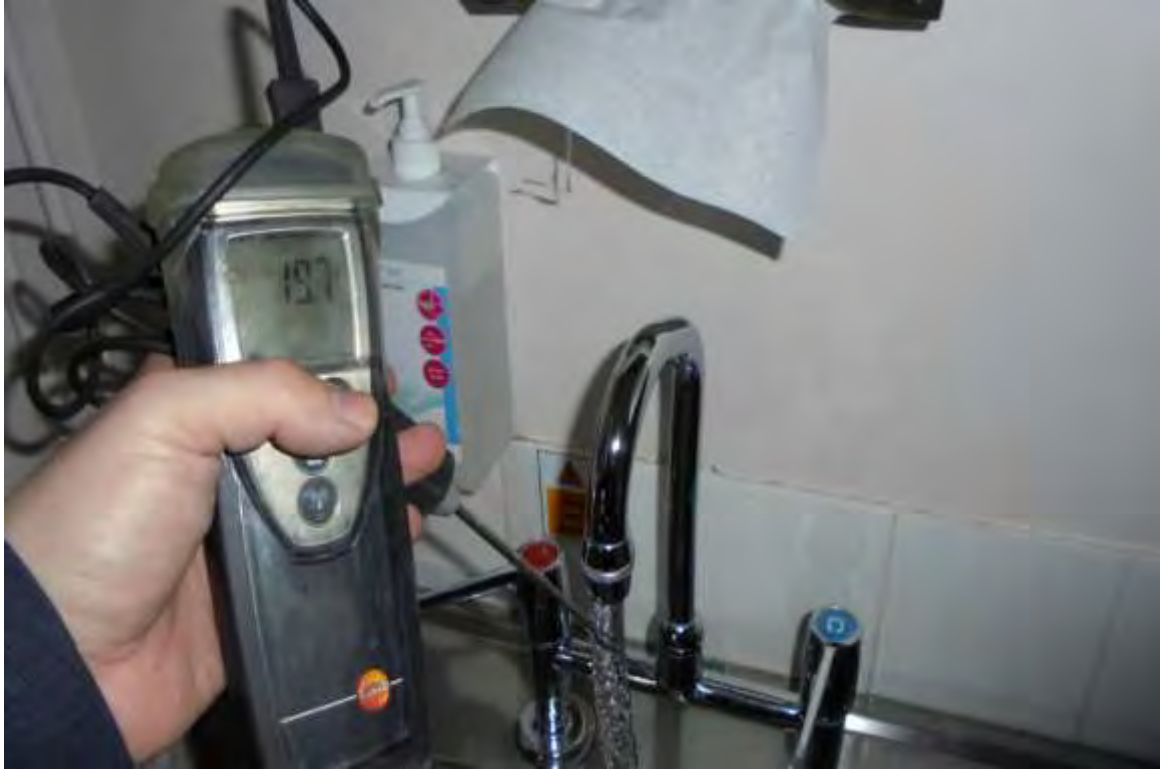
**Treatment Room G/49 Sink – Hot Water Too Low After 1 Minute (<55°C)**

Service	Remedial Action	Priority Rating	Status
Domestic Hot Water Service	Thermostatic controls to be adjusted to reduce the scald risk to users.	2	
	Investigate the cause of low initial hot water temperature at Treatment Room g49 Sink.	2	
Dead Legs	MWS supply in Bin Store to be completely removed, back to the live system.	2	
	Check valve to be installed on MWS supply to heating system pressurisation unit in Plant Room at branch point.	2

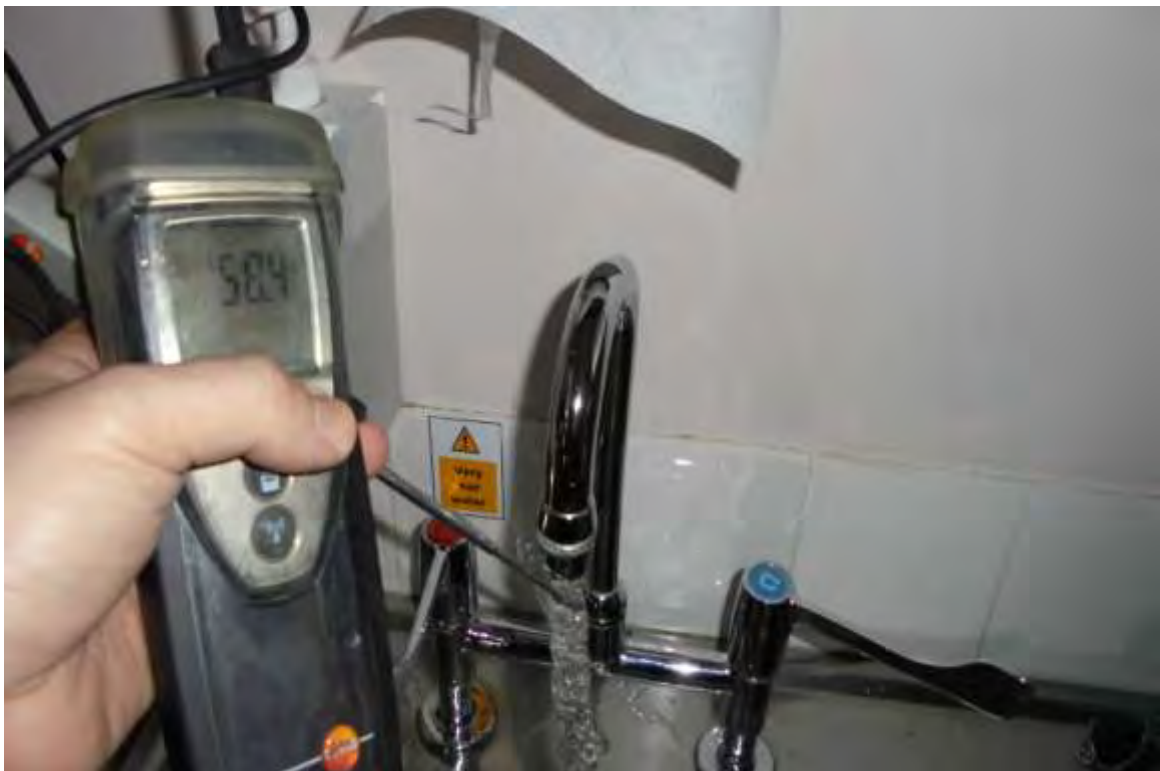
**Treatment Room G/49 Sink – Hot Water Satisfactory After Extended Flush**

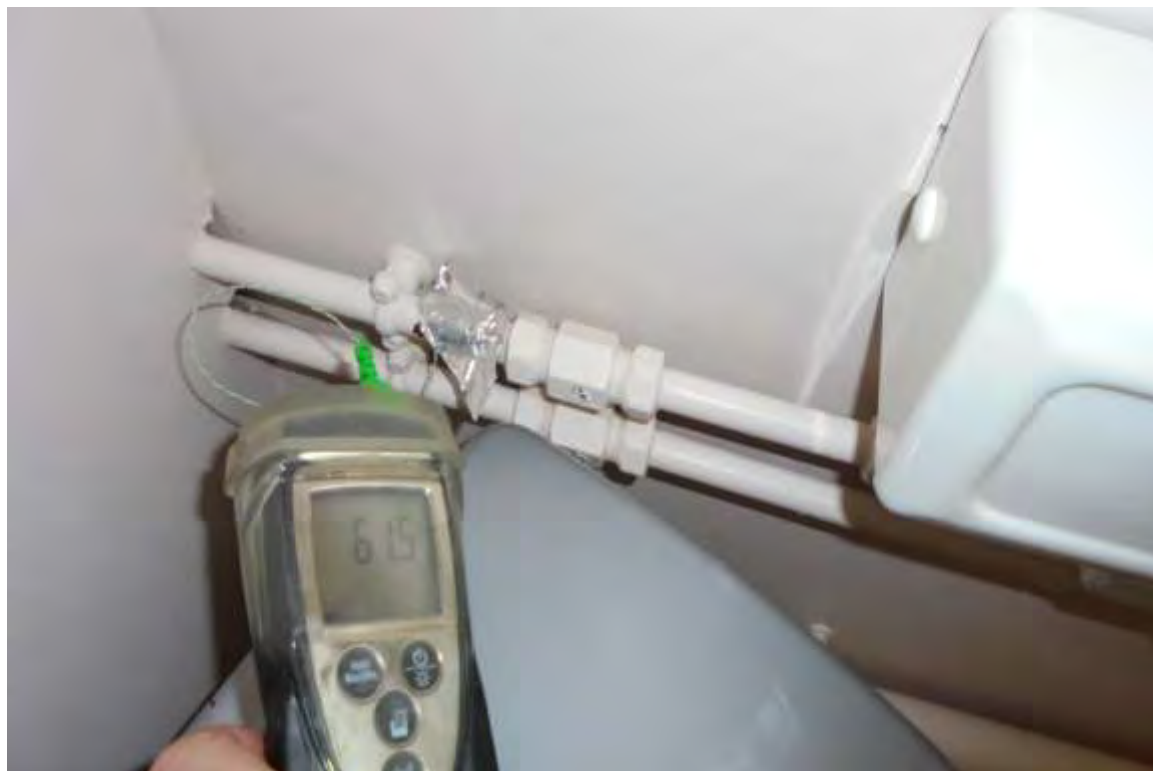
**Public Toilet WHB – Hot Water Temperature to TMV Satisfactory**

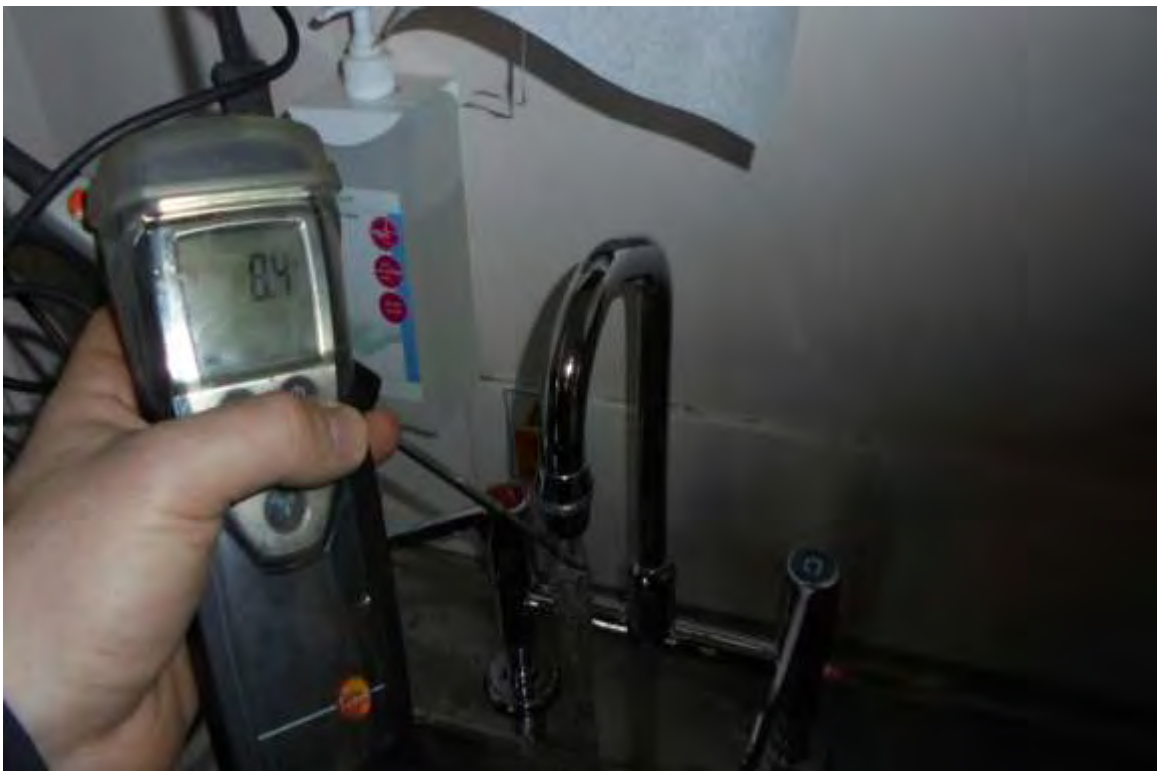
**Treatment Room G/49 Sink – Cold Water Satisfactory After Extended Flush**

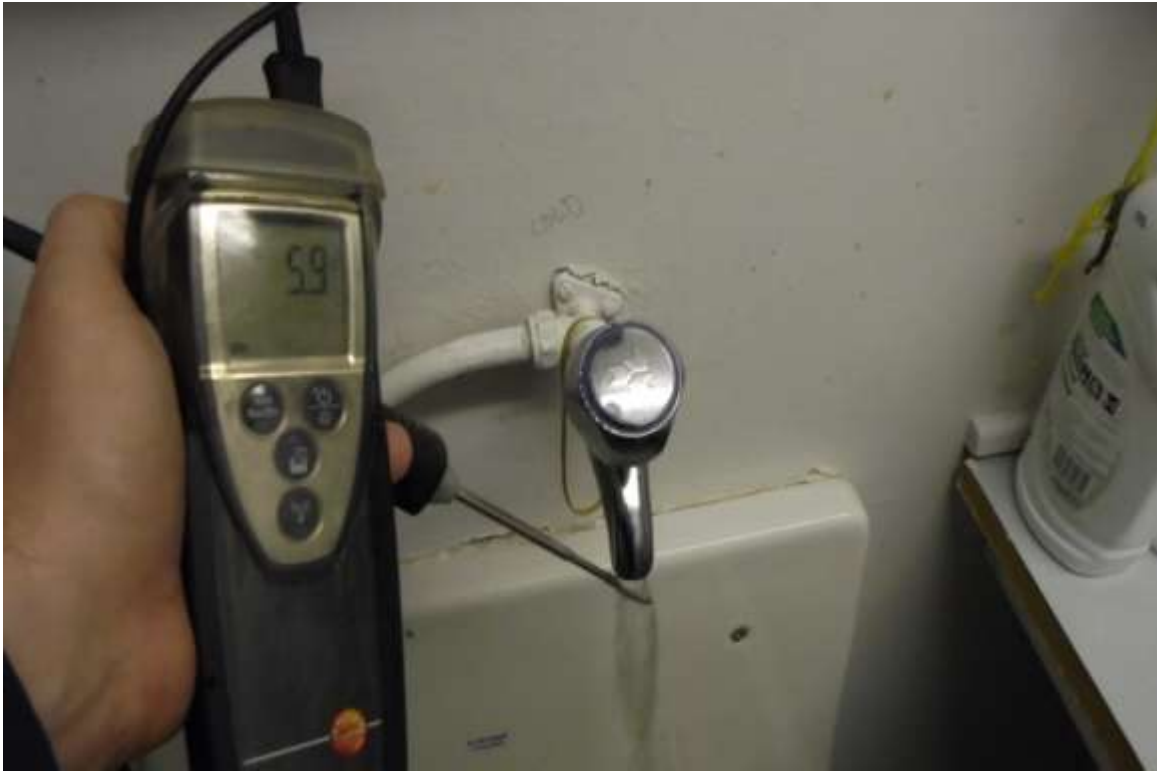
**DRS Sink – Cold Water Outlet Temperature Satisfactory**

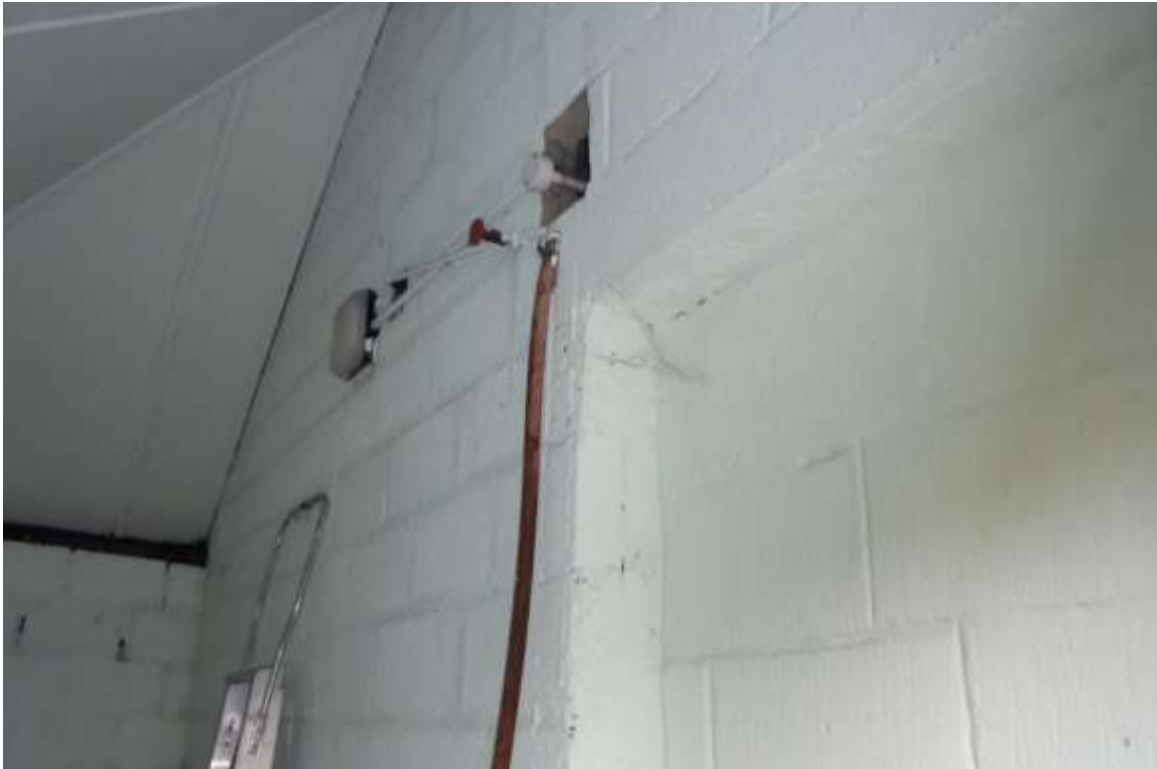
No actual dead legs were identified during the survey, although it should be recognised that effective dead legs are created by any rarely used outlets. As stated in previous reports, it has been pointed out that there is a MWS supply within the bin wash area which was found to be isolated at high level. This branch represents a significant effective dead leg and it is recommended that this pipework be completely removed, back to the branch point on the MWS supply to prevent back-contamination of the live system. Any outlets which are considered to be rarely used should be included within a weekly SUP to ensure a fresh charge of water is drawn through the supplying pipework on a regular basis. Any outlets no longer required should also be removed with pipework properly capped as close as possible to the live system.

**Bin Store MWS Connection – Effective Dead Leg**

As stated in previous reports, there is a MWS supply within the Bin Wash area which was found to be isolated at high level. This branch represents a significant effective dead leg and it is recommended that this pipework be completely removed, back to the branch point on the MWS supply to prevent back-contamination of the live system.

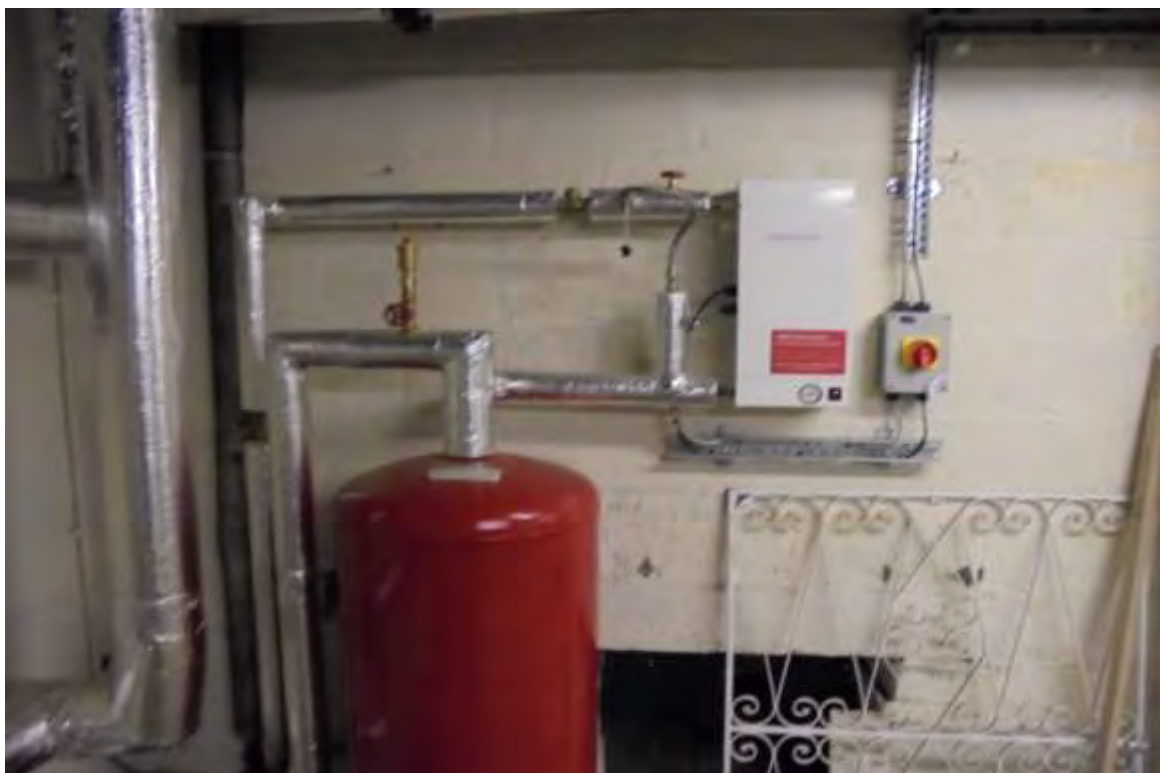
**MWS Branch to Heating System Pressurisation Unit with Check Valve installed at Connection to Pressurisation Unit**

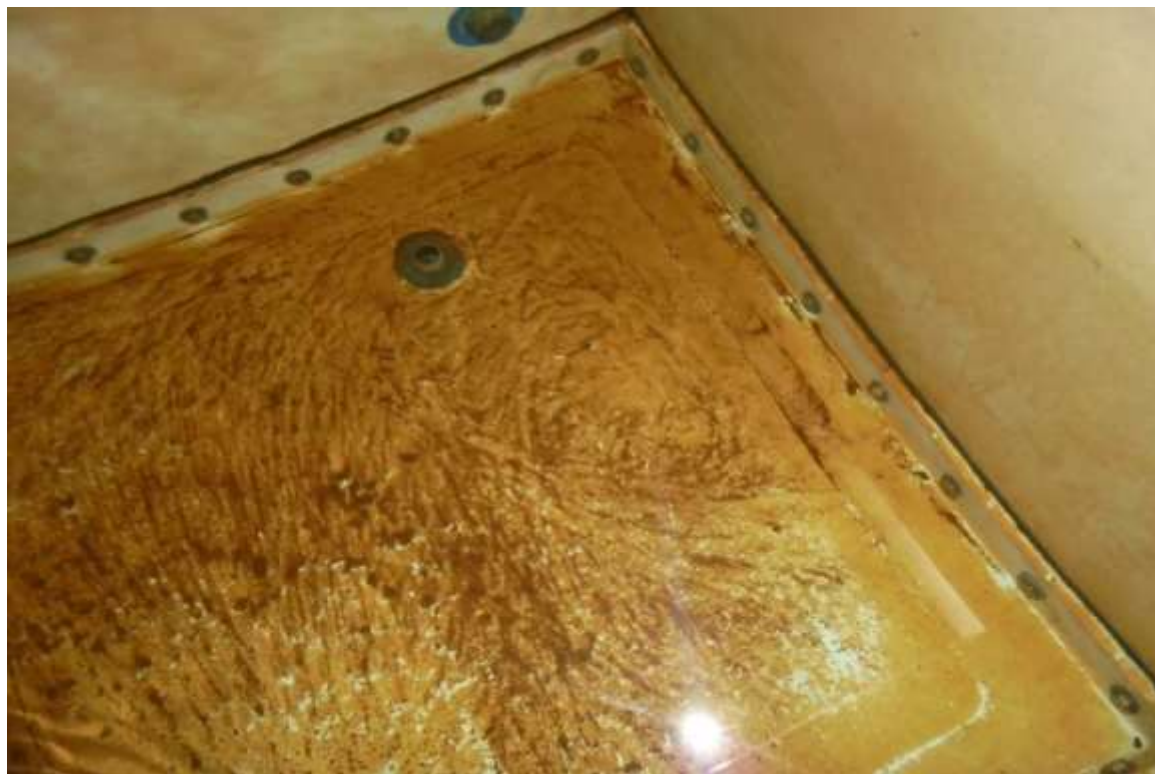
**CWS Tank No. 1 – Light Sedimental Accumulations**

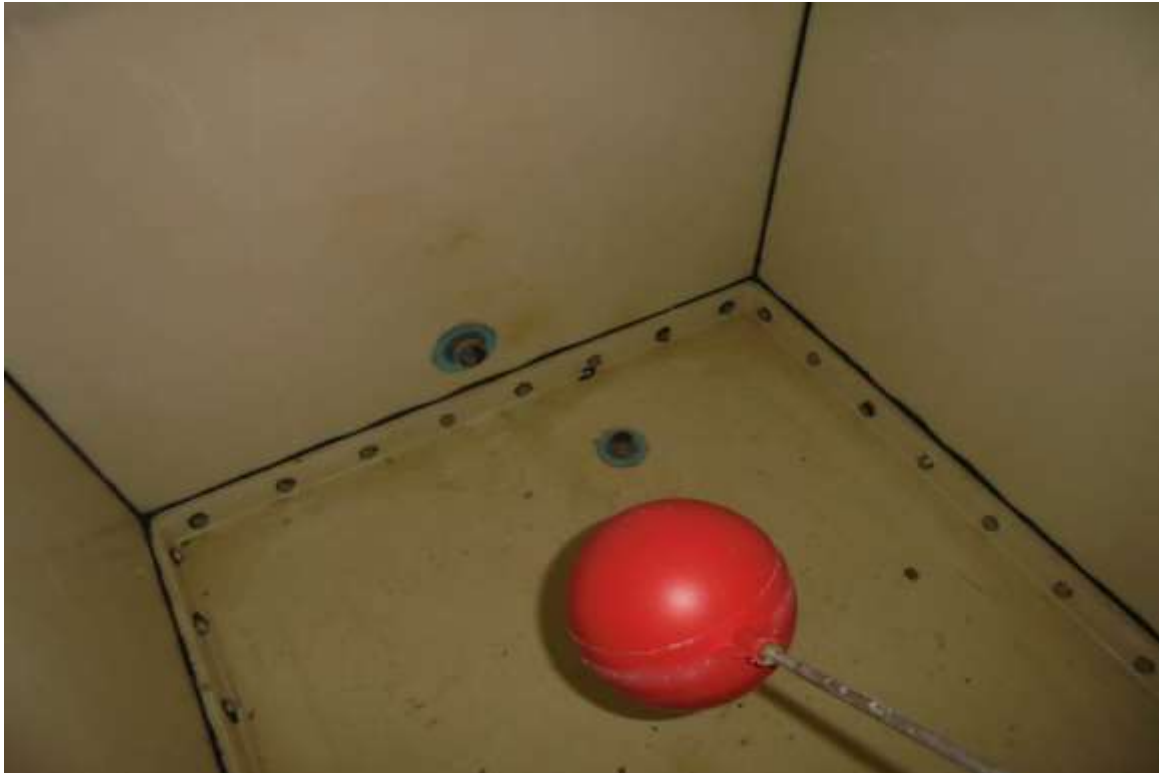
**CWS Tank No. 2 – Drained and Isolated**

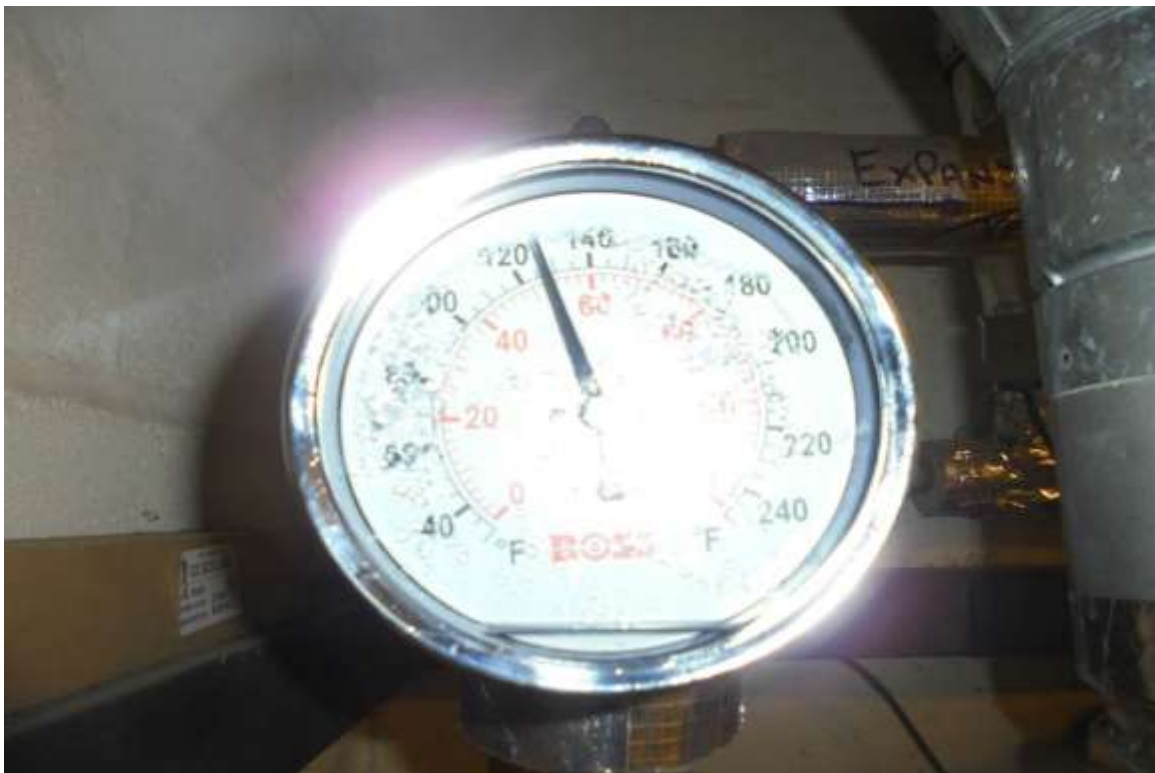
**Gas Fired Water Heater No. 1 – Contents Gauge at 55°C**

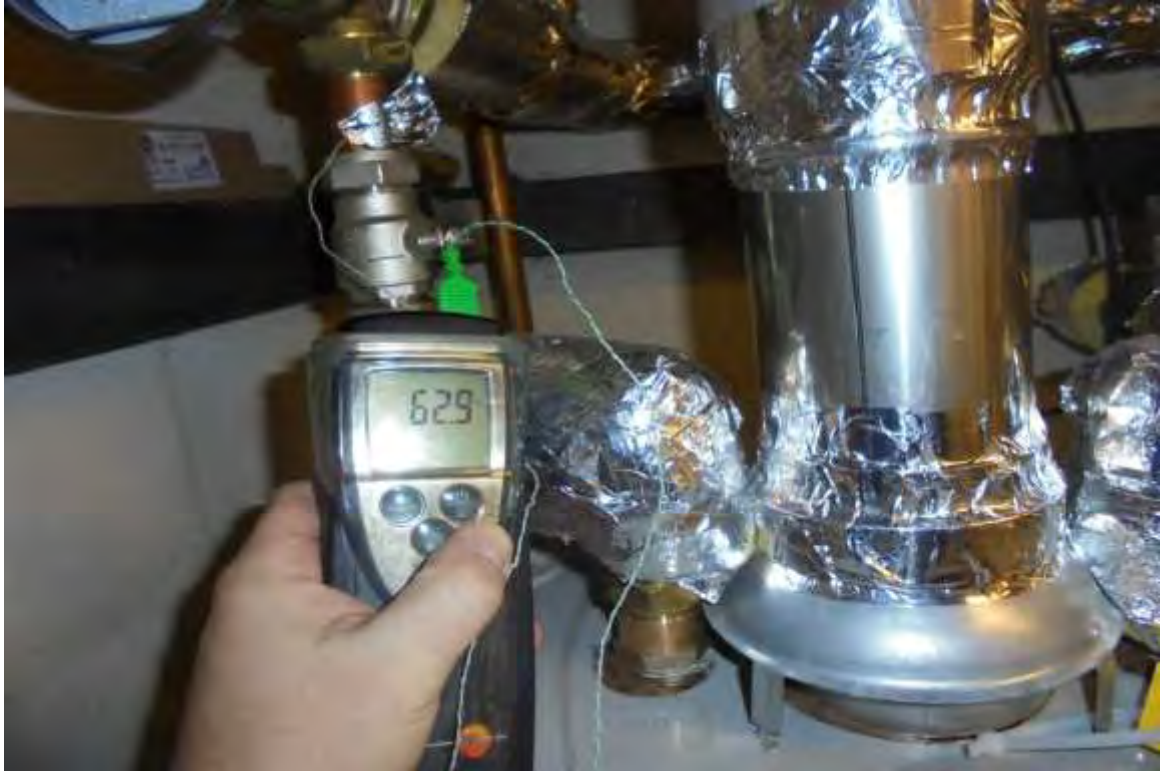
**Gas Fired Water Heater No. 1 – Contents Temperature Confirmed at 63°C**

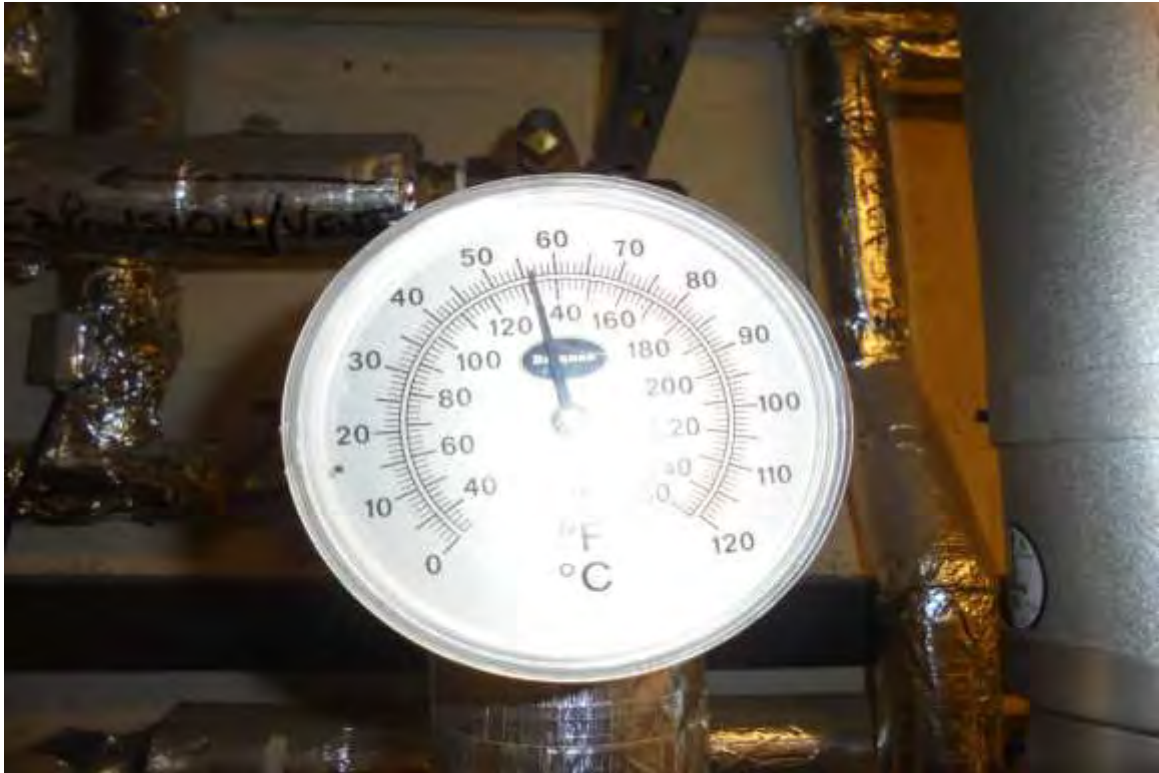
**Gas Fired Water Heater No. 2 – Contents Gauge at 56°C**

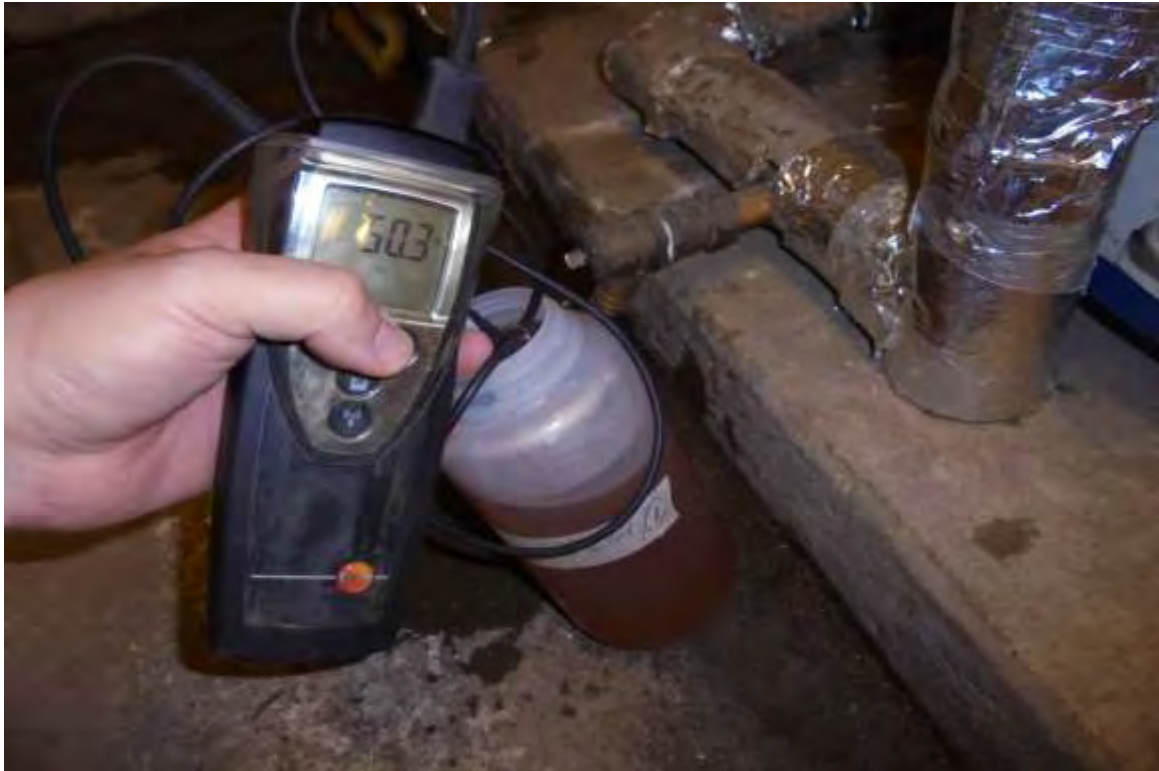
**Gas Fired Water Heater No. 2 –Drain Sample Discoloured and at Satisfactory Temperature**

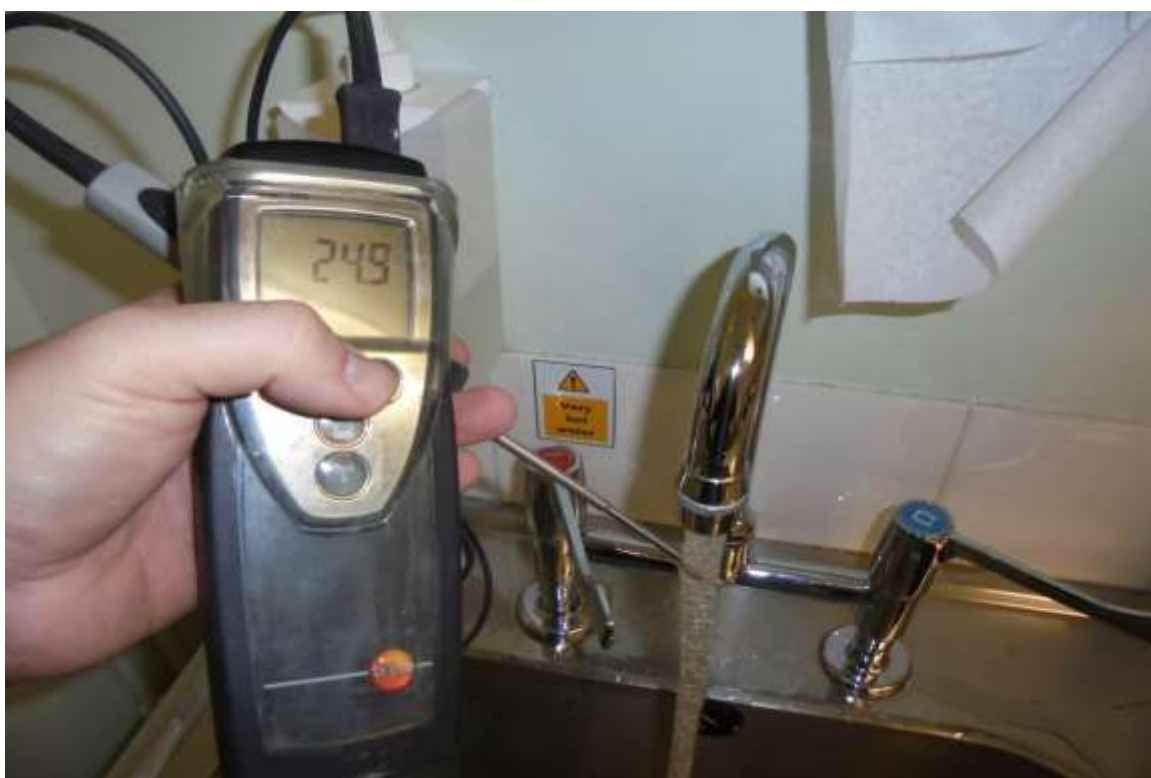
**Treatment Room G/49 Sink – Hot Water Too Low After 1 Minute ( $<55^{\circ}\text{C}$ )**

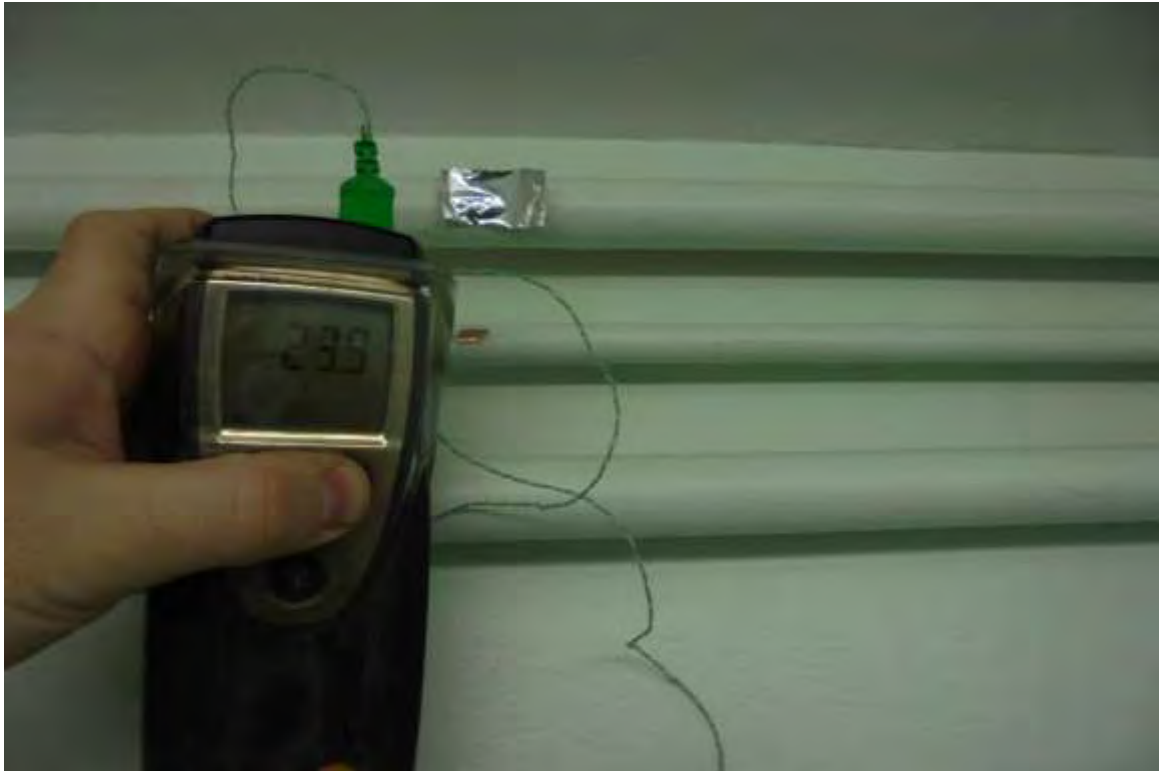
**DHWS Flow Temperature to Treatment Room G/49 Too Low (<55°C)**

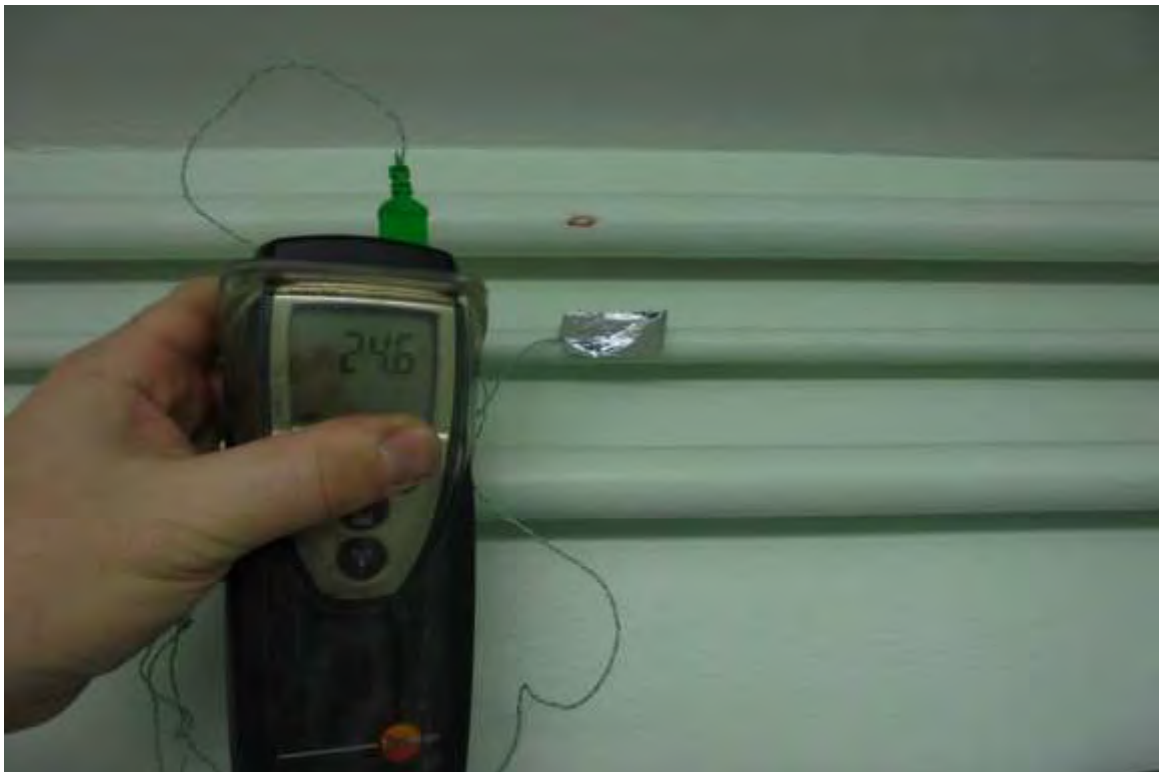
**DHWS Return Temperature from Treatment Room G/49 Too Low (<55°C)**
