## FREEDOM OF INFORMATION – LEGIONELLA

I write in response to your request for information in relation to Legionella in East Calder Health Centre.

This document relates to an ongoing programme of water quality monitoring at East Calder Health Centre, carried out by Westfield Caledonian during February 2016. As part of this visit, a review of the Water Quality Risk Assessment, relating to the domestic water systems contained within this building was carried out. This survey was carried out to satisfy the requirements of the Approved Code of Practice (L8) and guidance document HSG 274 and to determine aspects of the system design, condition and mode of operation which may compromise the quality of the water to which occupants are exposed and subsequent health risk. This assessment survey and control scheme review was carried out in a manner consistent with requirements with *BS8580:2010 Water Quality-Risk Assessment for Legionella control – code of practice*.

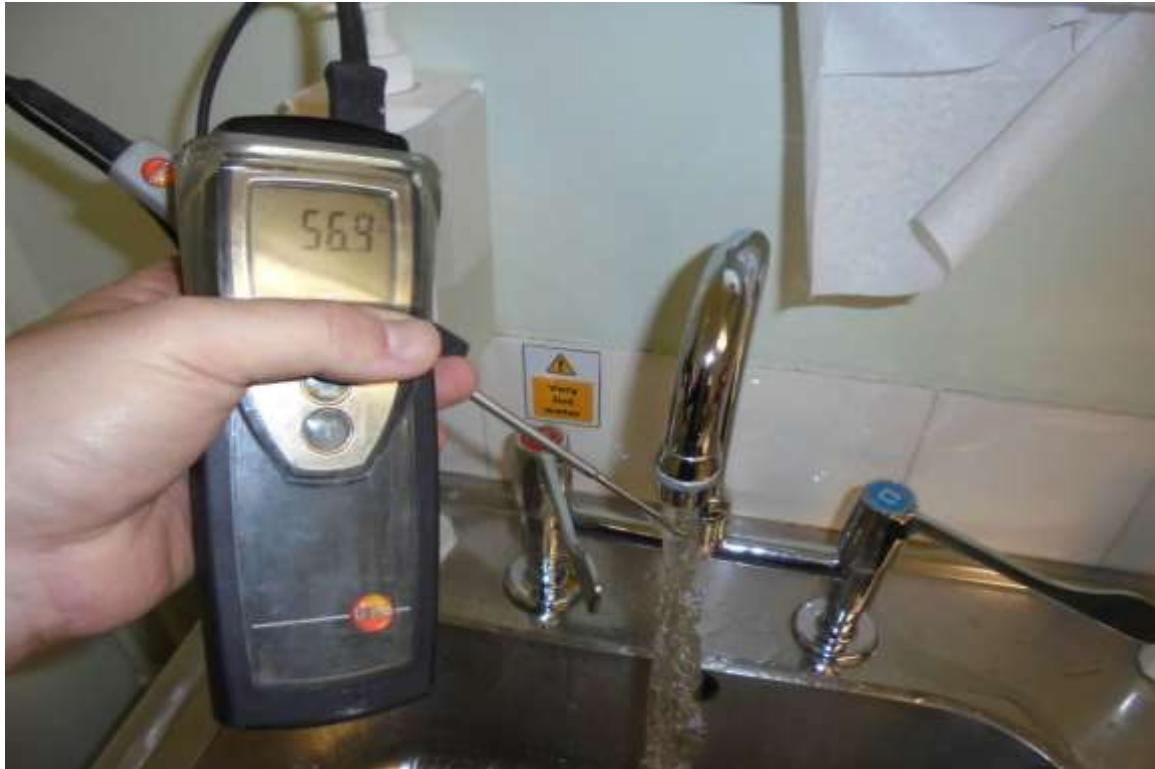
**Treatment Room G/49 Sink – Hot Water Satisfactory After Extended Flush  
Ineffective Circulation**

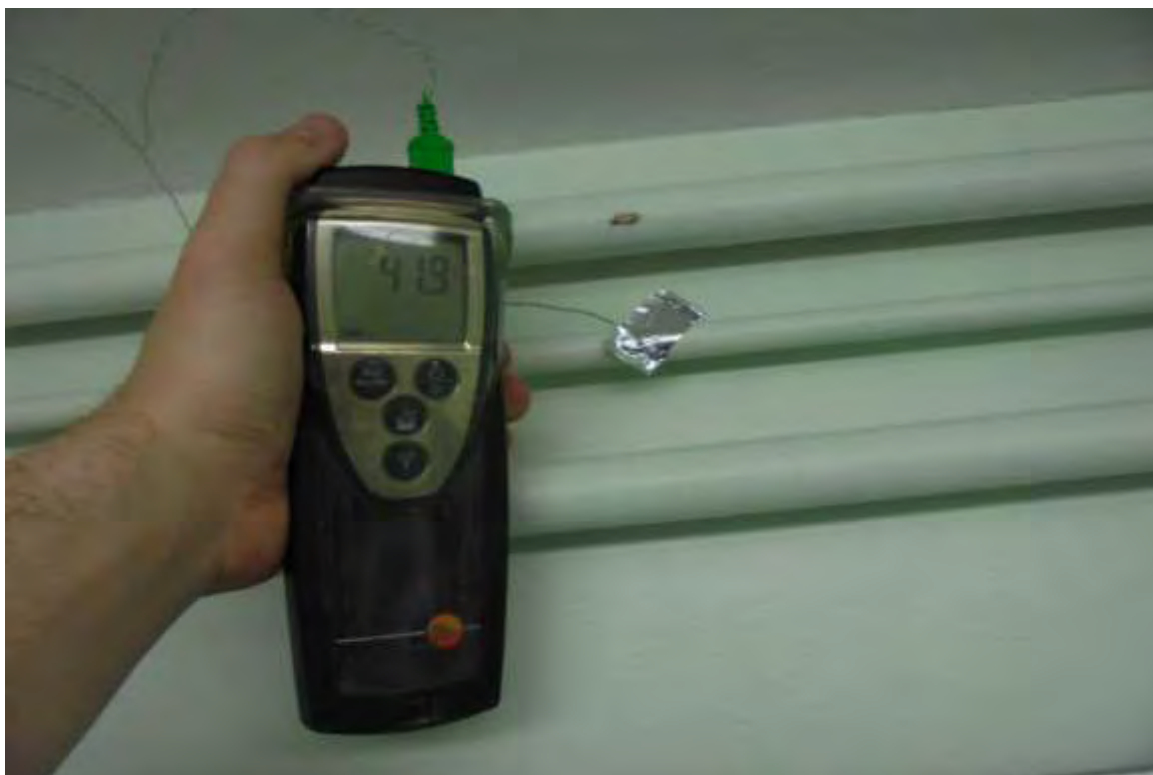
**DHWS Return Temperature from Treatment Room G/49  
Too Low (<55°C) after Extended Flush**

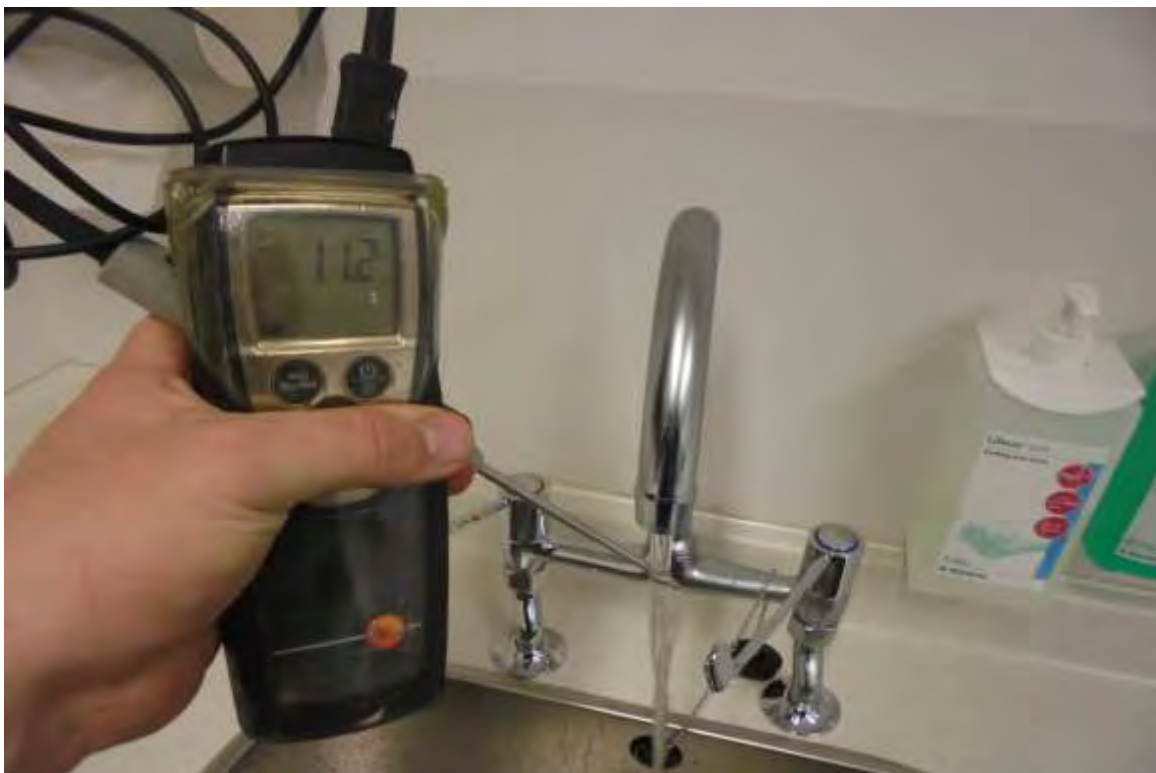
Mains fed, electric under-sink point of use water heaters are used to provide hot water to the Consulting Rooms within the extension wing. Where these are used, a minimum temperature of 55°C is required in healthcare premises. The temperature recorded at the extension Consultant Room 3 sink was below 50°C and the heater appeared to be faulty. It should be ensured that the thermostatic controls are set to ensure a minimum temperature of 55°C can be achieved after a period of low demand, as these heaters require a recovery period following a recent draw off.

**Extension Consulting Room 3 Sink – Hot Water Outlet Temperature Too Low (<50°C) Supplied via POUH**

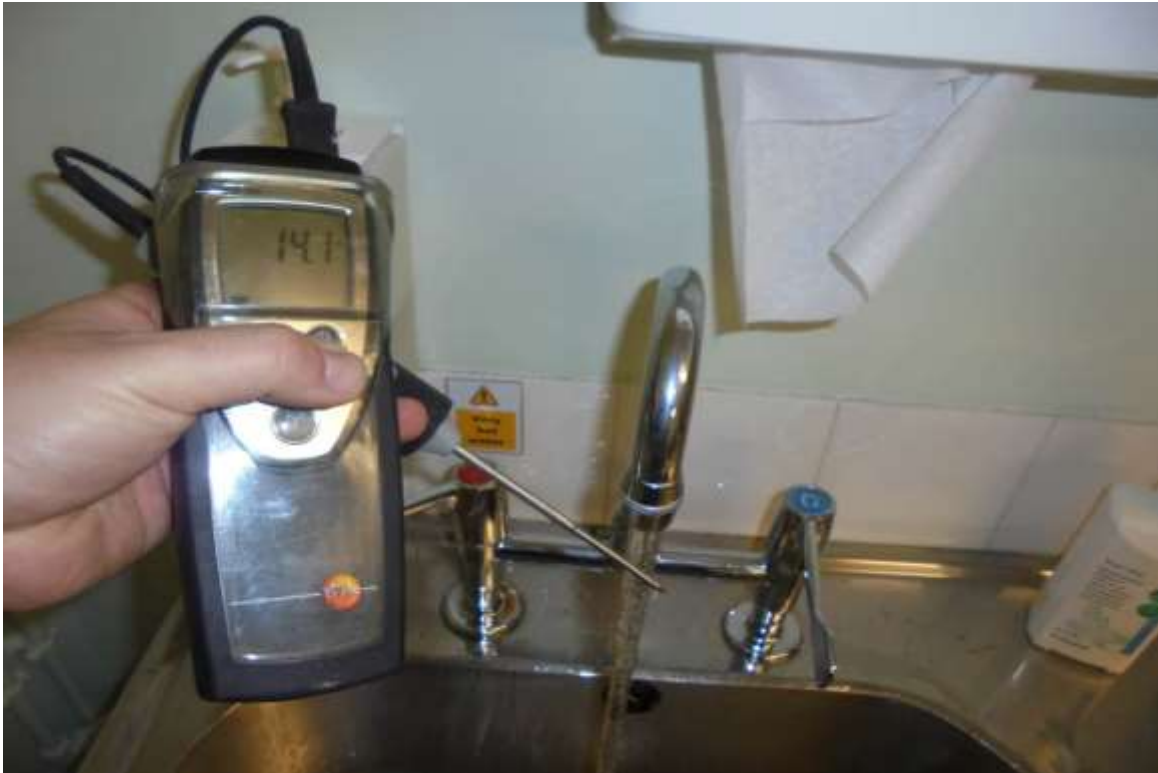
With regard to these guidelines, cold water outlet temperatures recorded throughout the Health Centre were generally satisfactory, although an extended flush was required at the Treatment Room G/49 Sink to achieve a temperature which compared well with the storage temperature within the CWS tank. It is recommended that this outlet be included in a twice-weekly simulated usage programme (SUP) to ensure that a fresh charge of water is drawn through the pipework to prevent heat gain, stagnation and back-contamination of the live systems. Regular temperature monitoring should be carried out to help identify any additional outlets which may be rarely used and these should be included in the SUP.

**Treatment Room G/49 Sink – Cold Water Acceptable After Extended Flush**

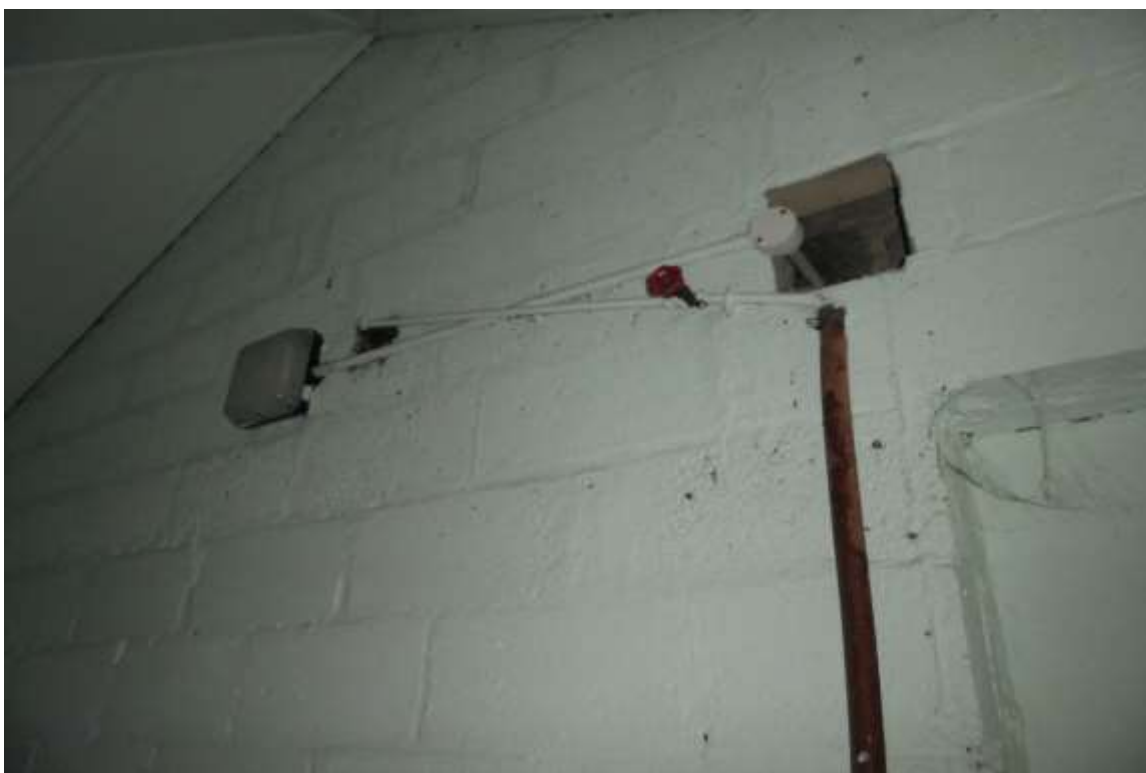
No actual dead legs were identified during the survey, although it should be recognised that effective dead legs are created by any rarely used outlets. As stated in previous reports, a MWS supply within the bin wash area exists although this has been isolated at high level. This branch represents a significant effective dead leg and it is recommended that this pipework be completely removed, back to the branch point on the MWS supply to prevent back-contamination of the live system. Alternatively the valve can be opened and the outlet included in a twice weekly flushing programme. Any outlets which are considered to be rarely used should be included within a SUP to ensure a fresh charge of water is drawn through the supplying pipework on a regular basis. Any outlets no longer required should also be removed with pipework properly capped as close as possible to the live system.

**Bin Store MWS Connection Isolated at High Level – Effective Dead Leg**

Service	Remedial Action	Priority Rating	Status
Domestic Hot Water Service	Thermostatic controls to be adjusted to reduce the scald risk to users.	2	
	Investigate the cause of low initial hot water temperature at Treatment Room g49 Sink.	2	
Dead Legs	MWS supply in Bin Store to be completely removed, back to the live system.	2	
	Check valve to be installed on MWS supply to heating system pressurisation unit in Plant Room at branch point.	2

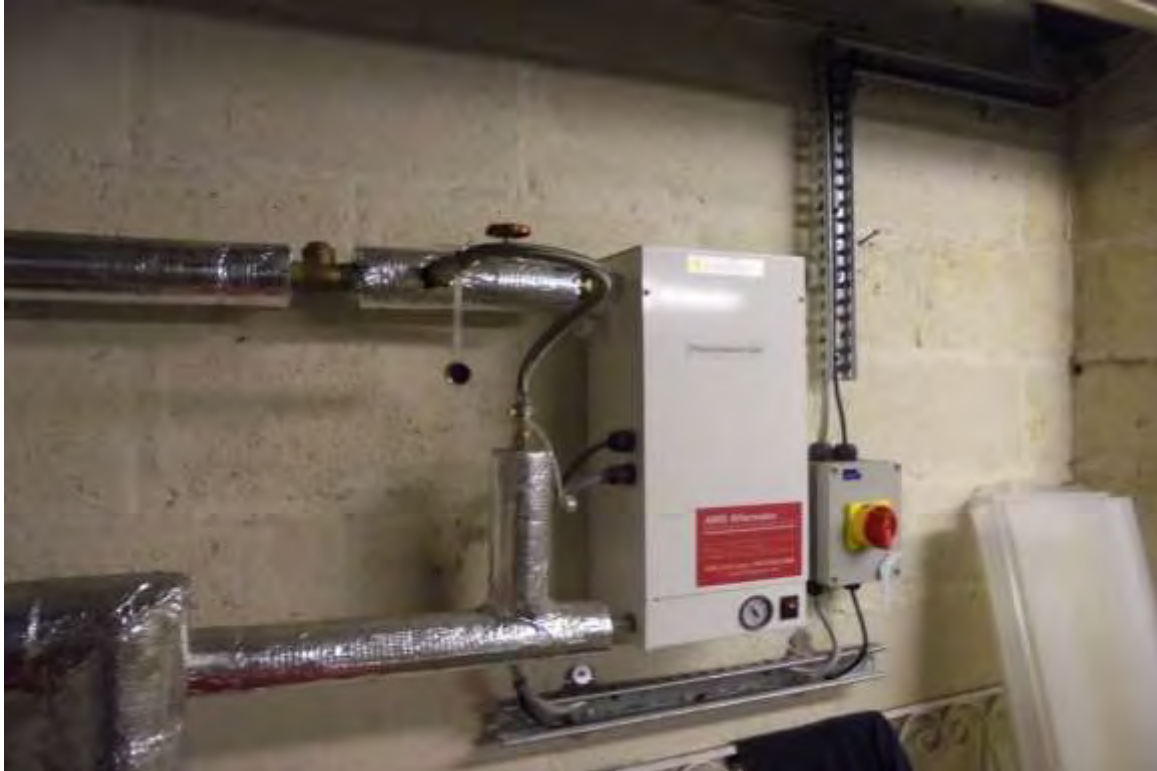
A MWS branch has also been taken in the ground floor plantroom to supply the heating system pressurisation unit. Although a check valve was installed prior to the connection to the pressurisation unit, this should be installed at the branch point to prevent back-contamination. The flexible quick-fill connection should also be physically disconnected when not in use.

**MWS Branch to Heating System Pressurisation Unit with Check Valve installed and Flexible Quick-fill Hose Connected**

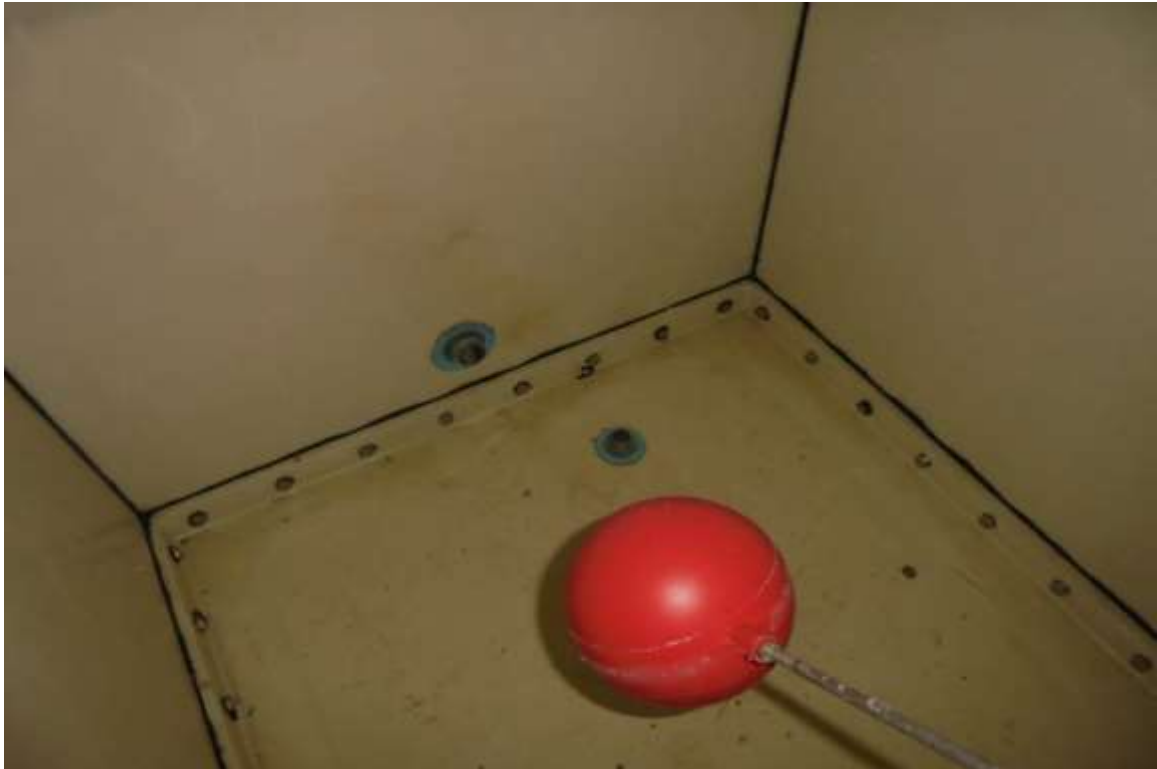
**CWS Tank No.1 – Drained and Isolated**

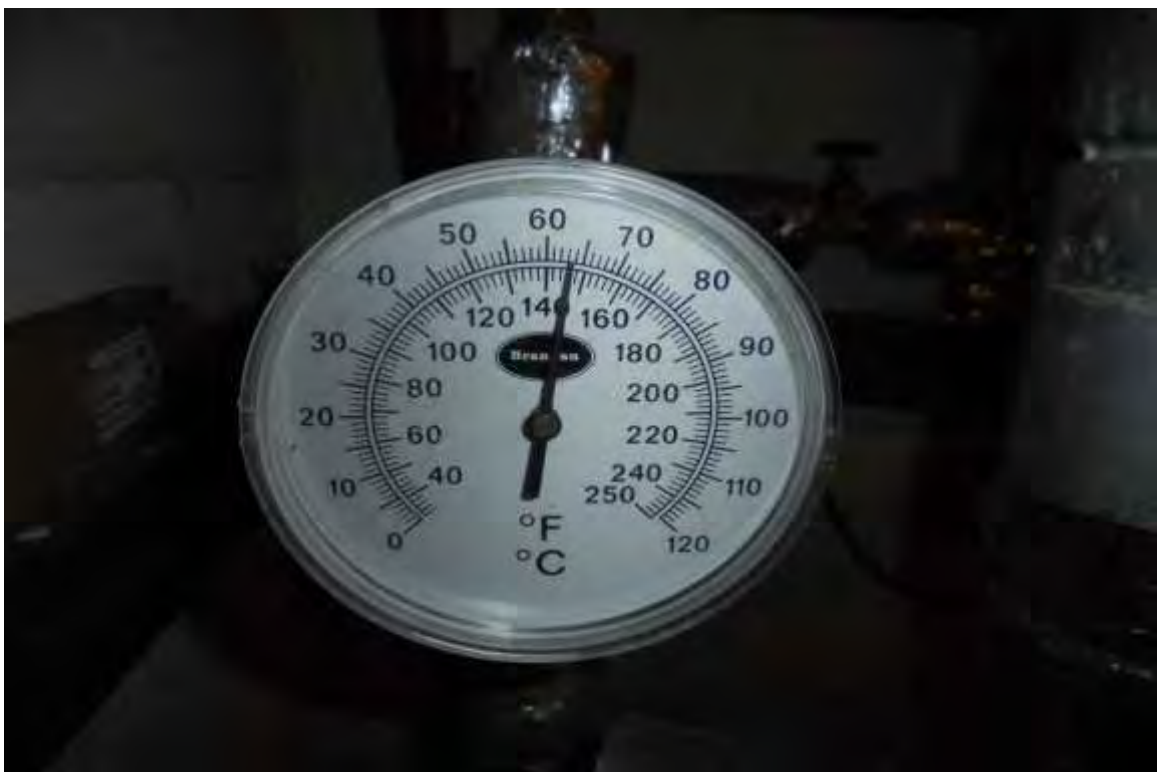
**DHWS Gas Fired Water Heater No.1 - Storage Temperature Approximately 65°C**

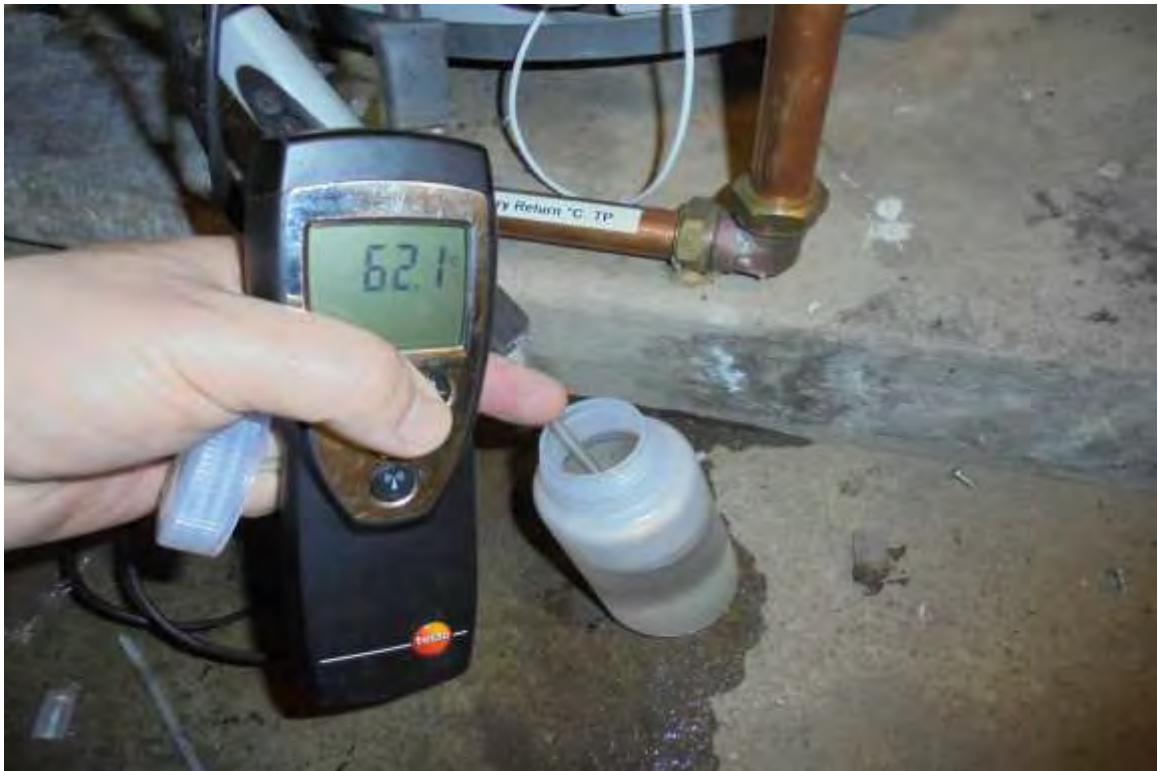
**DHWS Gas Fired Water Heater No.1 – Drain Sample Clear  
and at Satisfactory Temperature**

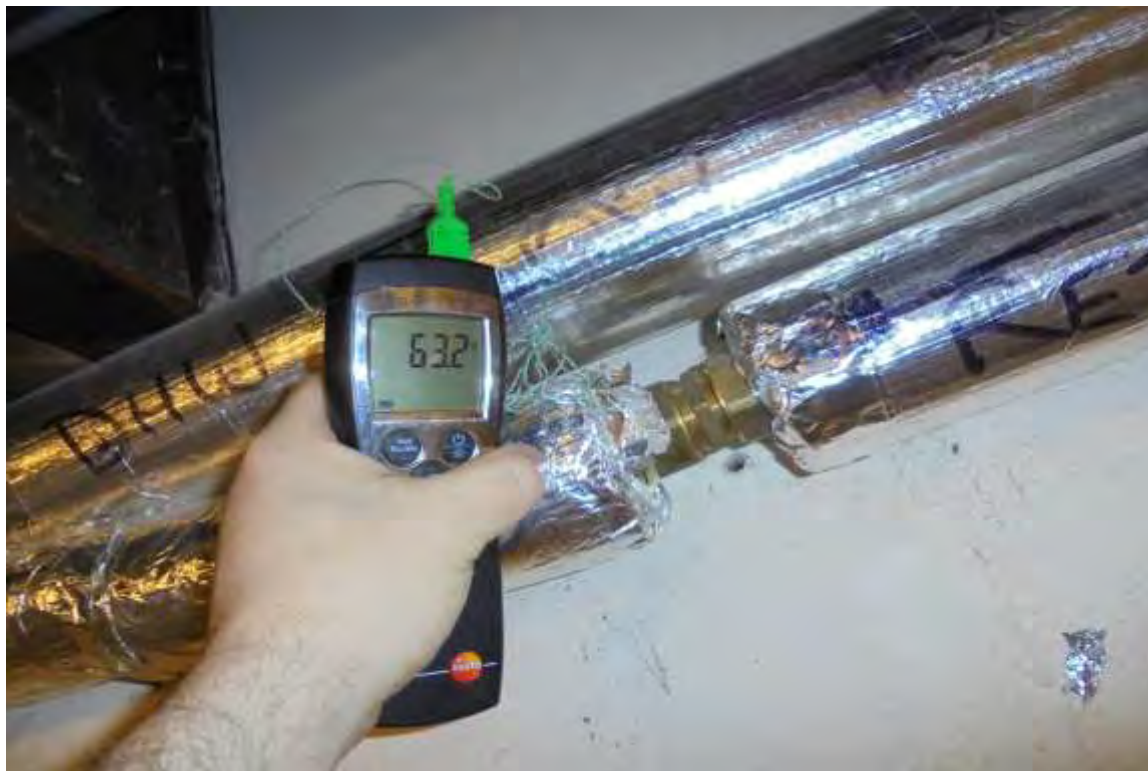
**Plantroom Principle Loop Return Temperature Satisfactory**

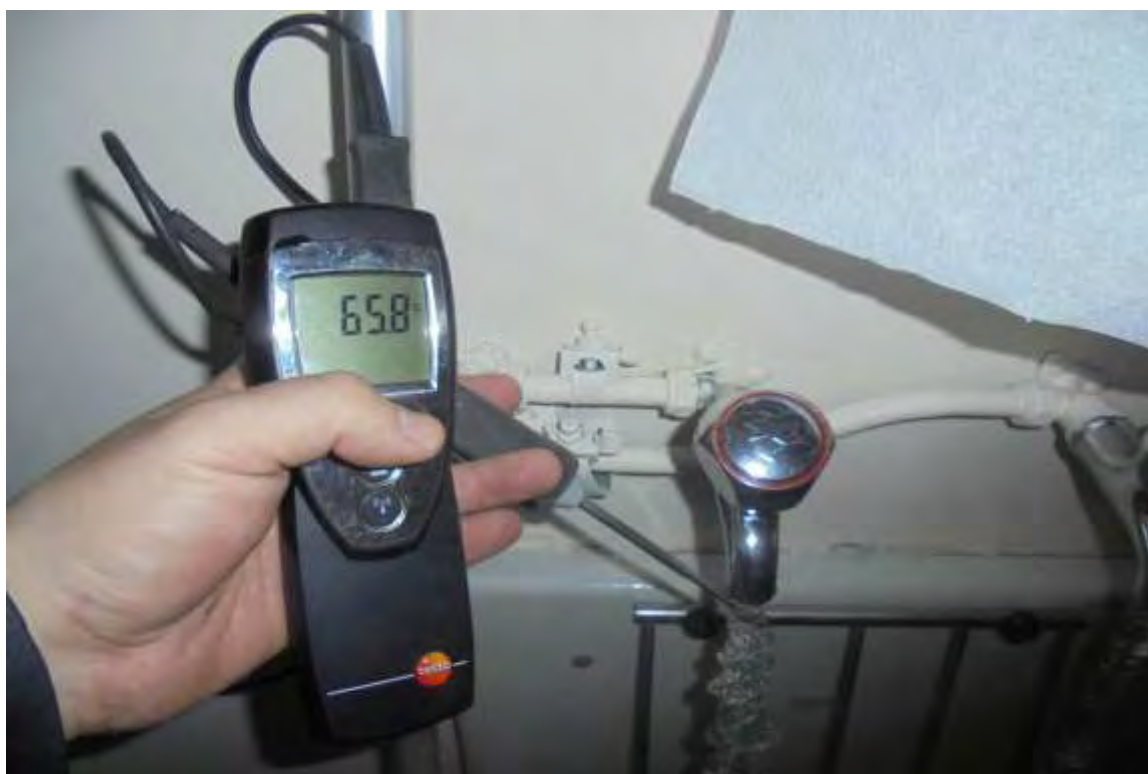
**DSR Sink - Hot Water Outlet Temperature Satisfactory**

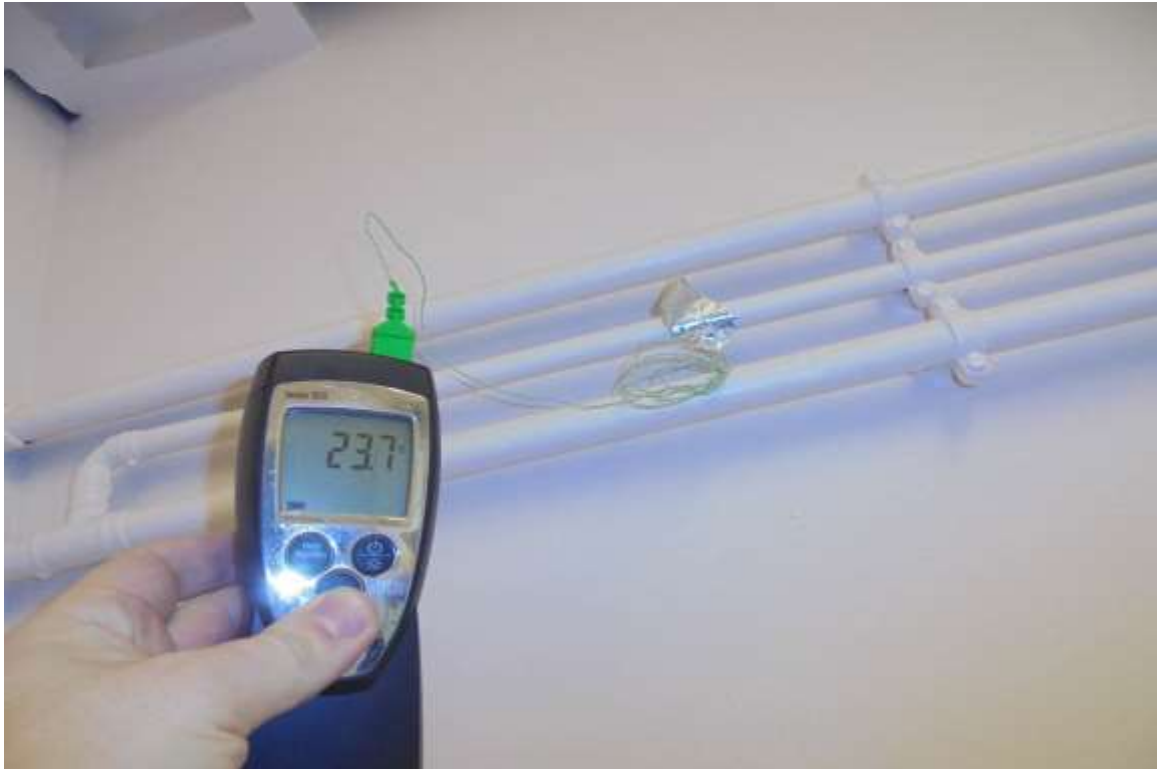
**Health Education/Physio Room - Tertiary Loop Return Temperature Too Low (<55°C)**

We do however recommend that circulation to this area be investigated to ensure a sufficiently high hot water temperature can be maintained to provide an effective thermal control regime within the building.

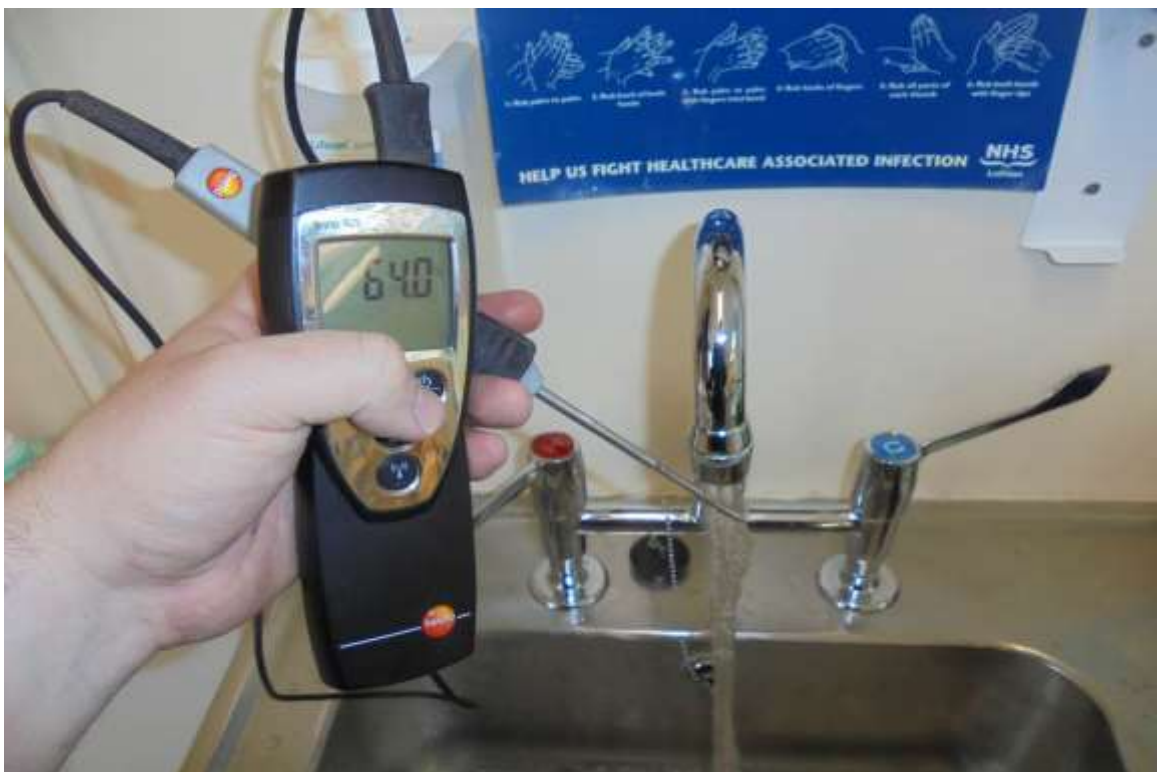
**Health Education/Physio Room Sink - Hot Water Outlet Temperature Satisfactory**

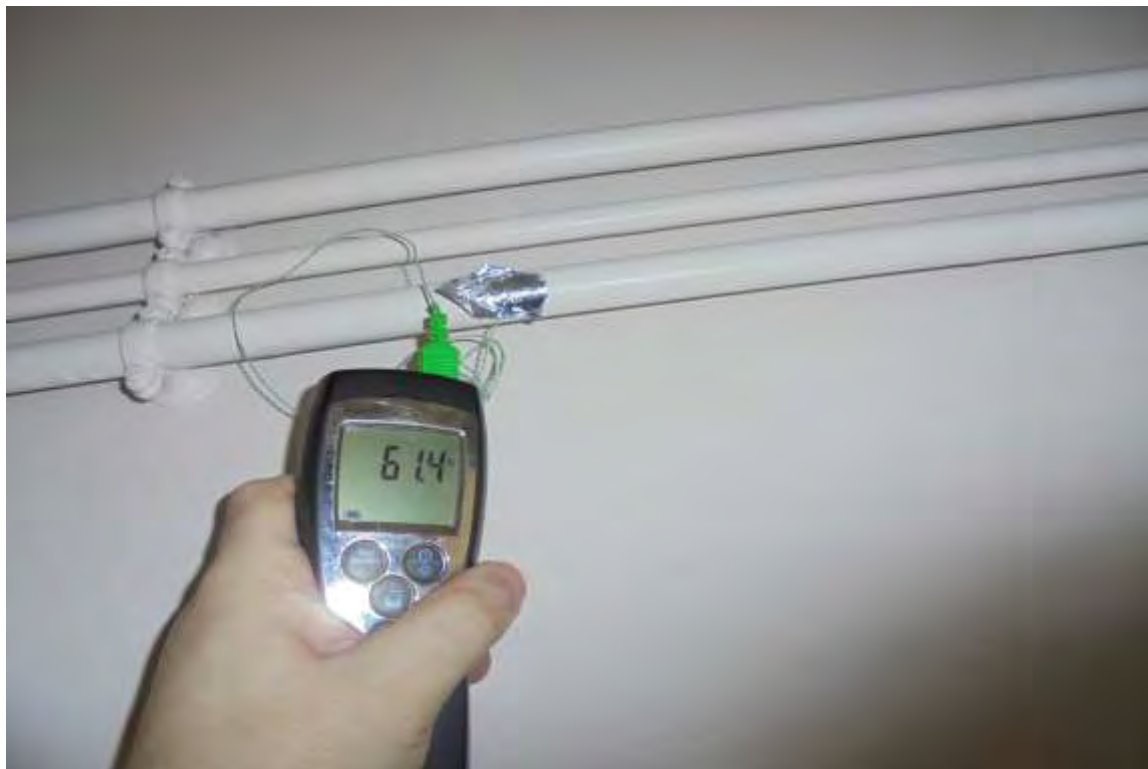
**Health Education/Physio Room - Tertiary Loop Flow Temperature Satisfactory After Flushing Outlet**

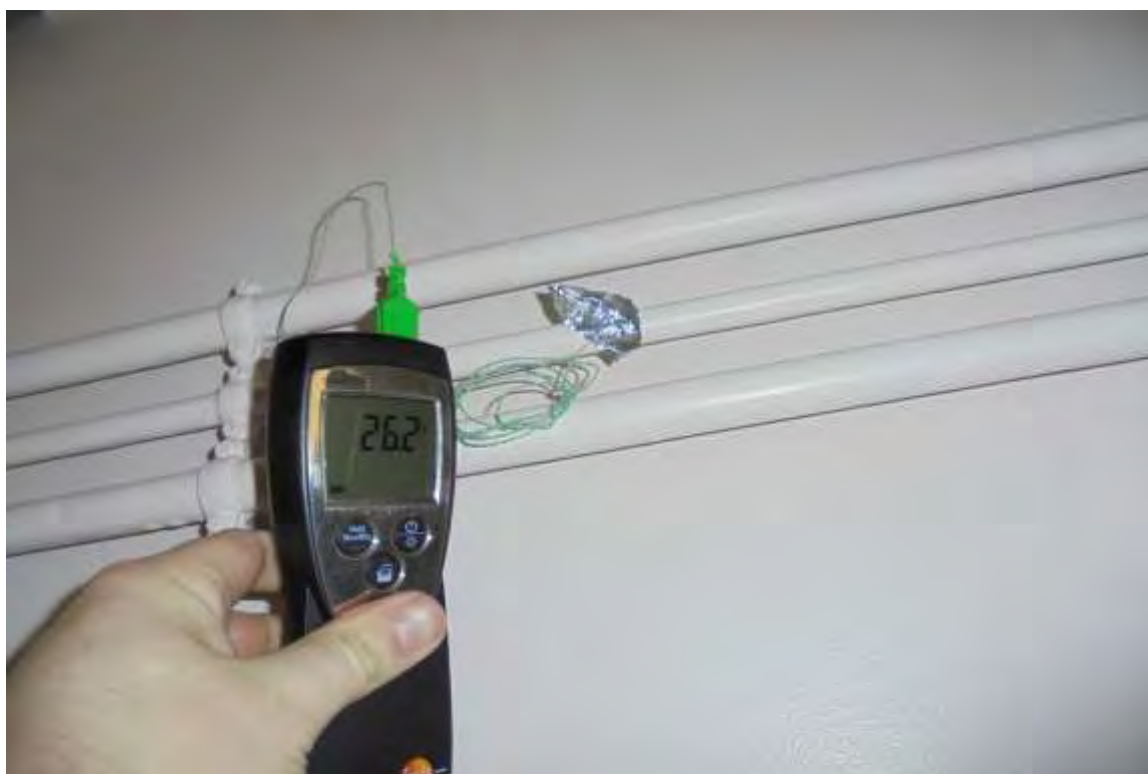
**Health Education/Physio Room - Tertiary Loop Return Temperature Too Low (<55°C) After Flushing Outlet**

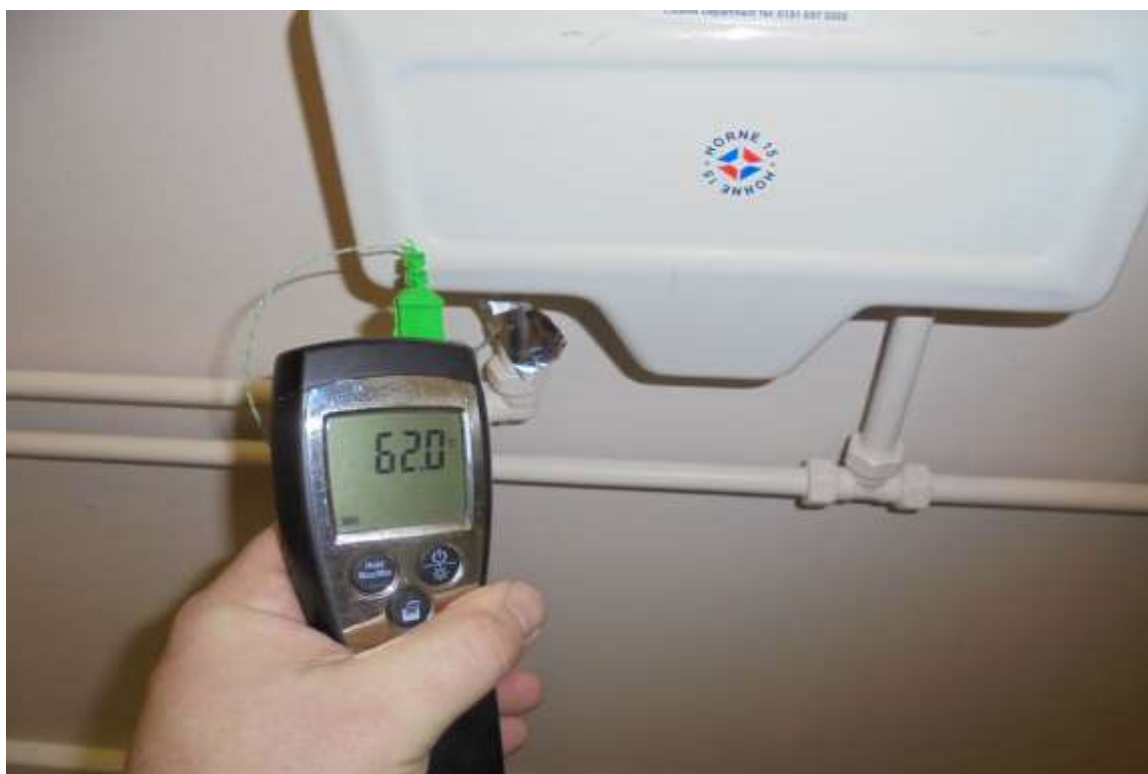
**Public Toilet WHB - Supply Temperature to TMV Satisfactory (>55°C)**

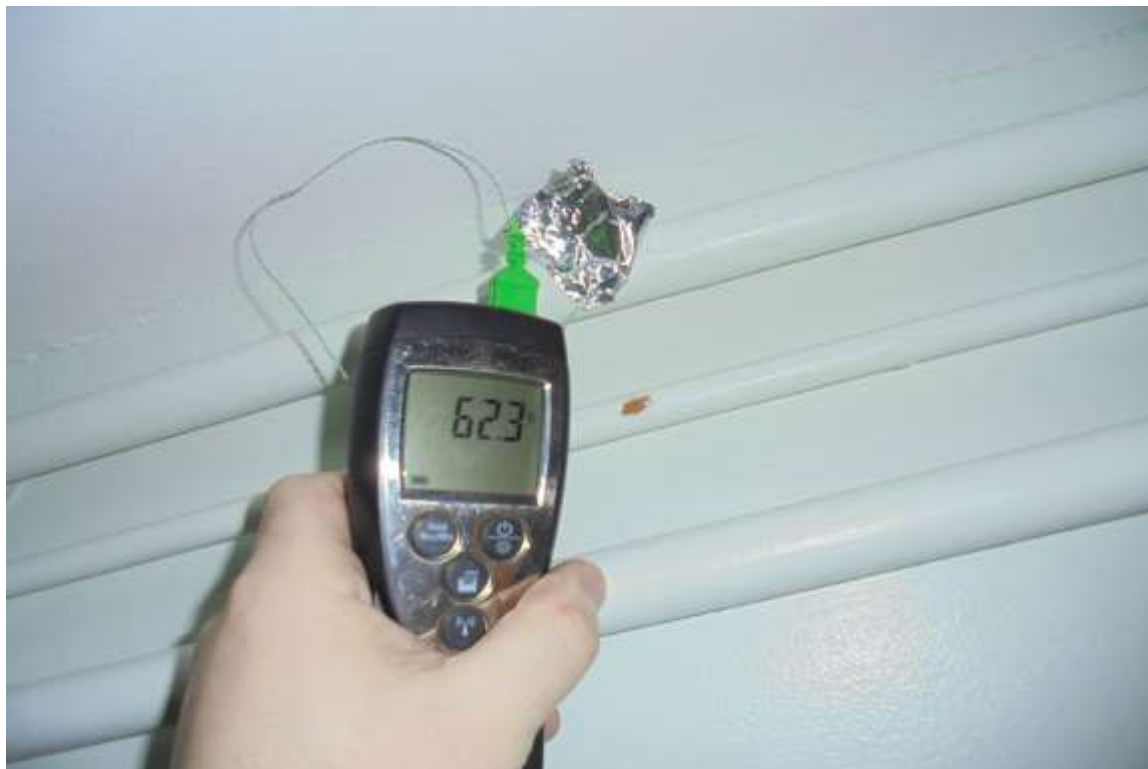
**Flow Temperature to Consultant Room 8 Satisfactory**

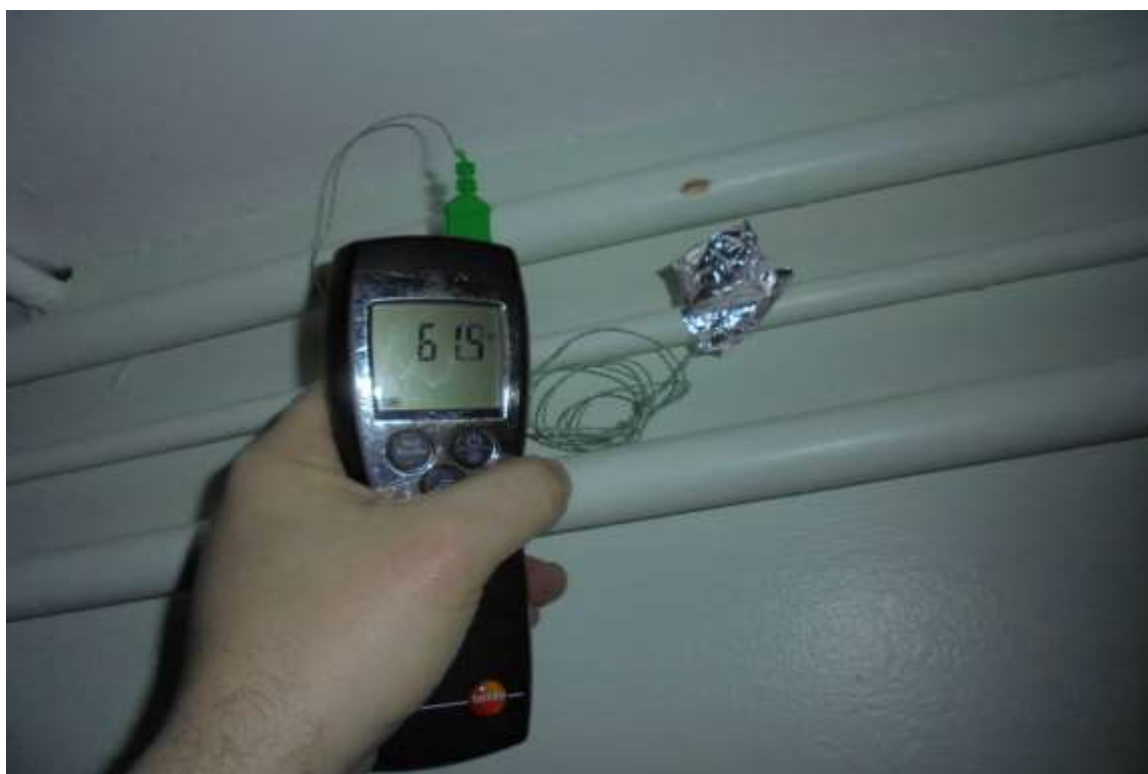
**Return Temperature from Consultant Room 8 Satisfactory**

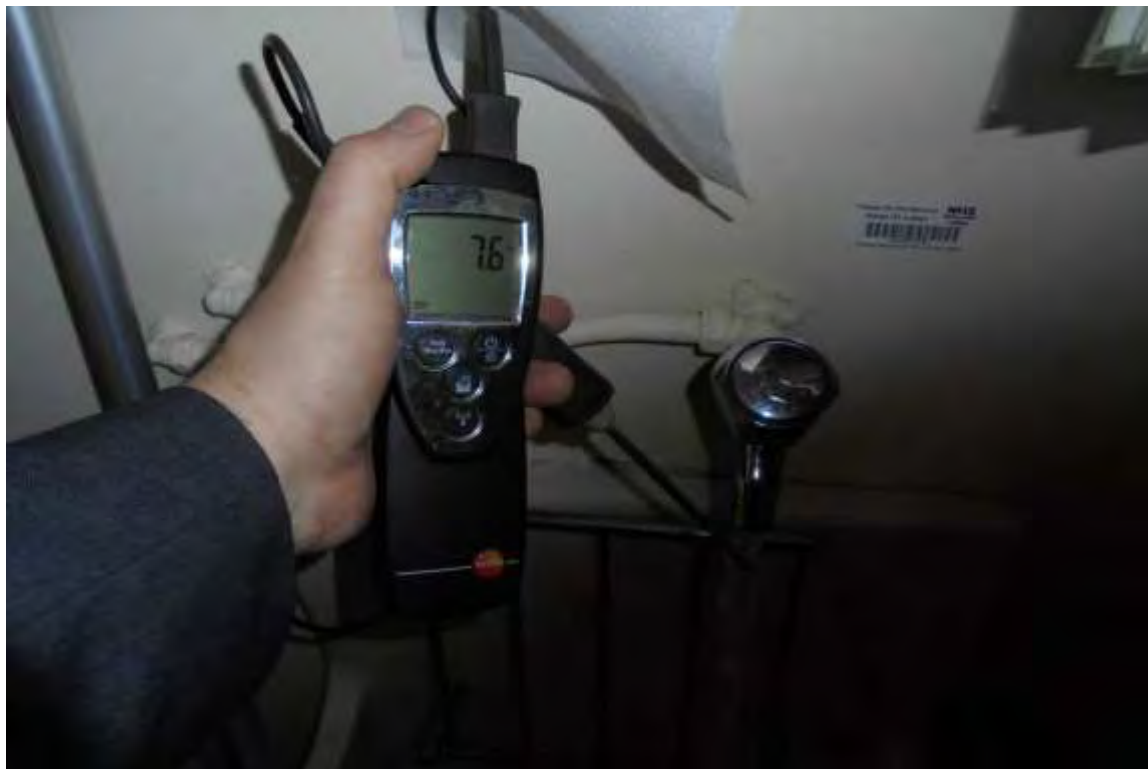
**DSR Sink – Cold Water Outlet Temperature Satisfactory**

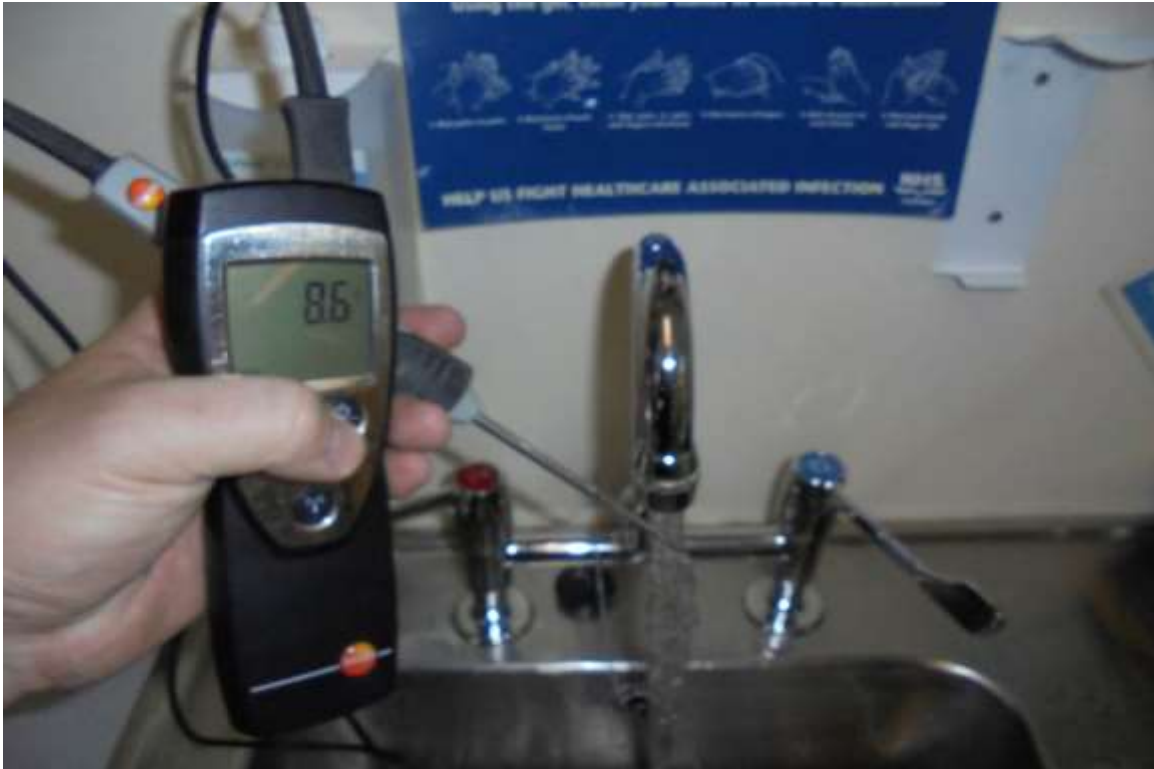
**Health Education/Physio Room Sink – Cold Water Outlet Temperature Satisfactory**

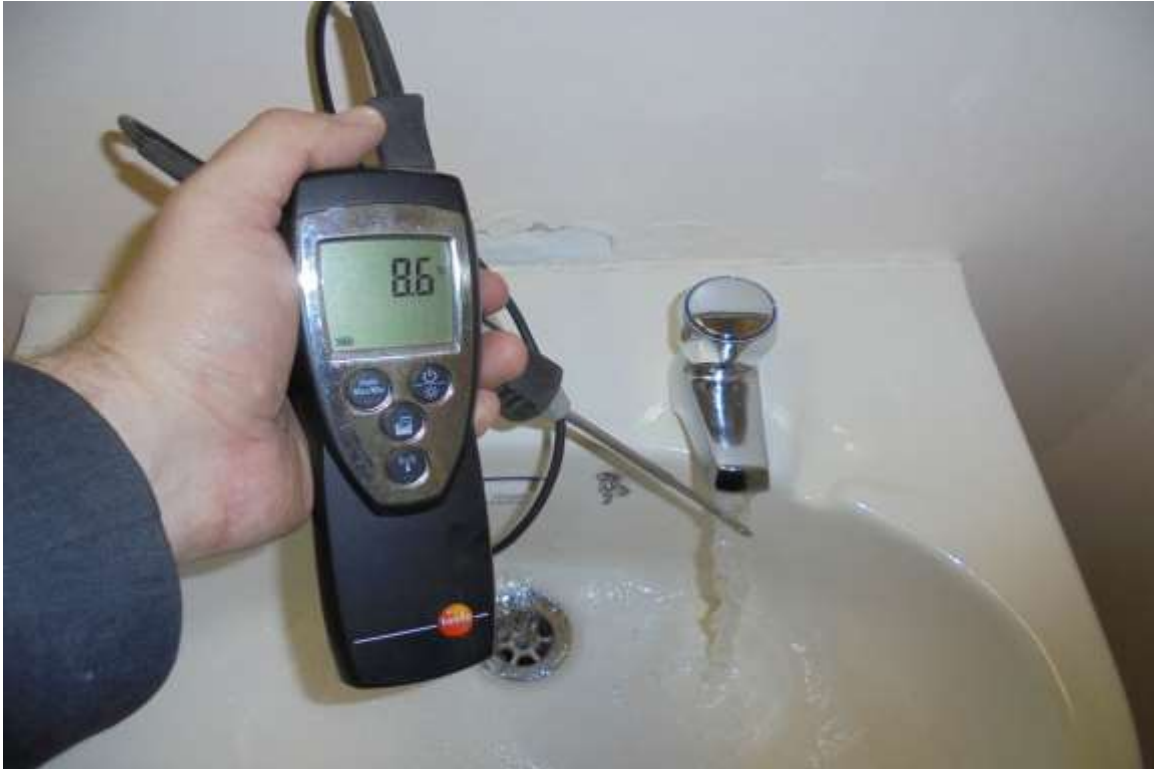
**Public Toilet WHB - Cold Water Outlet Temperature Satisfactory**

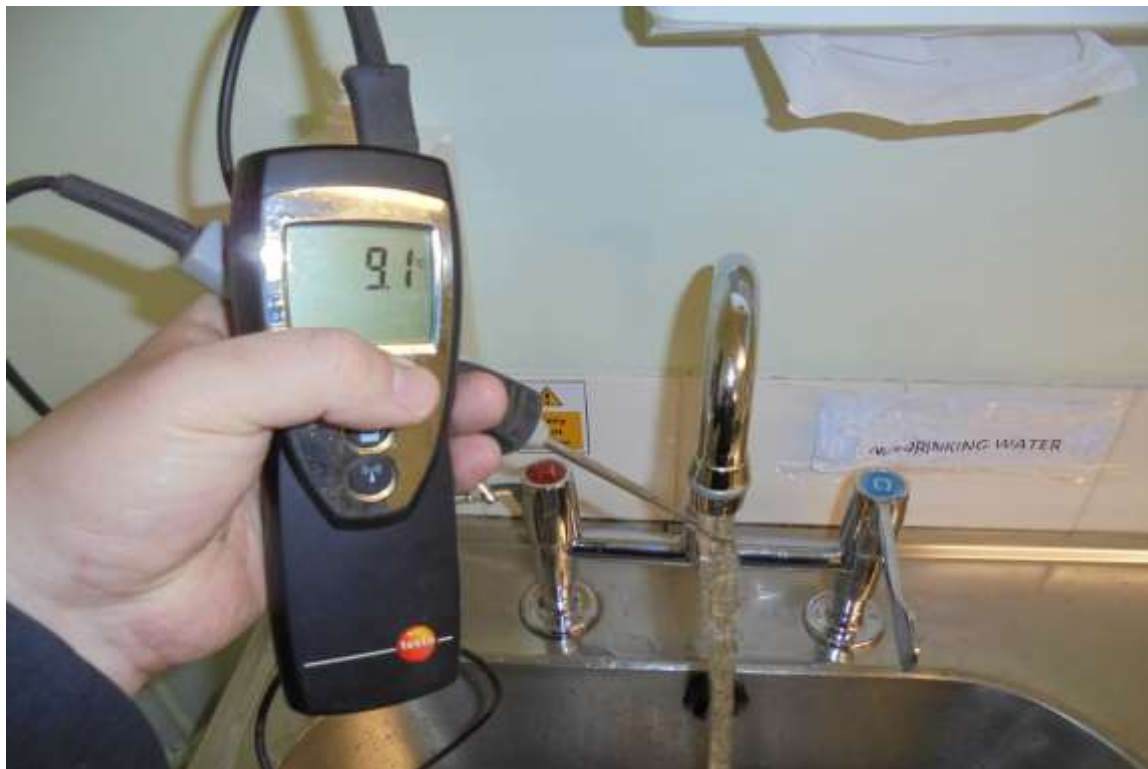
**Consultant Room 8 Sink - Cold Water Outlet Temperature Satisfactory**

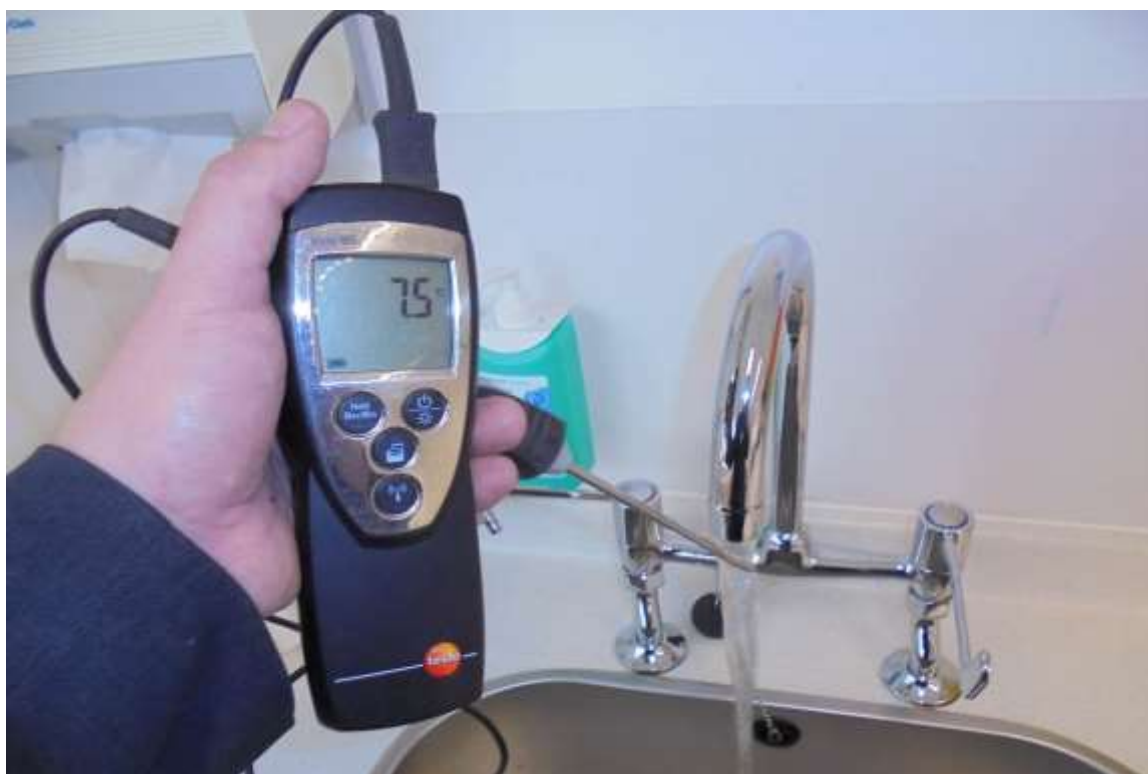
**Extension Consultant Room 2 Sink - Cold Water Outlet Temperature Satisfactory**

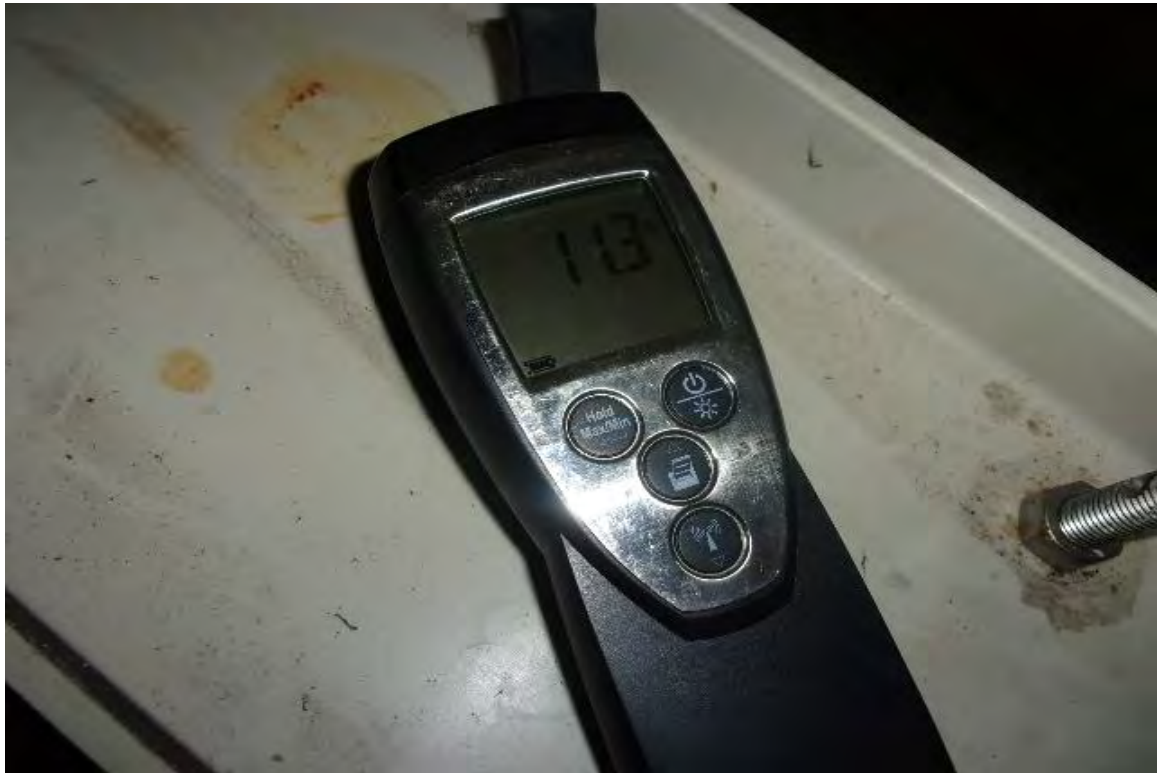
**CWS Tank No. 1 – Contents Temperature at 11.5°C**
