## FREEDOM OF INFORMATION – LEGIONELLA

I write in response to your request for information in relation to Legionella in East Calder Health Centre.

This document relates to an ongoing programme of water quality monitoring at East Calder Health Centre, carried out by Westfield Caledonian during February 2016. As part of this visit, a review of the Water Quality Risk Assessment, relating to the domestic water systems contained within this building was carried out. This survey was carried out to satisfy the requirements of the Approved Code of Practice (L8) and guidance document HSG 274 and to determine aspects of the system design, condition and mode of operation which may compromise the quality of the water to which occupants are exposed and subsequent health risk. This assessment survey and control scheme review was carried out in a manner consistent with requirements with *BS8580:2010 Water Quality-Risk Assessment for Legionella control – code of practice*.

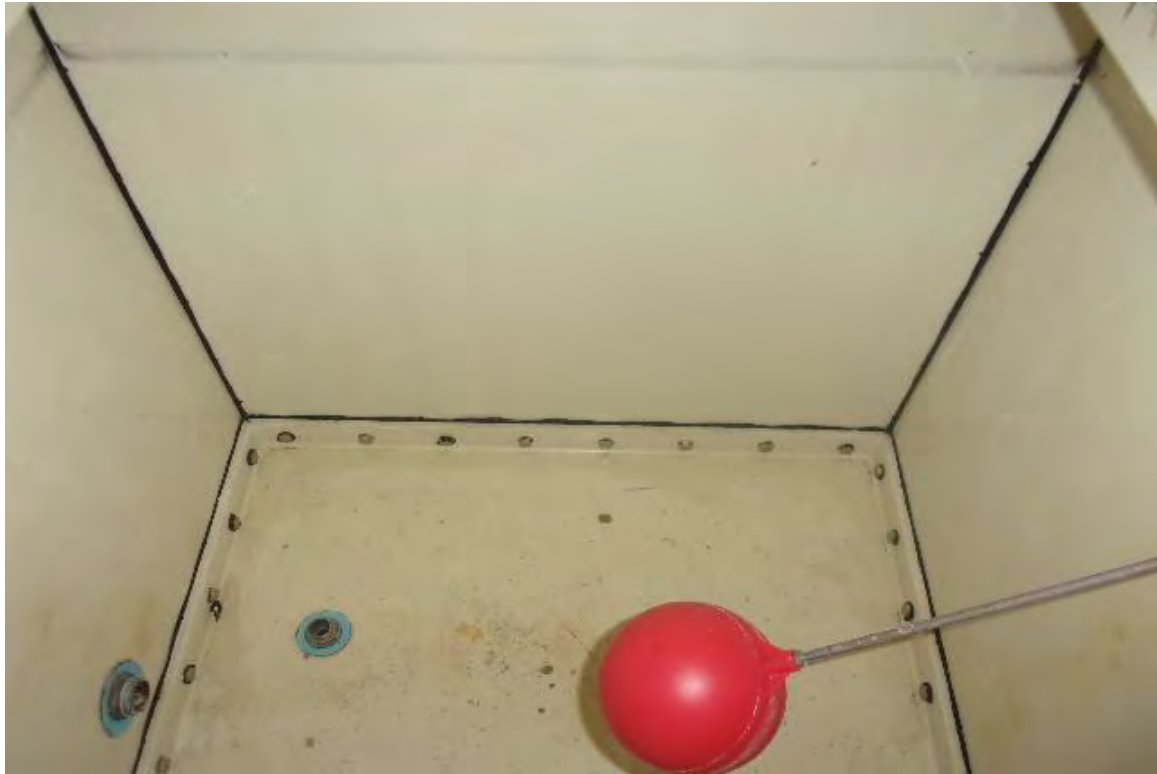
The CWS tanks are located at high level within the 1<sup>st</sup> floor plantroom and CWS tank No.2 continues to be drained and isolated and this has been done so in a way to minimise the creation of dead legs within the system. The tanks are of a modern GRP construction and can be considered fully Byelaw compliant. Internal inspection of CWS tank No.1 revealed light sediment at the base of the vessel. The storage temperature recorded was comfortably below the recommend upper limit of 20°C and compared favourably with the MWS reference temperature recorded at the 1<sup>st</sup> floor staffroom kitchen sink. Therefore, we have no recommendations regarding cold water storage at this time.

**CWS Tank No. 2 – Drained and Isolated**

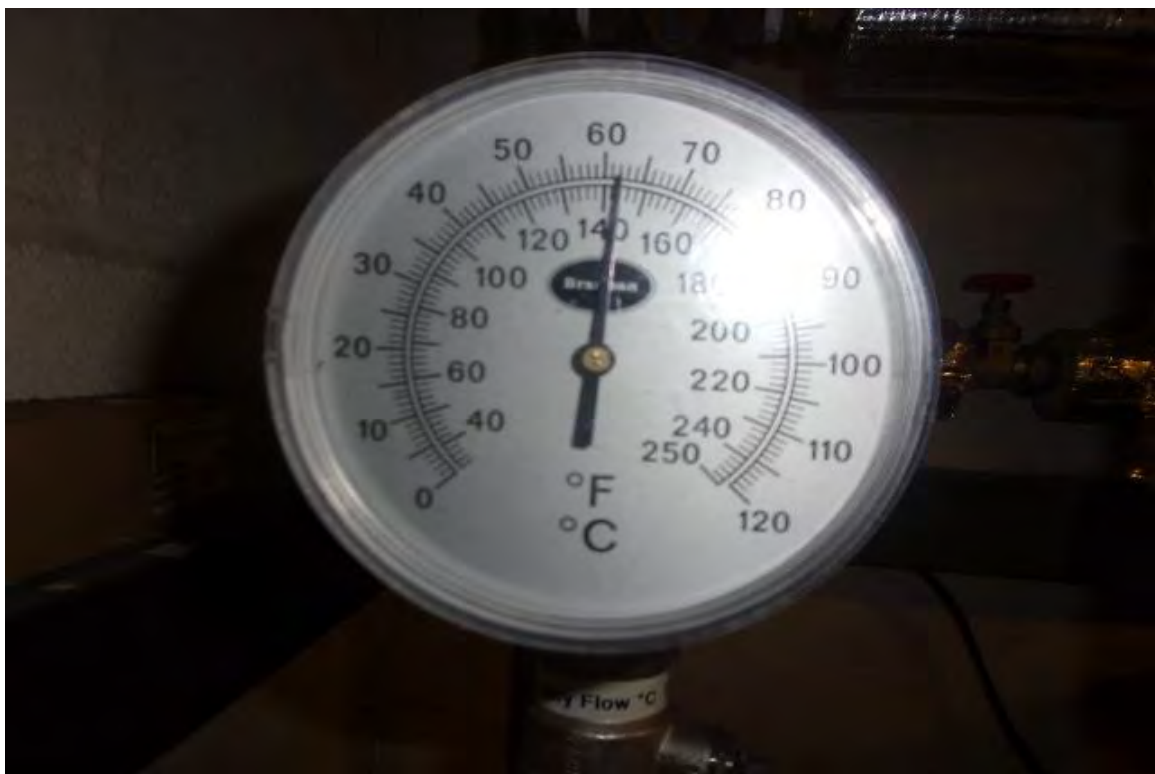
**Gas Fired Water Heater No. 1– Contents Temperature approx. 62°C**

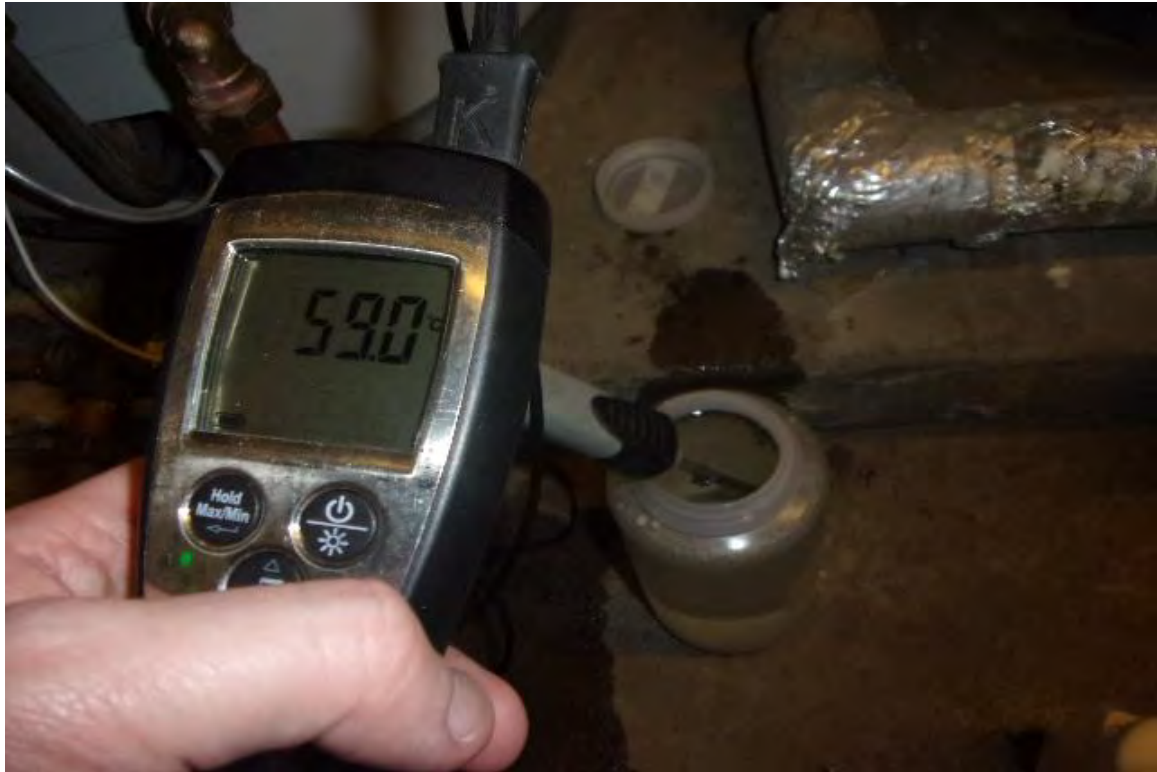
**Gas Fired Water Heater No. 1 – Drain Sample Containing Light Sediment and at Satisfactory Temperature**

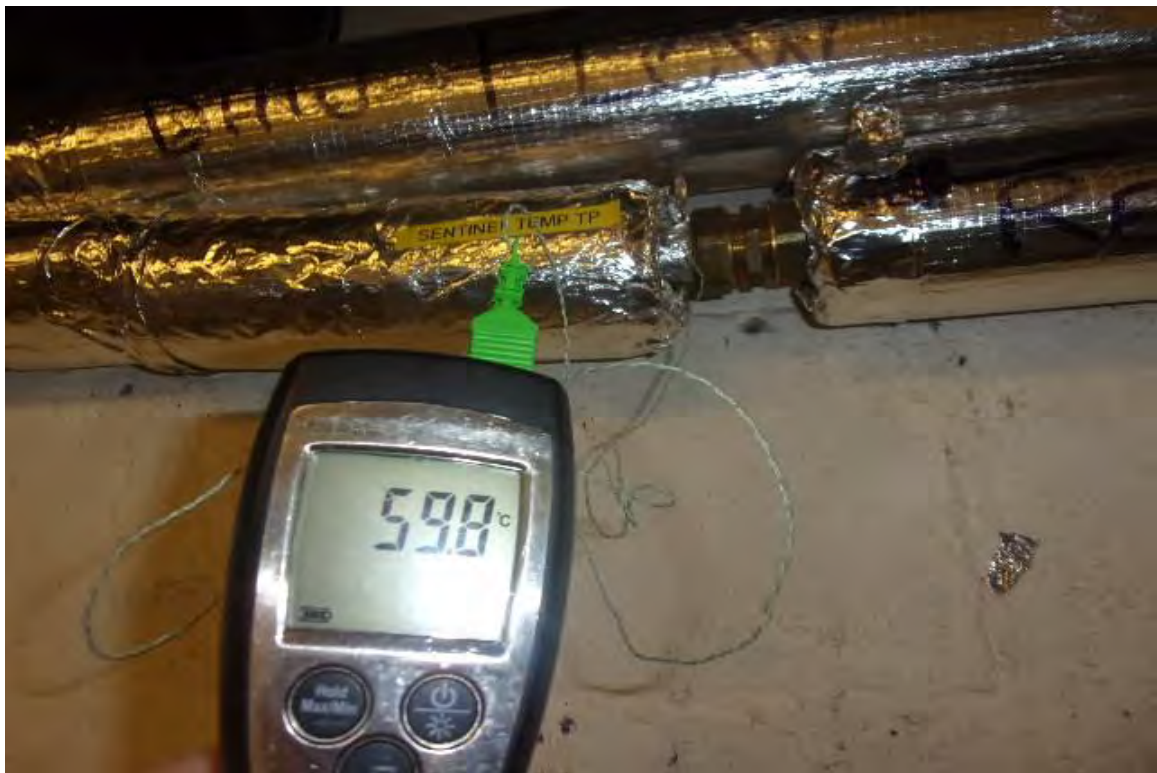
**Plantroom Return Temperature Satisfactory**

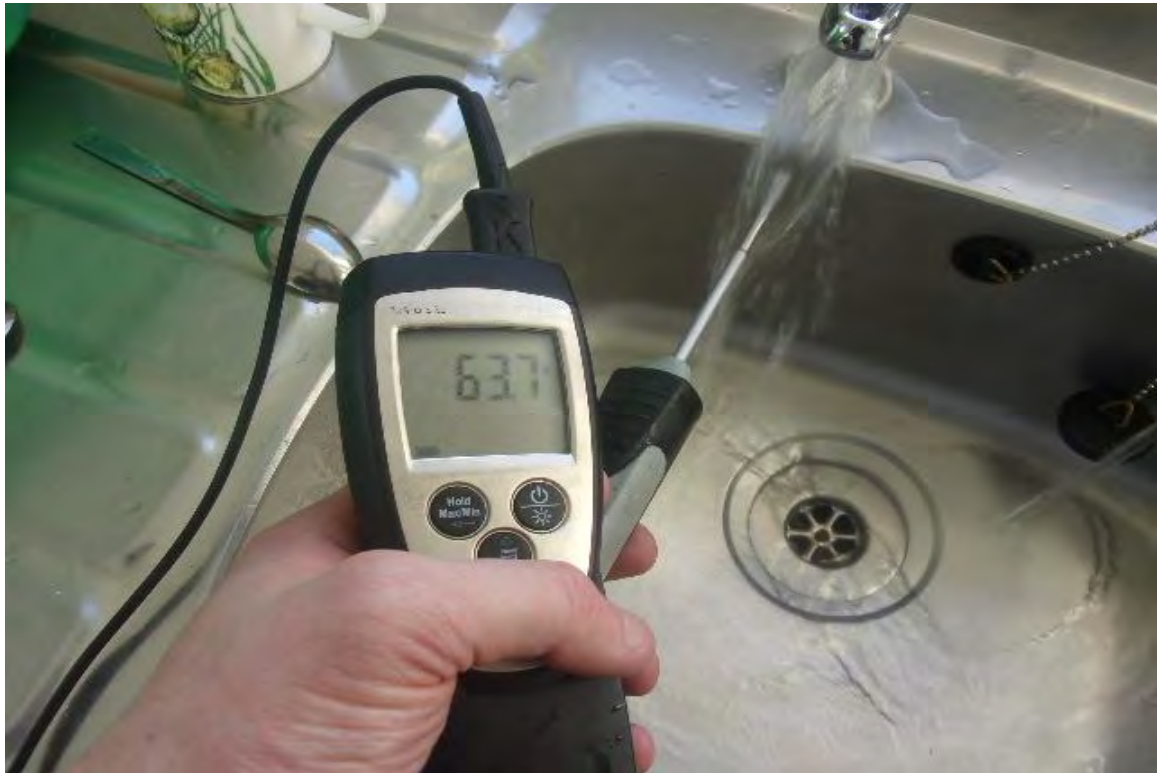
**1<sup>st</sup> Floor Staff Room Sink - Hot Water Outlet Temperature Satisfactory**

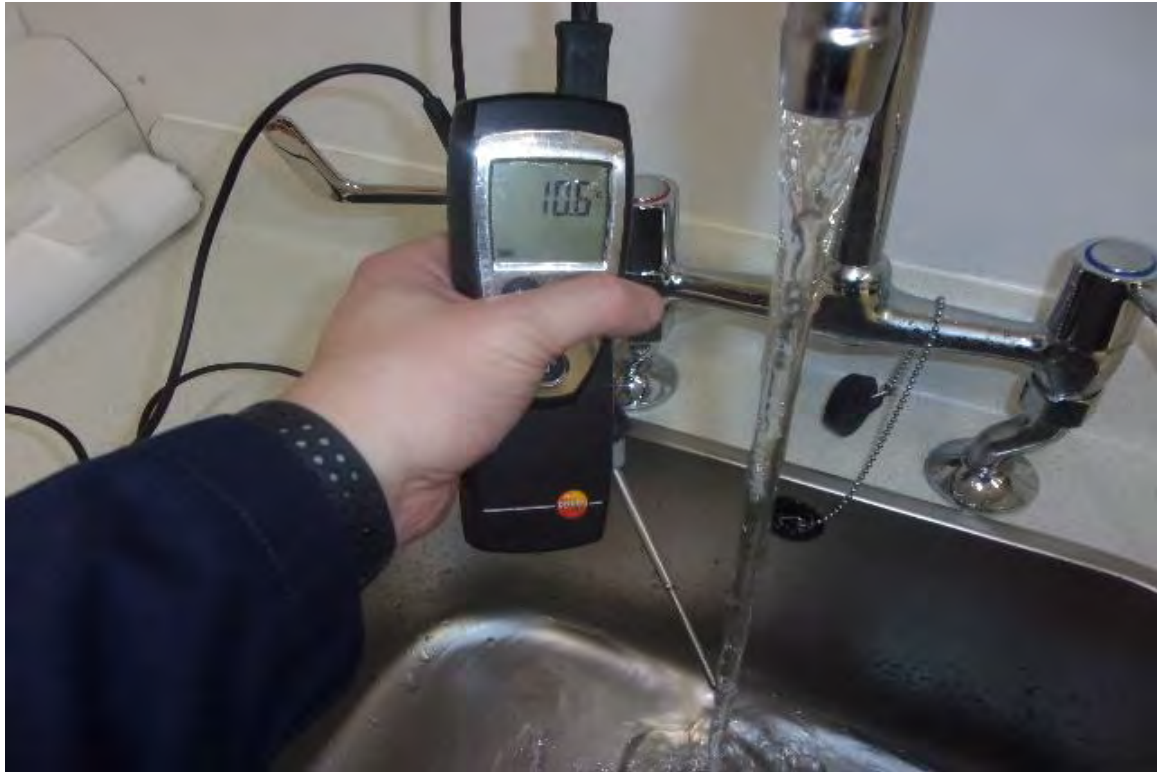
**Consultant Room 1 (G/55) Sink - Cold Water Outlet Temperature Satisfactory**

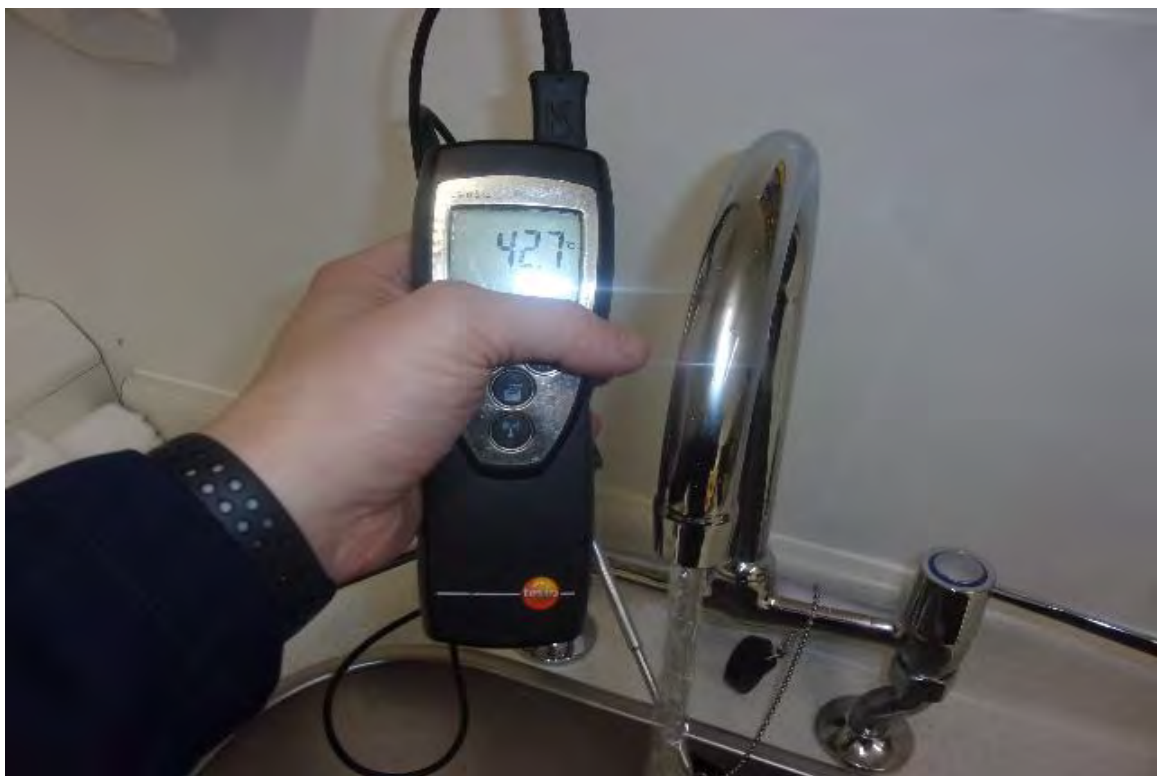
Within the extension at the rear of the building HeatStore under-sink water point of use water heaters are located in each of the three Consultation Rooms. These are considered low risk components as there is minimal storage and water turnover is high. However, upon inspection revealed the water heater to be supplying hot water below 50°C and it is recommended that the thermostatic controls be adjusted to deliver hot water at a minimum of 50°C, and temperatures should be verified following a period of low demand.

**Consultant Room 1 (G/55) Sink – Hot Water Outlet Temperature Unsatisfactory (<50°C)**

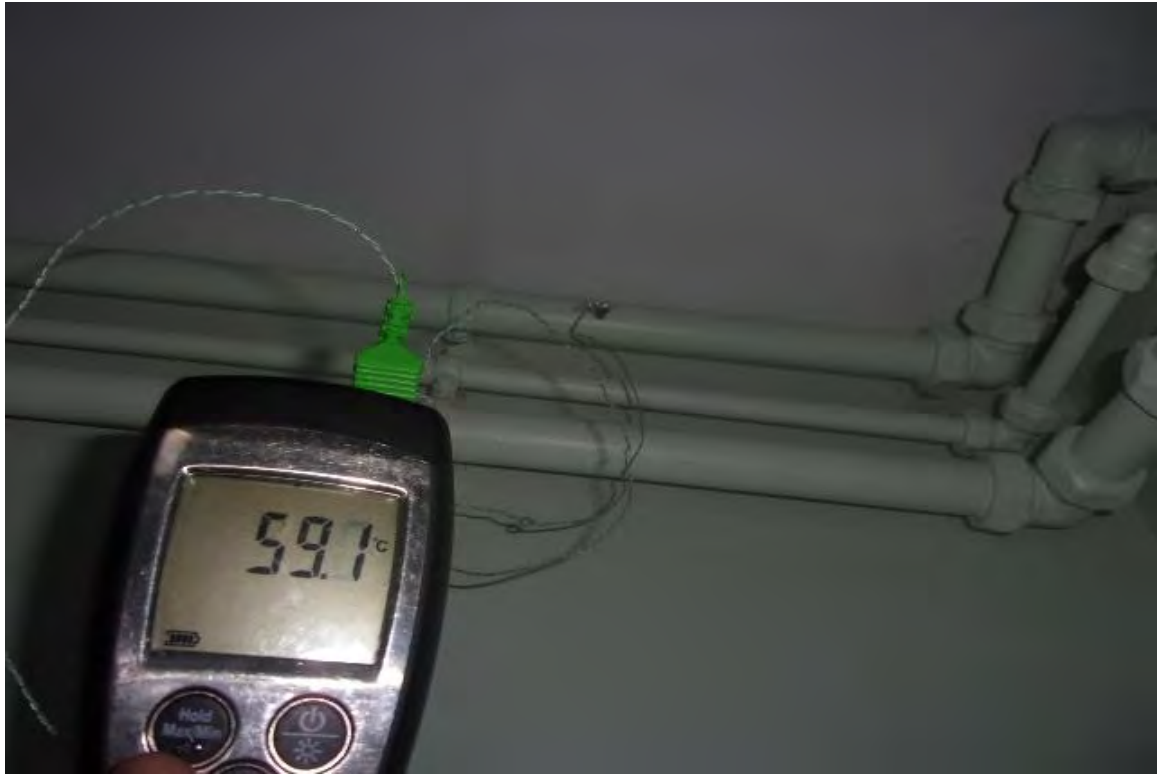
**Secretarial Office (G/09) Hot Water Flow Temperature Satisfactory**

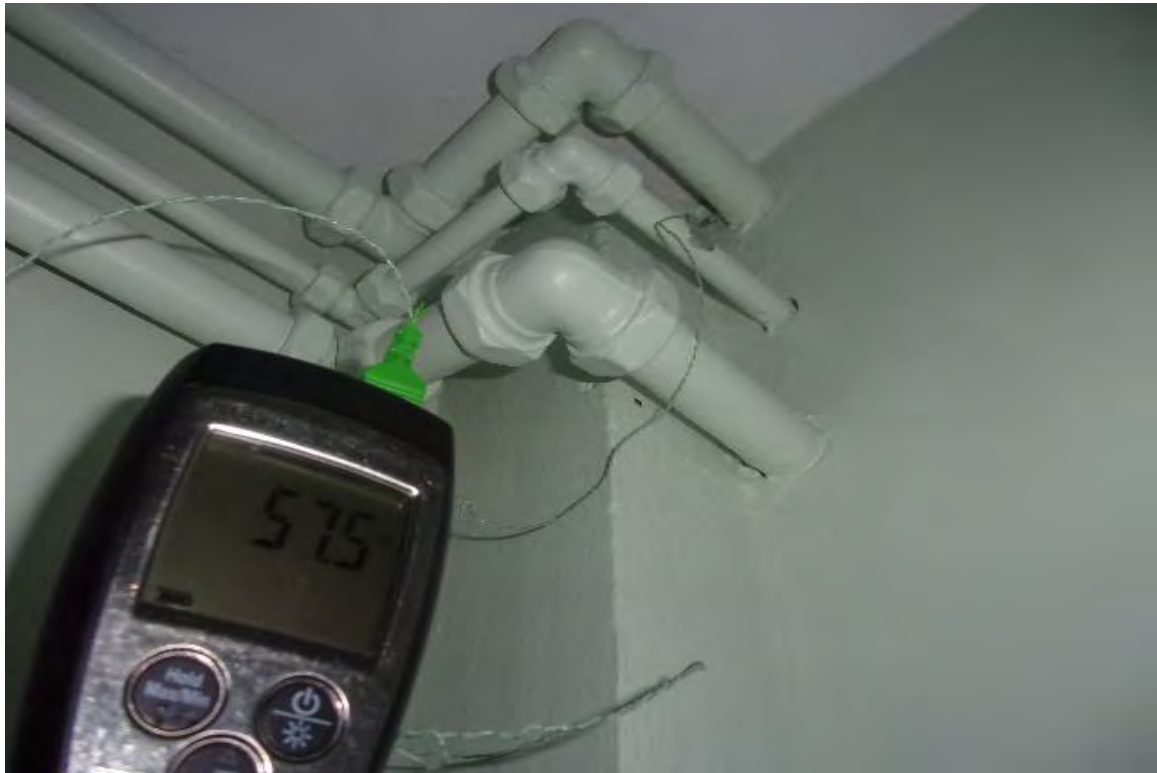
**Secretarial Office (G/09) Hot Water Return Temperature Satisfactory**

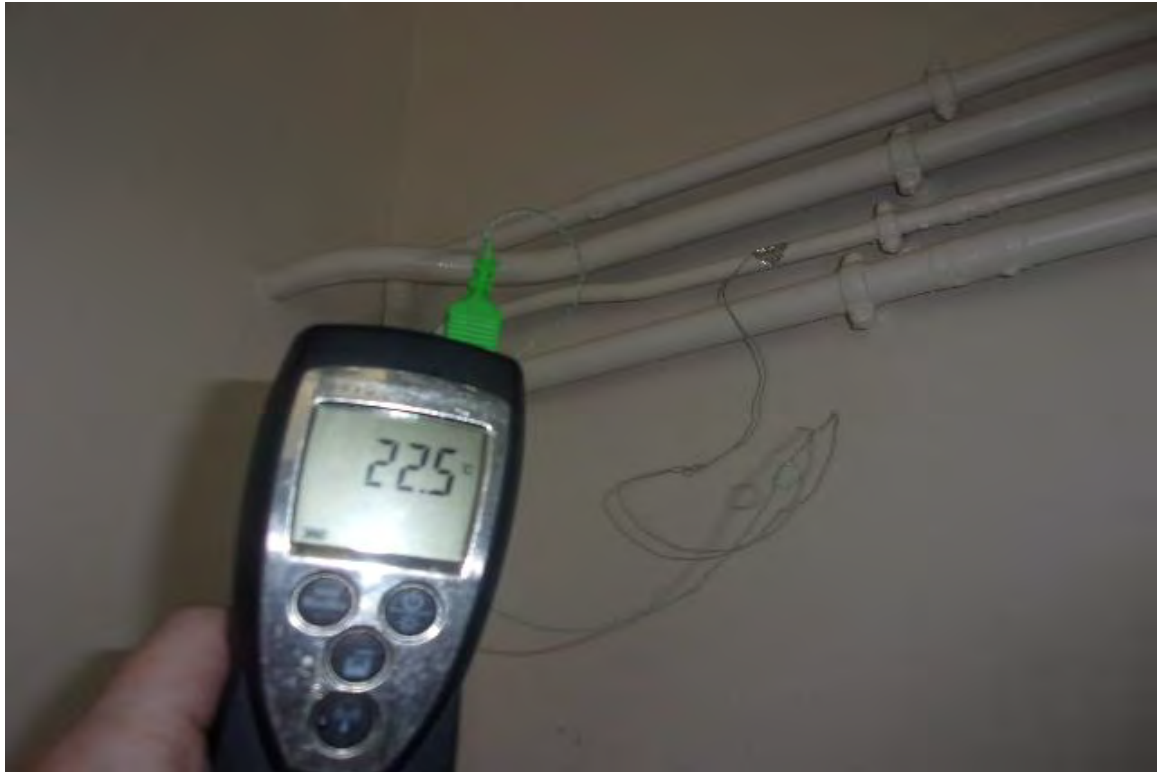
**Baby Changing Area Hot Water Return Temperature Too Low (<55°C)**

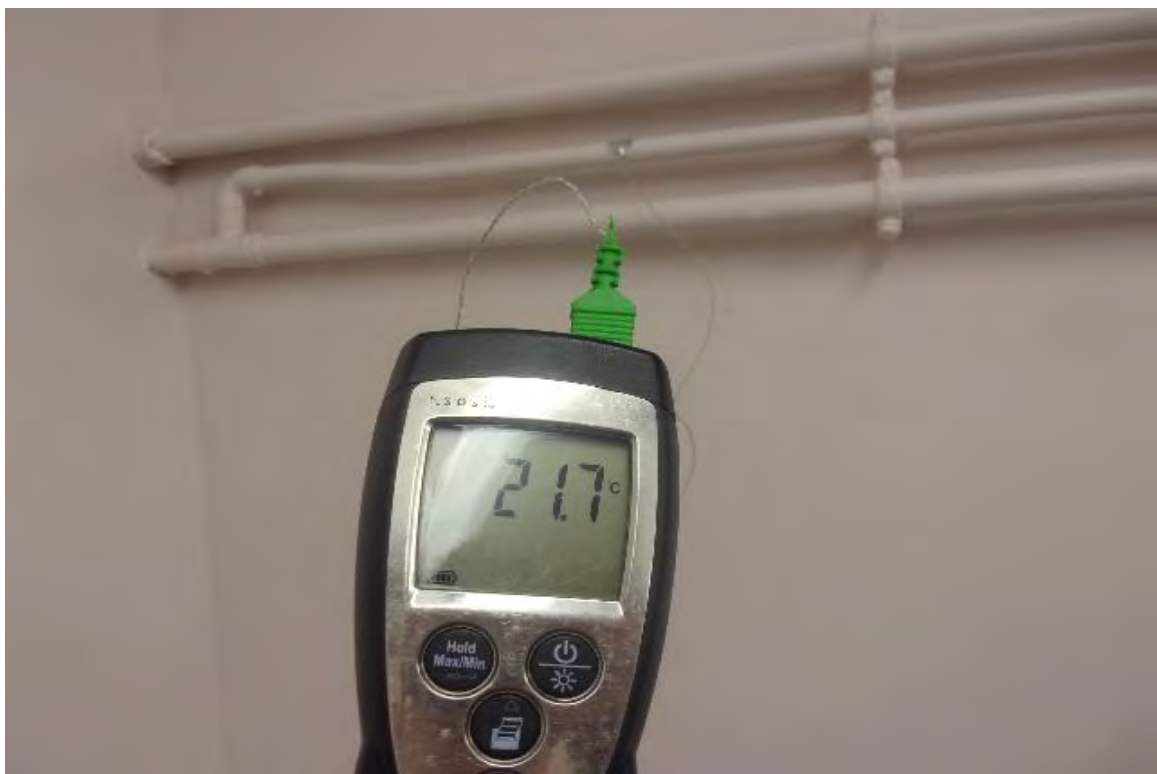
**Store Room (G/34) Hot Water Return Temperature Too Low (<55°C)**

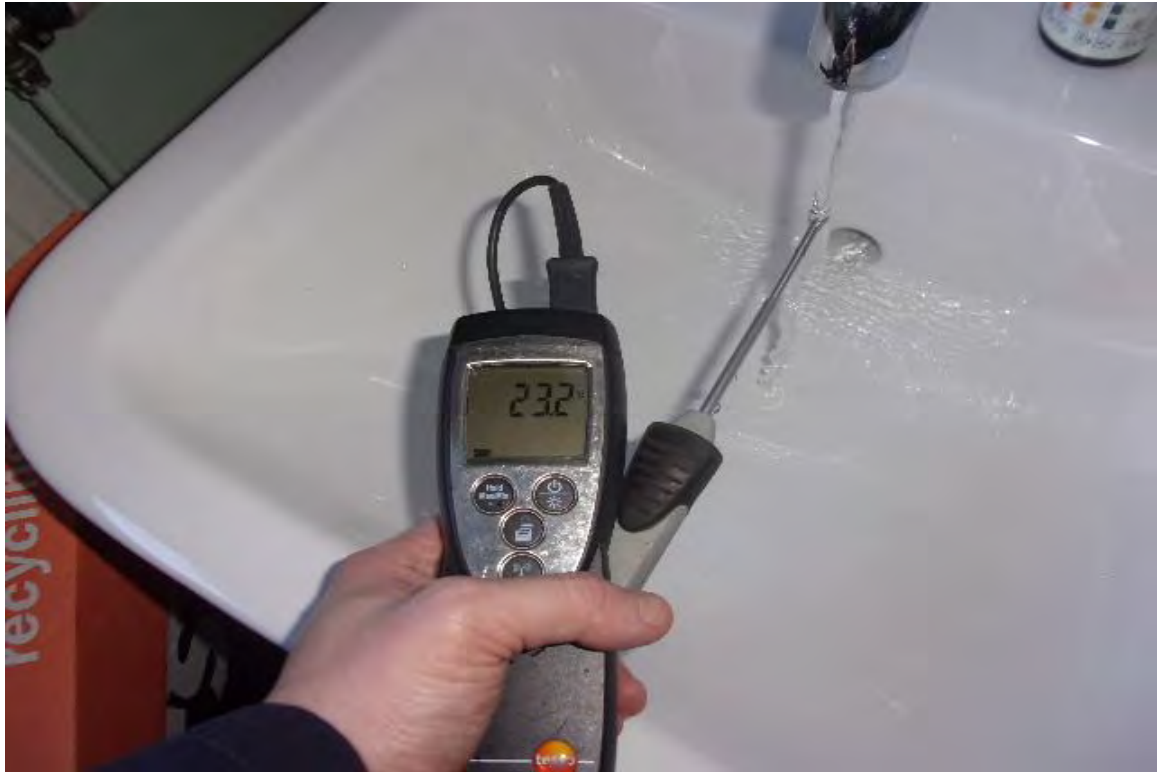
**Secretarial Office (G/09) WHB – Cold Water Outlet Temperature Slightly Elevated (>20°C)**

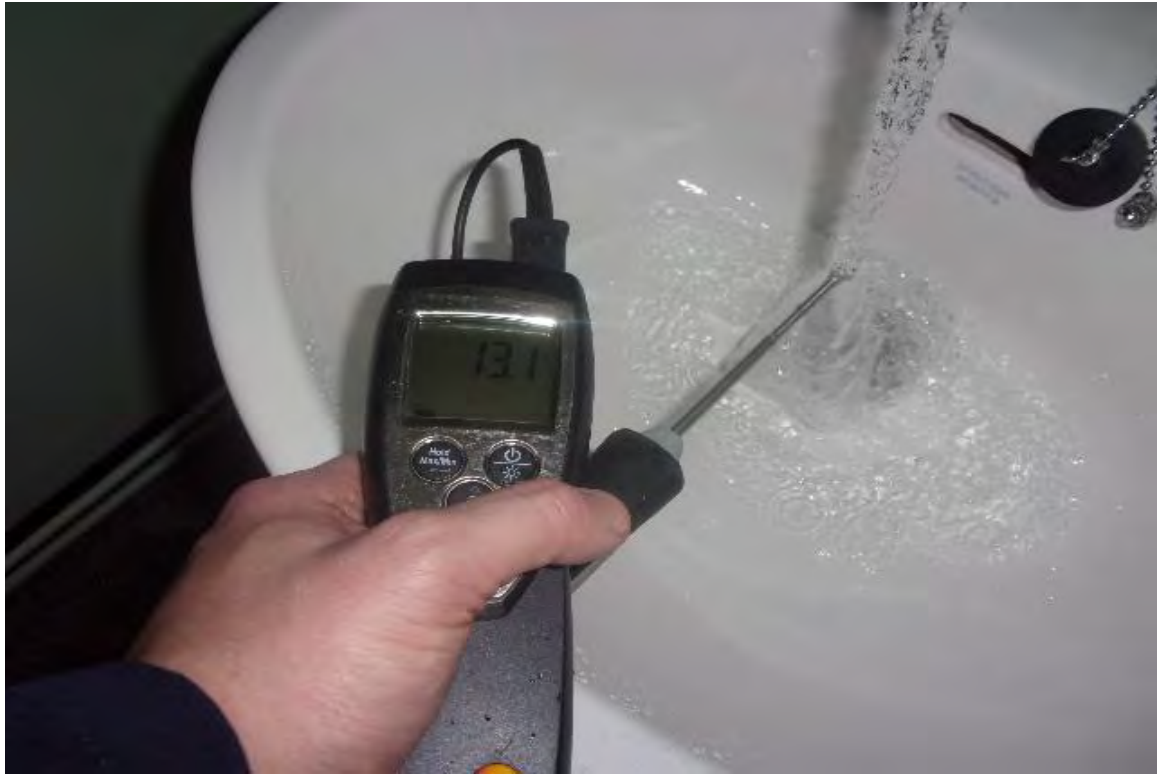
**Consultant Room 2 (G/14) Sink - Cold Water Outlet Temperature Satisfactory**

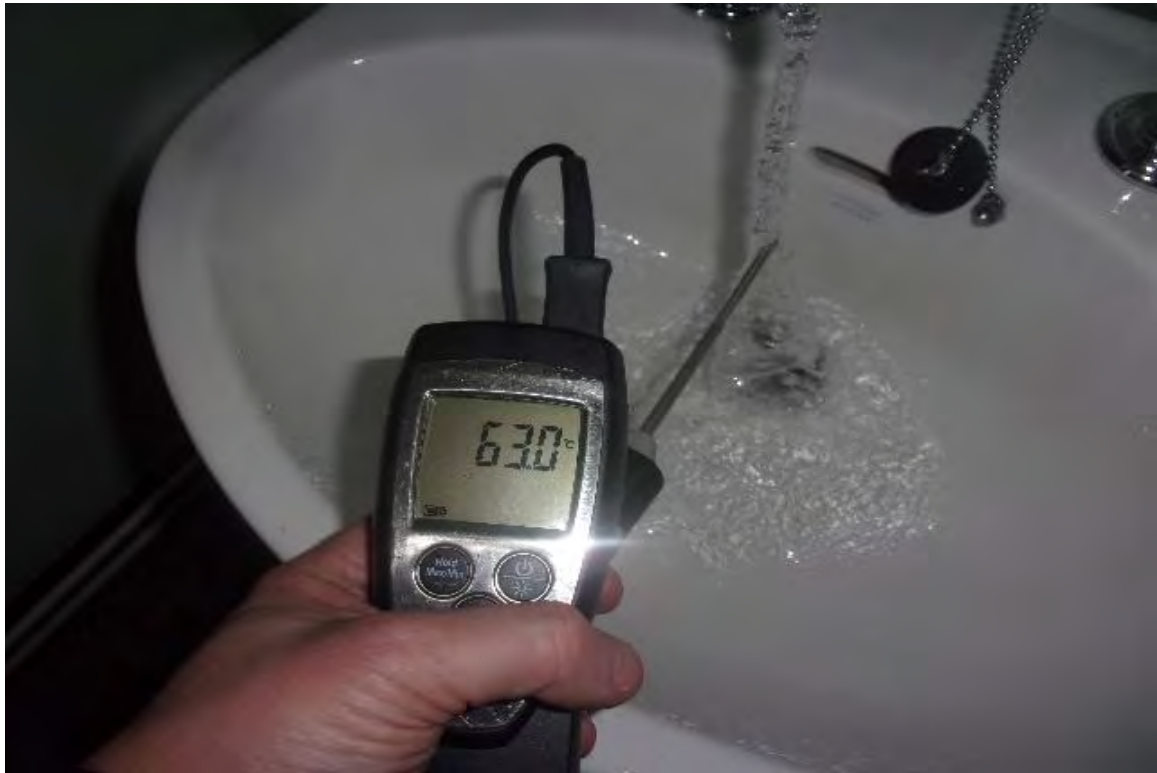
**Consultant Room 2 (G/14) Sink - Hot Water Outlet Temperature Satisfactory**

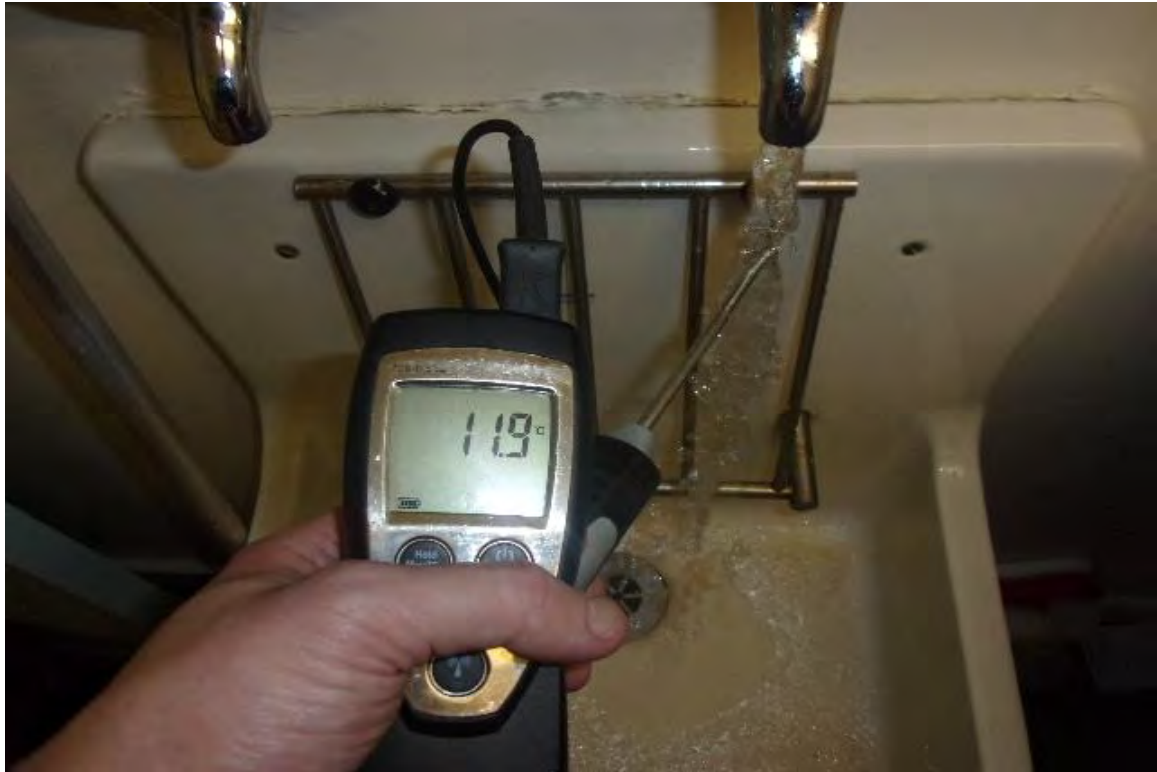
**Cleaners Cupboard (G/49) Sink – Cold Water Outlet Temperature Satisfactory**

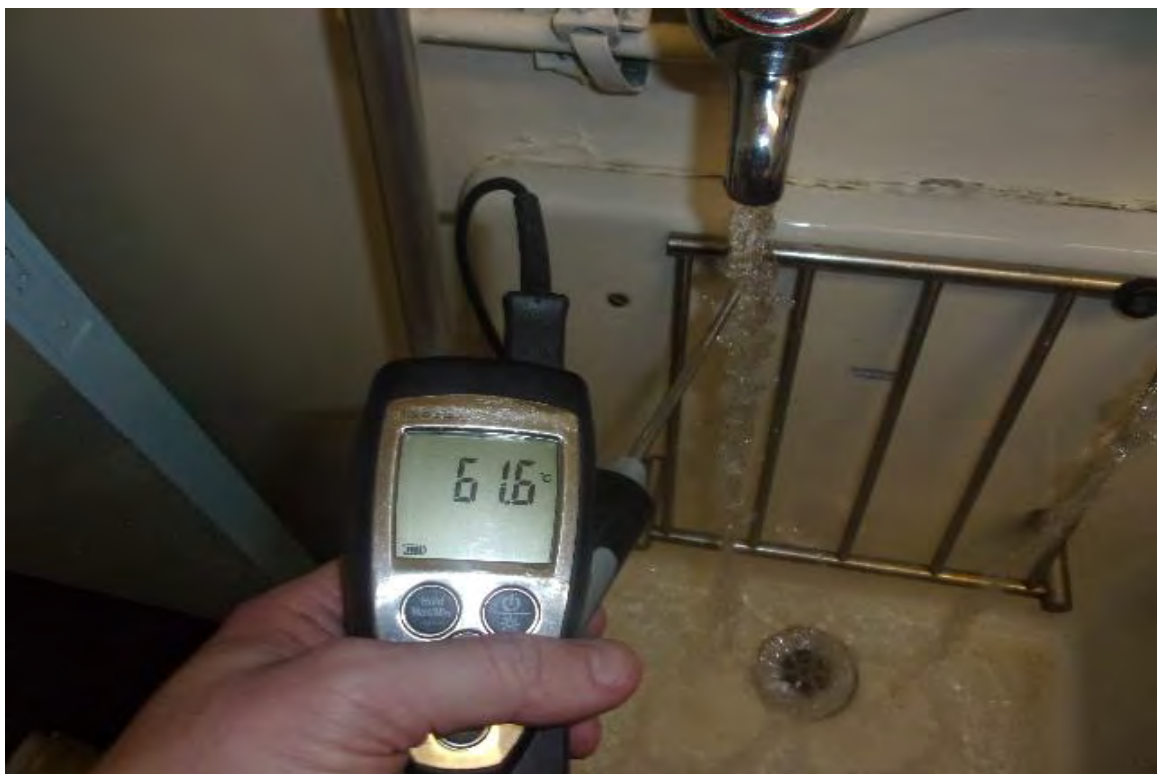
**Cleaners Cupboard (G/49) Sink – Hot Water Outlet Temperature Satisfactory**

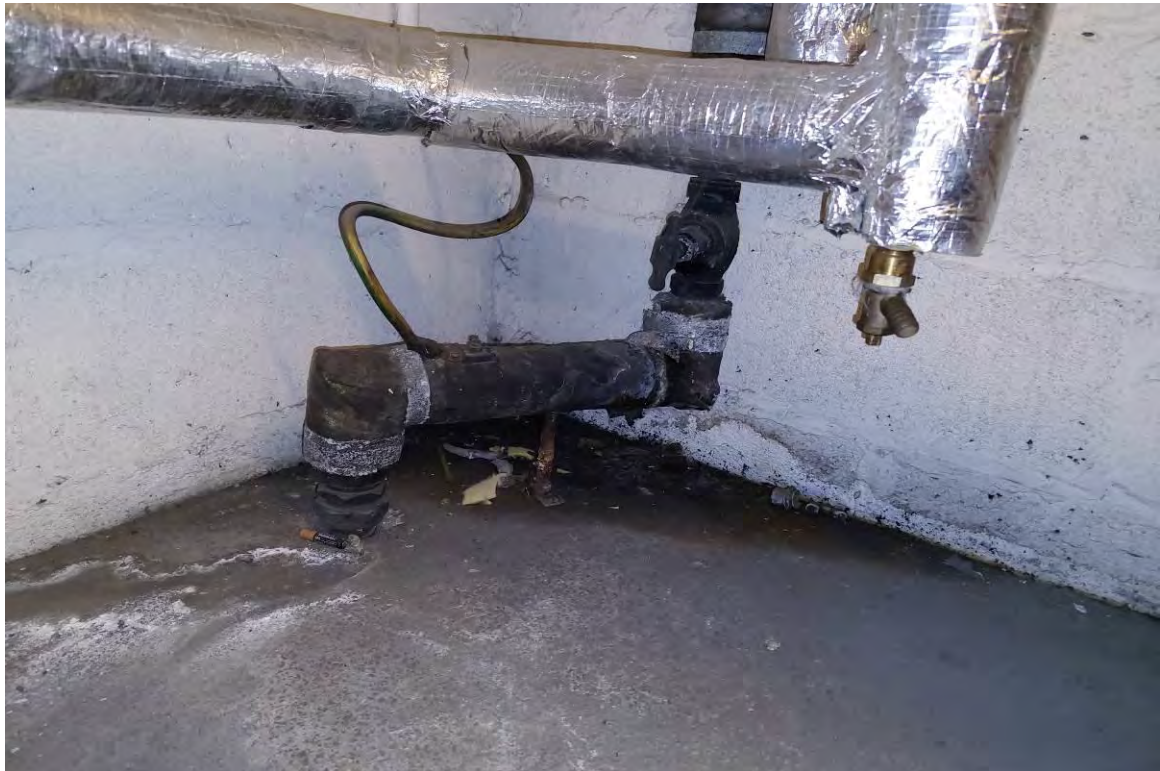
A public Mains Water Service (MWS) enters the main plant room and is provided with a stop cock and drain down facility. No check valve was identified and this may be requested by the water authority to comply with the Water Byelaws.

**MWS Inlet with Stop Cock and Drain Point**

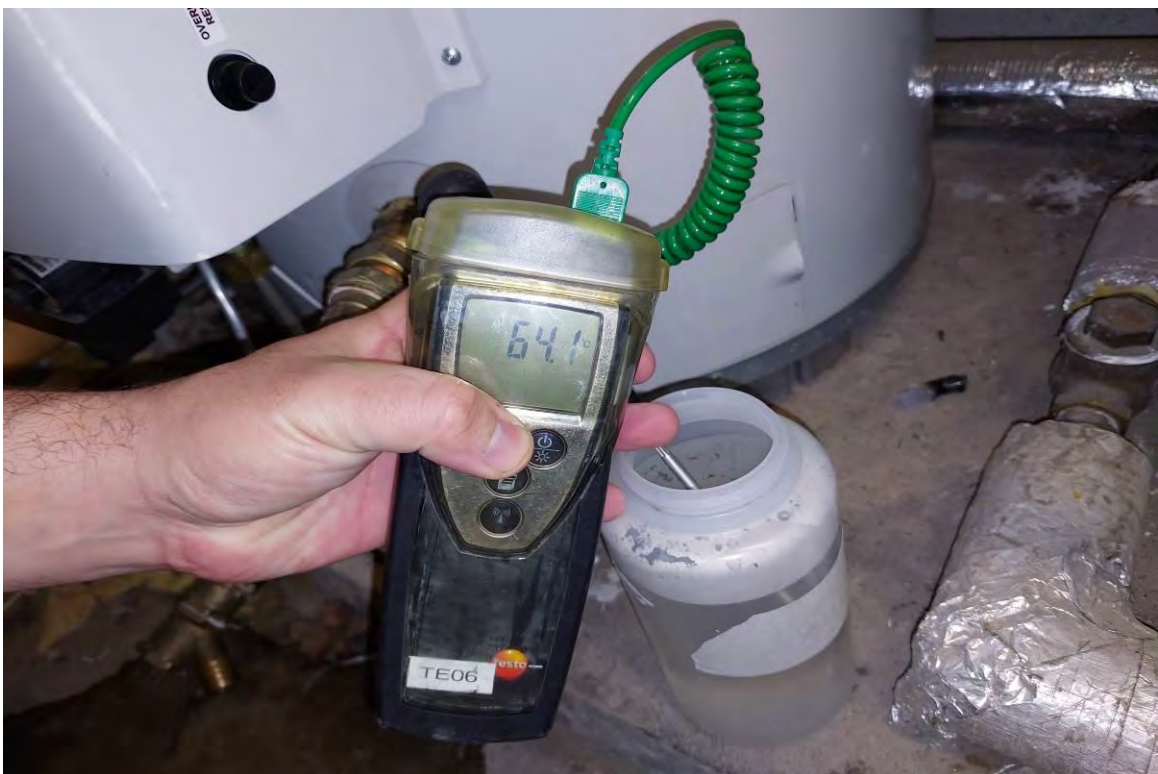
**DHWS Gas Fired Water Heater No.1 – Drain Sample Light Sediment and at Satisfactory Temperature**

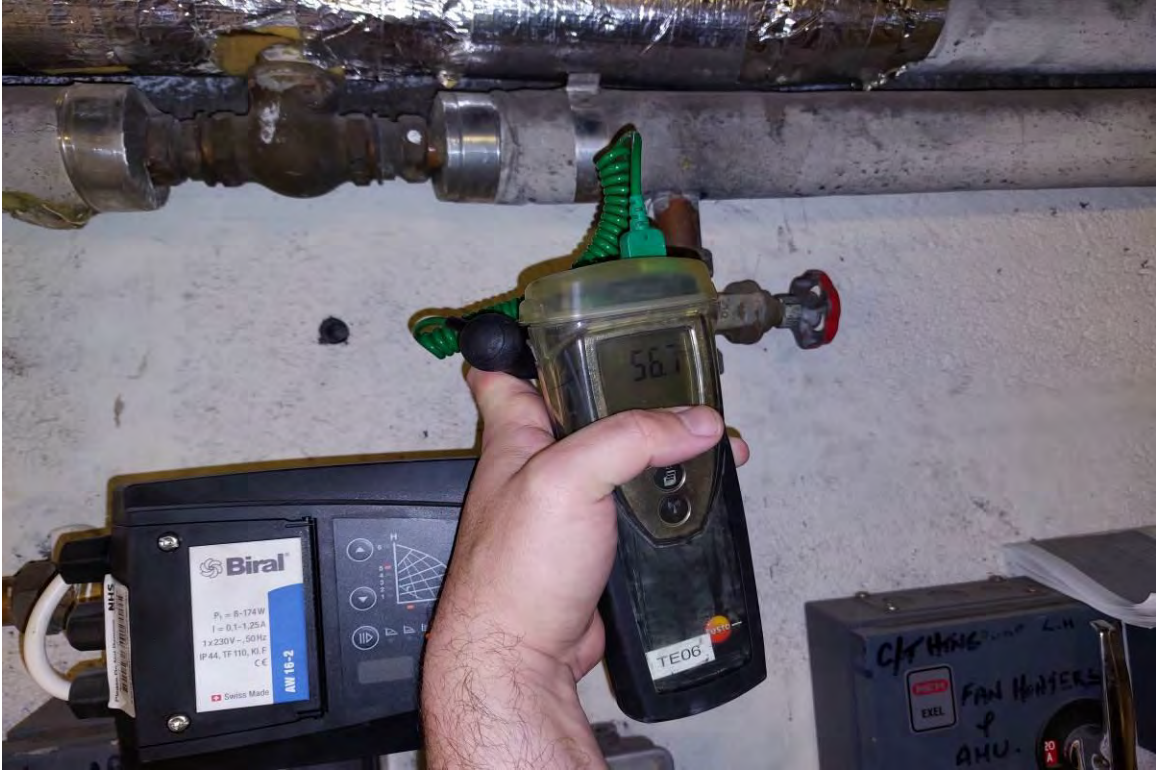
**Plantroom Principle Loop Return Temperature Satisfactory**

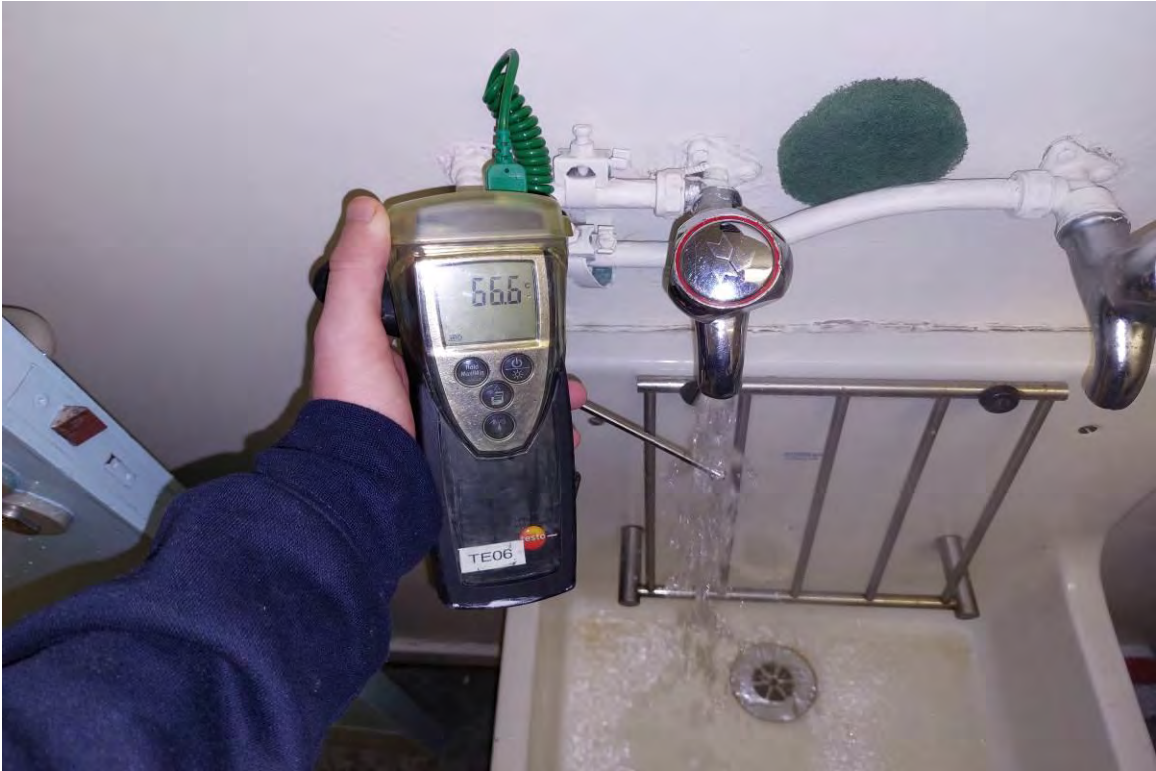
**DSR Sink - Hot Water Outlet Temperature Satisfactory**

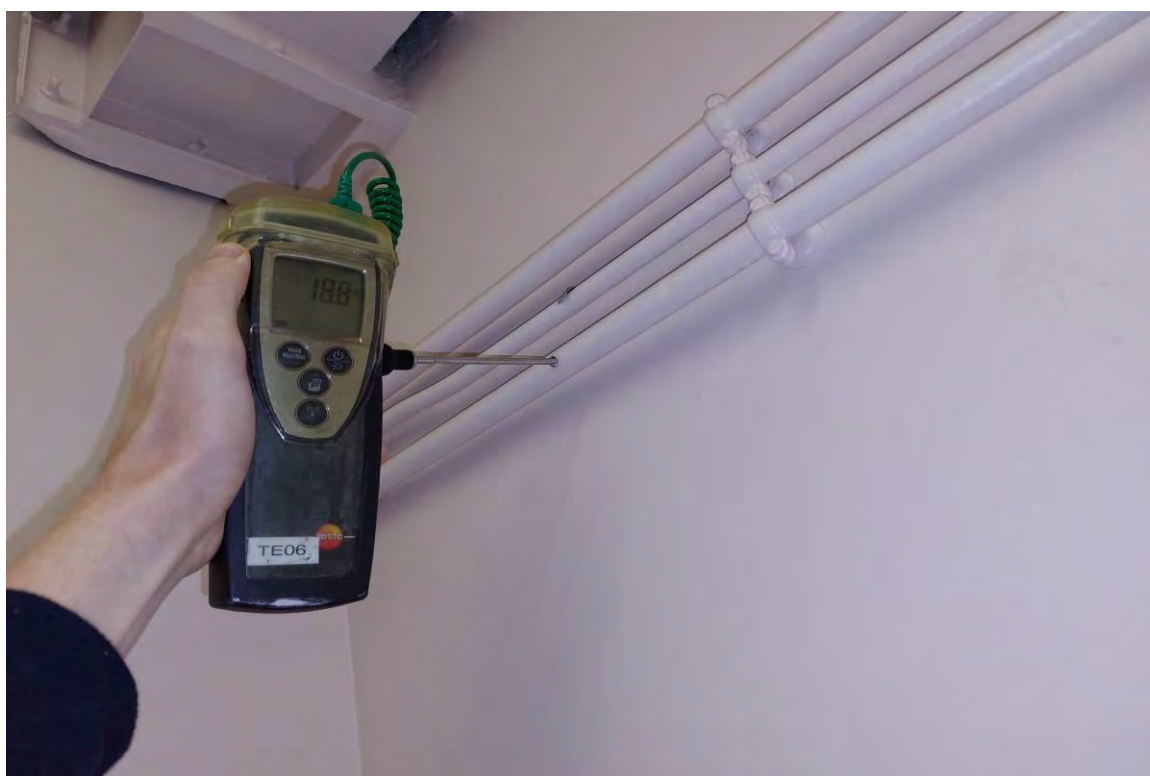
**Health Education/Physio Room - Tertiary Loop Flow Temperature Too Low (<55°C)**

Service	Remedial Action	Date Added	Priority	Status	Target Date	Date Complete
Gas Fired Water Heater	Storage temperature to be lowered slightly to minimise the risk of scalding.	October 2023	3	New	3 Months	
DHWS System	Investigate poor circulation to Health Education Room.	March 2021	2	Outstanding	1 Month	
Dead Legs	Install a double check valve on MWS at the branch point to heating system pressurisation unit.	December 2017	2	Outstanding	1 Month	
	Physically disconnect flexible quick-fill connection to heating system pressurisation unit under normal operation.	December 2017	2	Outstanding	1 Month	
Effective dead legs	Ensure flushing of rarely used outlets is carried out, Legionella positive result from Porto cabins highlights the need for regular flushing	October 2023	3	New	Ongoing

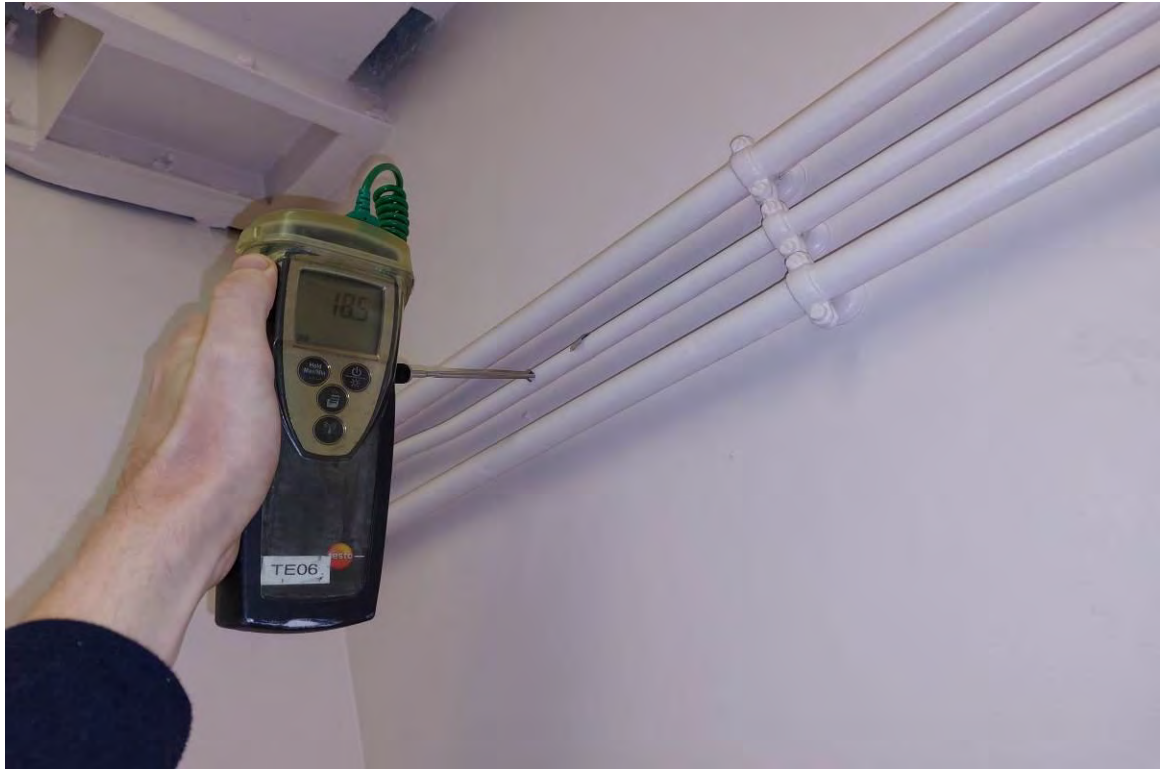
**Health Education/Physio Room - Tertiary Loop Return Temperature Too Low (<55°C)  
Ineffective Circulation**

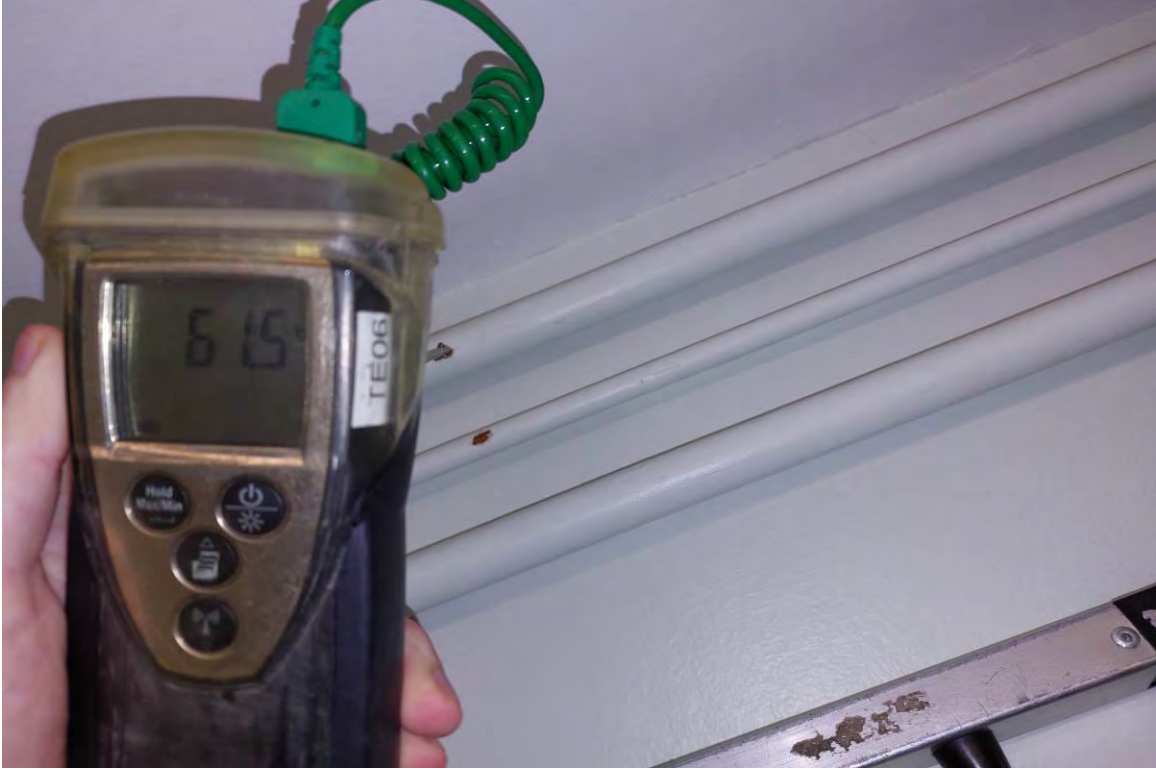
**Flow Temperature to Consultant Room 8 Satisfactory**

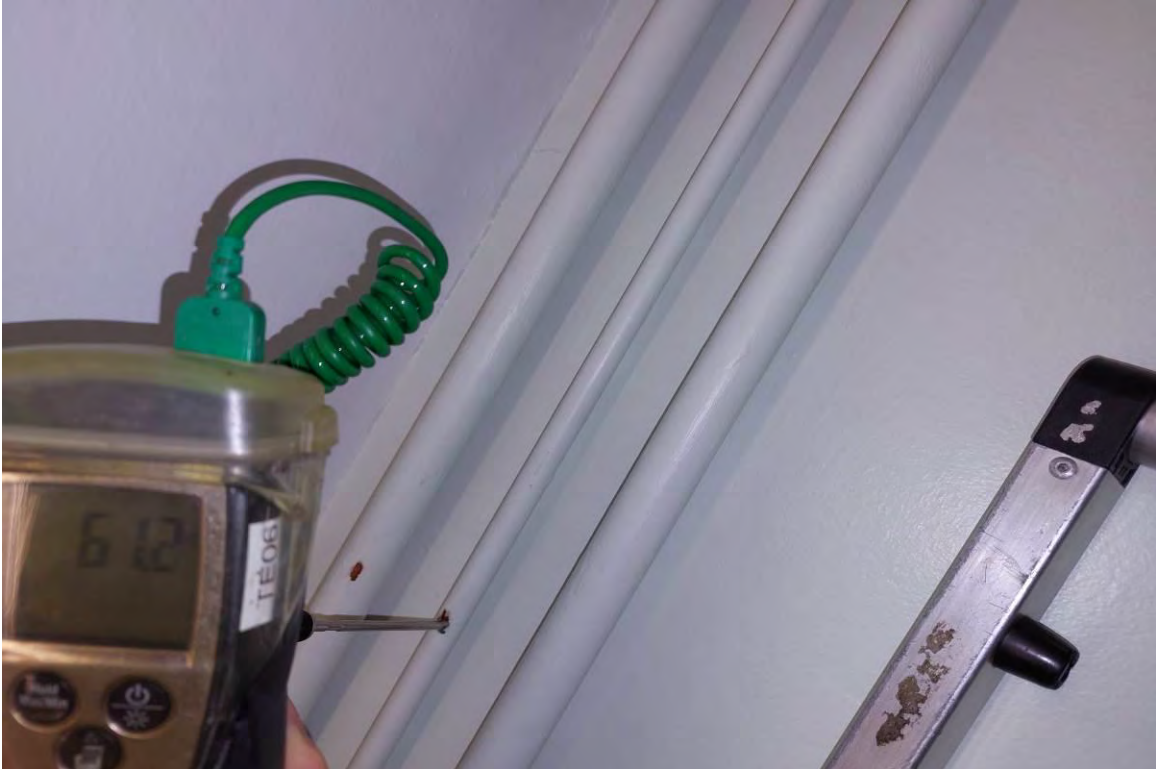
**Return Temperature from Consultant Room 8 Satisfactory**
