## FREEDOM OF INFORMATION – LEGIONELLA

I write in response to your request for information in relation to Legionella in East Calder Health Centre.

This document relates to an ongoing programme of water quality monitoring at East Calder Health Centre, carried out by Westfield Caledonian during February 2016. As part of this visit, a review of the Water Quality Risk Assessment, relating to the domestic water systems contained within this building was carried out. This survey was carried out to satisfy the requirements of the Approved Code of Practice (L8) and guidance document HSG 274 and to determine aspects of the system design, condition and mode of operation which may compromise the quality of the water to which occupants are exposed and subsequent health risk. This assessment survey and control scheme review was carried out in a manner consistent with requirements with *BS8580:2010 Water Quality-Risk Assessment for Legionella control – code of practice*.

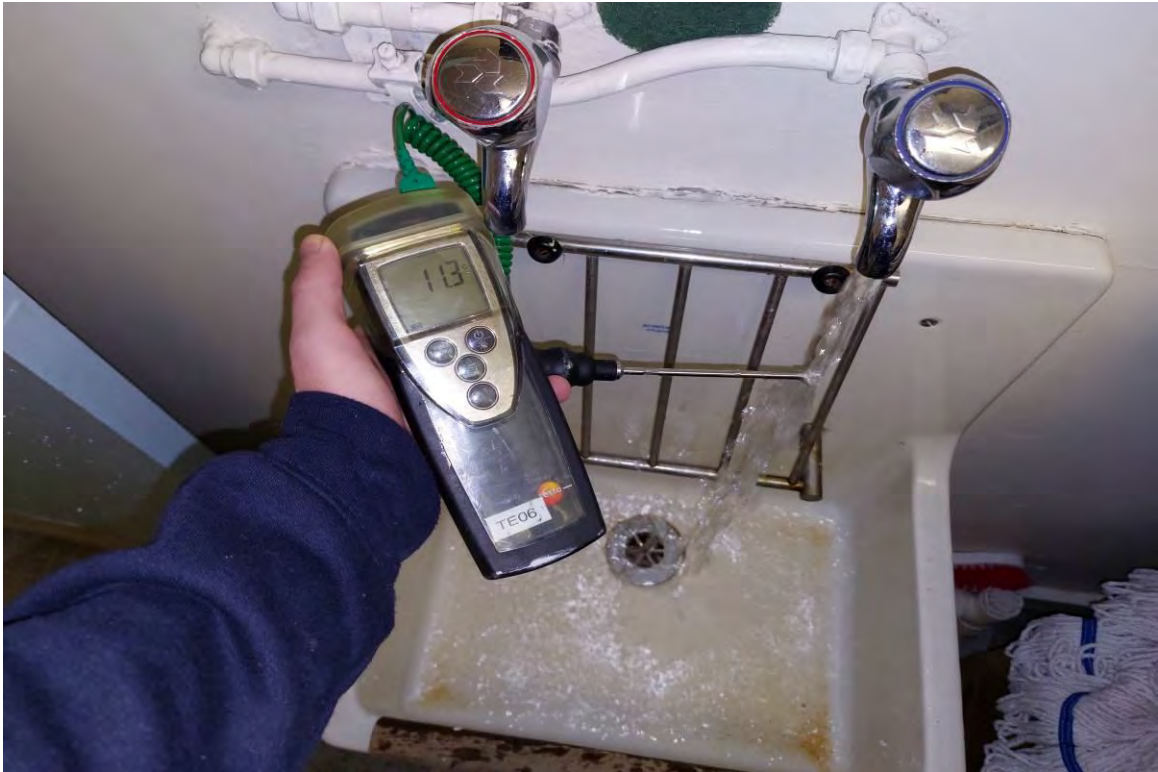
**DSR Sink – Cold Water Outlet Temperature Satisfactory**

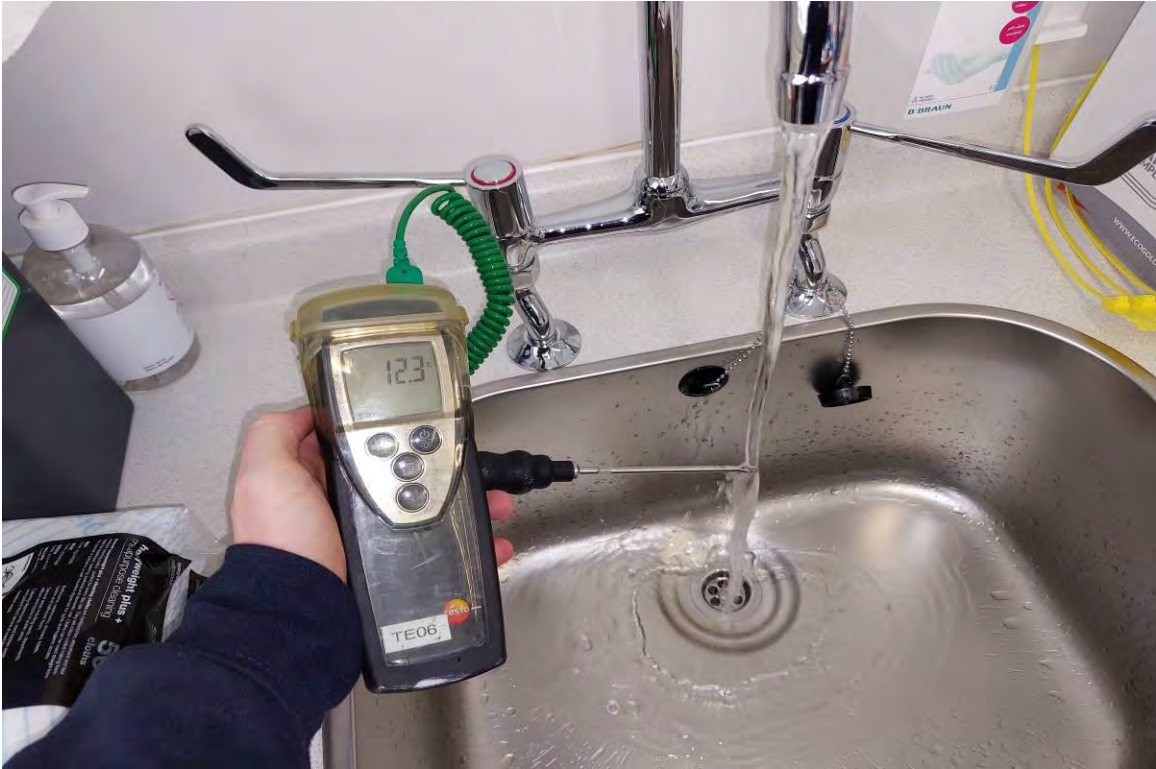
**Extension Consultant Room 3 Sink - Cold Water Outlet Temperature Satisfactory**
