## FREEDOM OF INFORMATION – LEGIONELLA

I write in response to your request for information in relation to Legionella in East Calder Health Centre.

This document relates to an ongoing programme of water quality monitoring at East Calder Health Centre, carried out by Westfield Caledonian during February 2016. As part of this visit, a review of the Water Quality Risk Assessment, relating to the domestic water systems contained within this building was carried out. This survey was carried out to satisfy the requirements of the Approved Code of Practice (L8) and guidance document HSG 274 and to determine aspects of the system design, condition and mode of operation which may compromise the quality of the water to which occupants are exposed and subsequent health risk. This assessment survey and control scheme review was carried out in a manner consistent with requirements with *BS8580:2010 Water Quality-Risk Assessment for Legionella control – code of practice*.

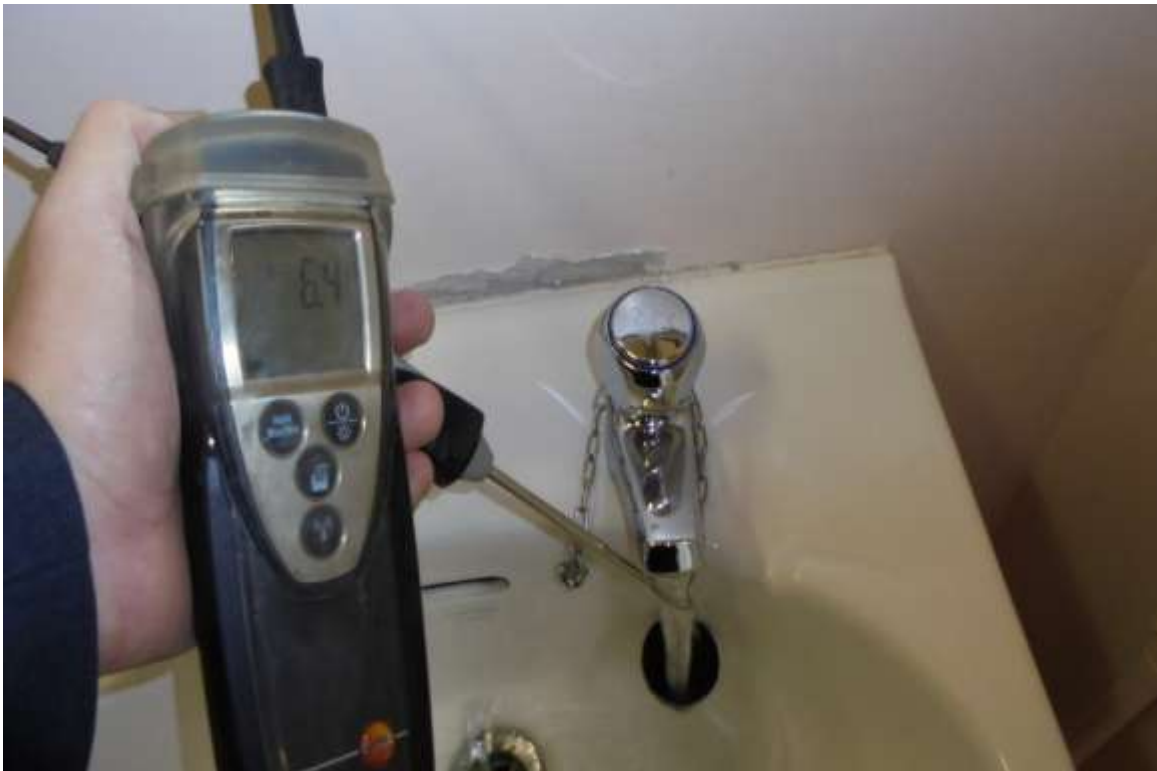
**Public Toilet WHB – Cold Water Outlet Temperature Satisfactory**

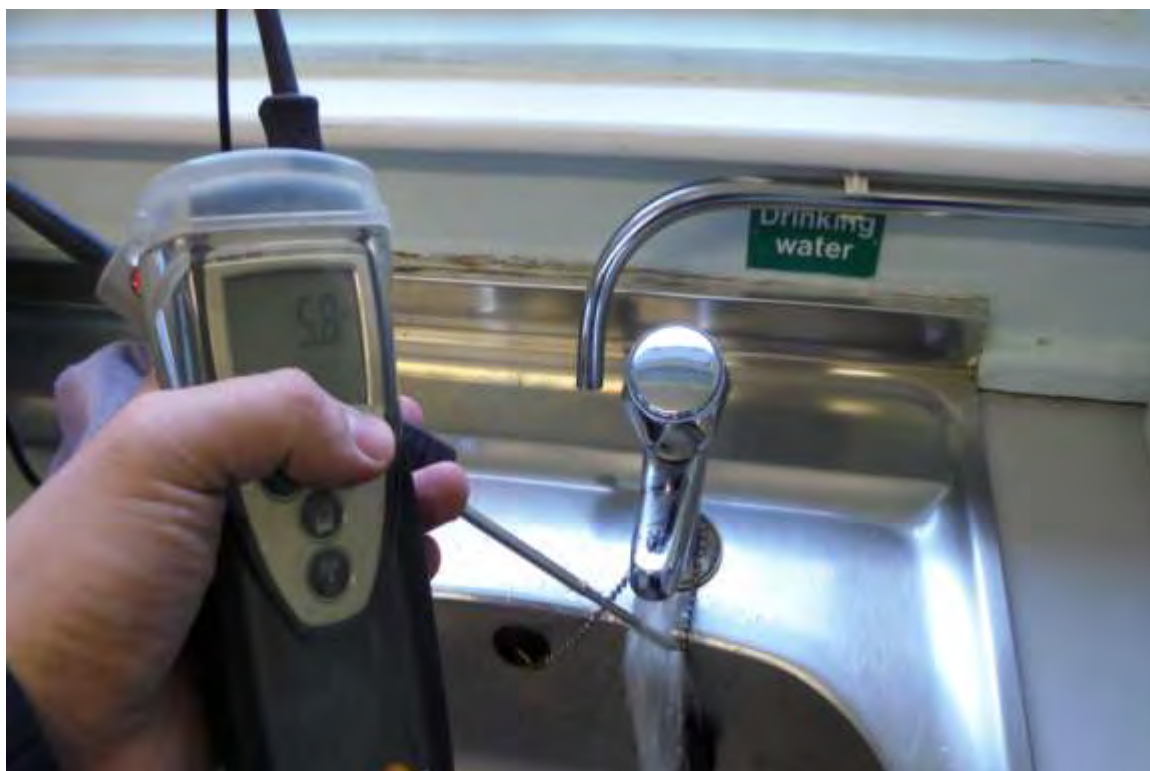
**1<sup>st</sup> Floor Staff Room Sink – Cold Water Outlet Temperature Satisfactory**

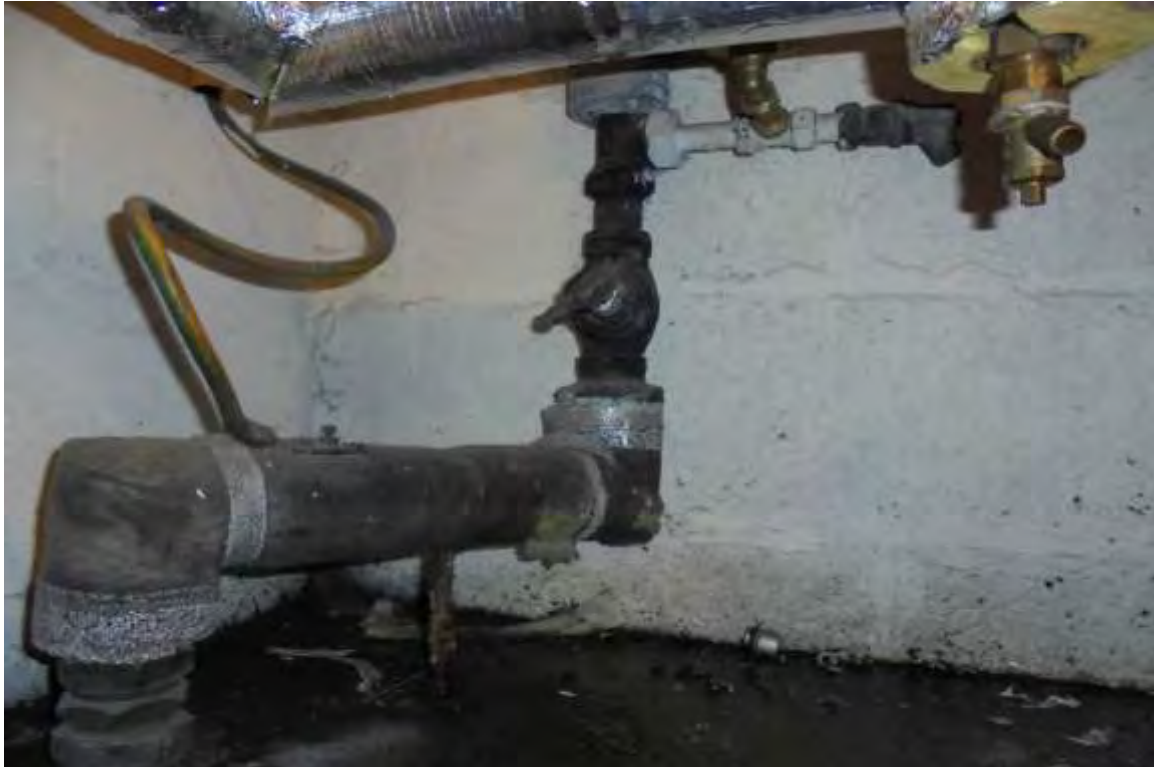
A public Mains Water Service (MWS) enters the main plant room and is provided with a stop cock and drain down facility. No check valve was identified and this may be requested by the water authority to comply with the Water Byelaws.

**MWS Inlet with Stop Cock and Drain Point**

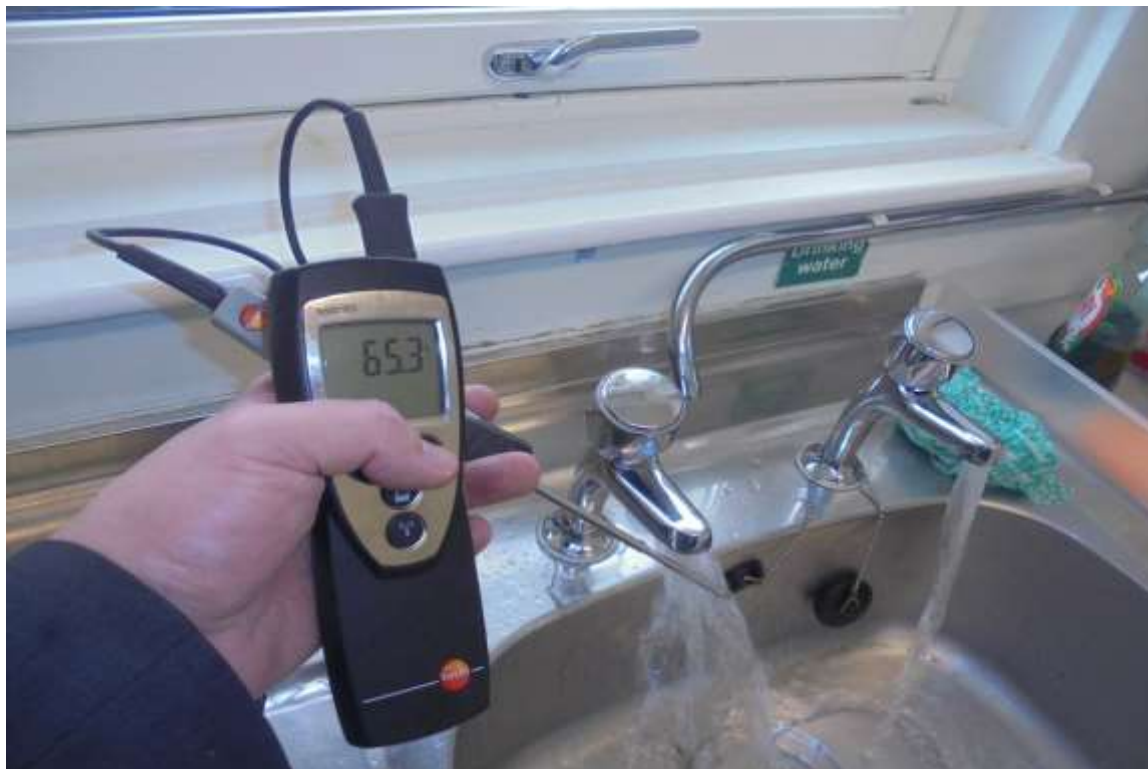
**1<sup>st</sup> Floor Staff Room Sink - Hot Water Outlet Temperature Satisfactory**

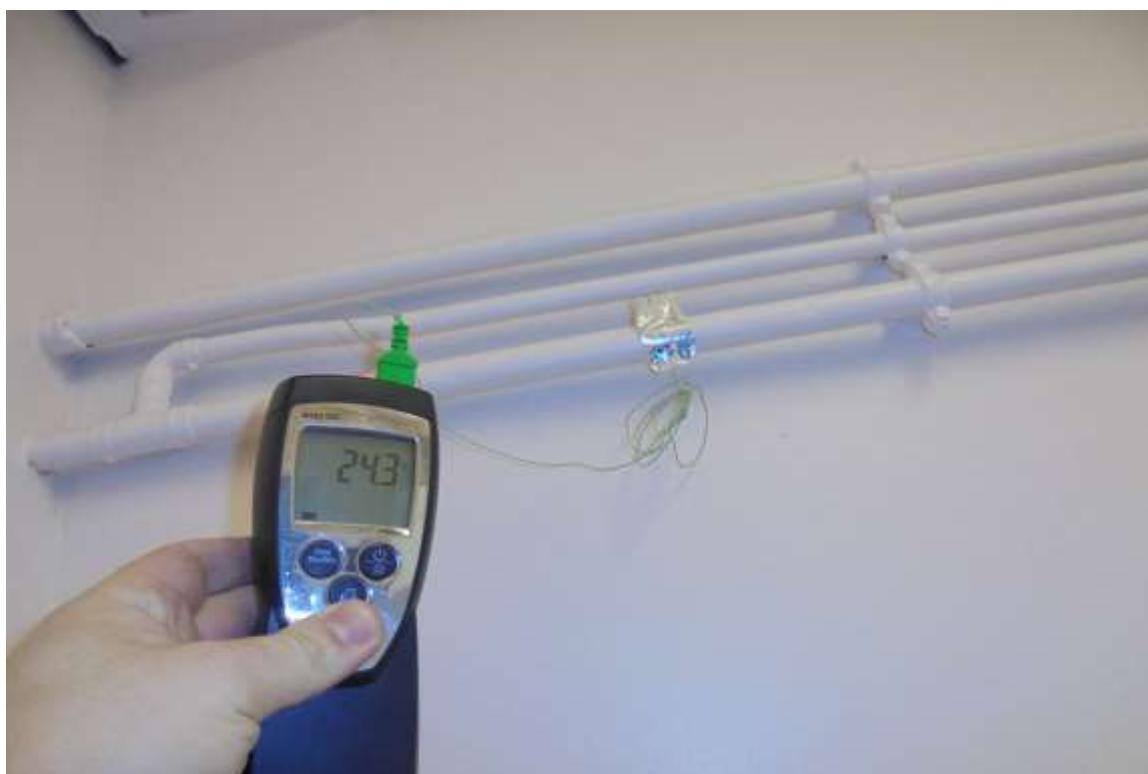
**Health Education/Physio Room - Tertiary Loop Flow Temperature Too Low (<55°C)**

We do however recommend that circulation to this area be investigated to ensure a sufficiently high hot water temperature can be maintained to provide an effective thermal control regime within the building.

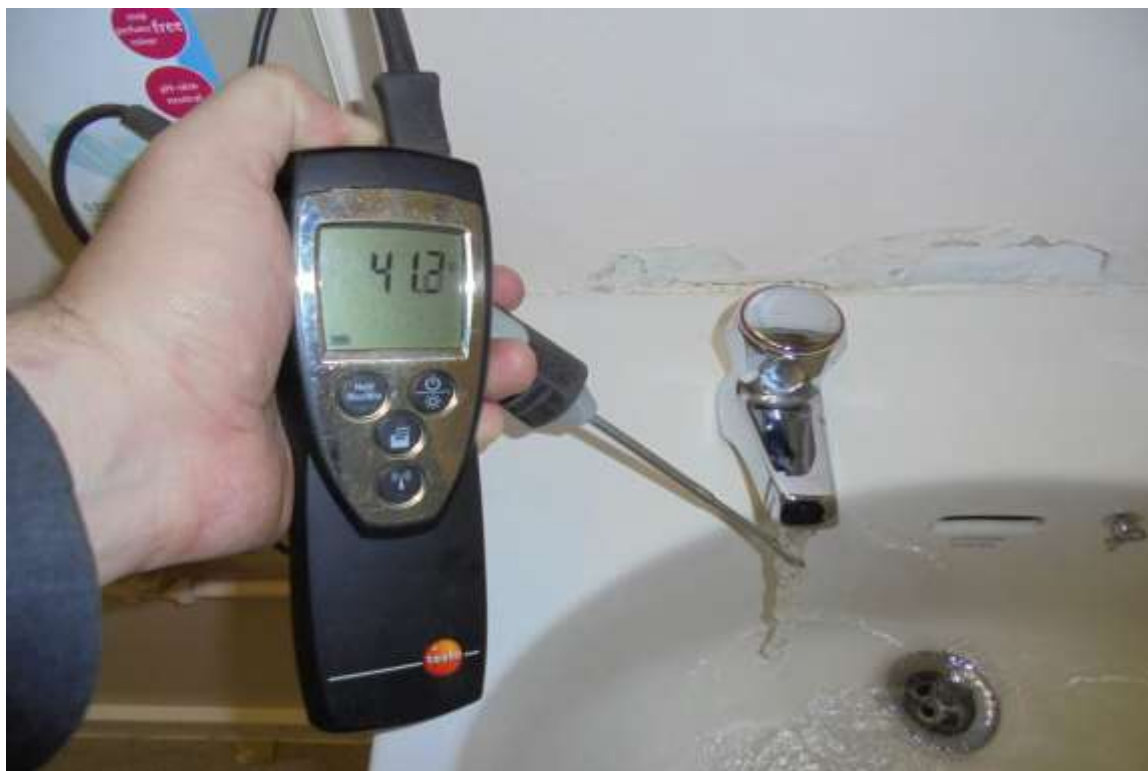
**Public Toilet WHB - Hot Water Outlet Temperature Satisfactory  
Thermostatic Control**

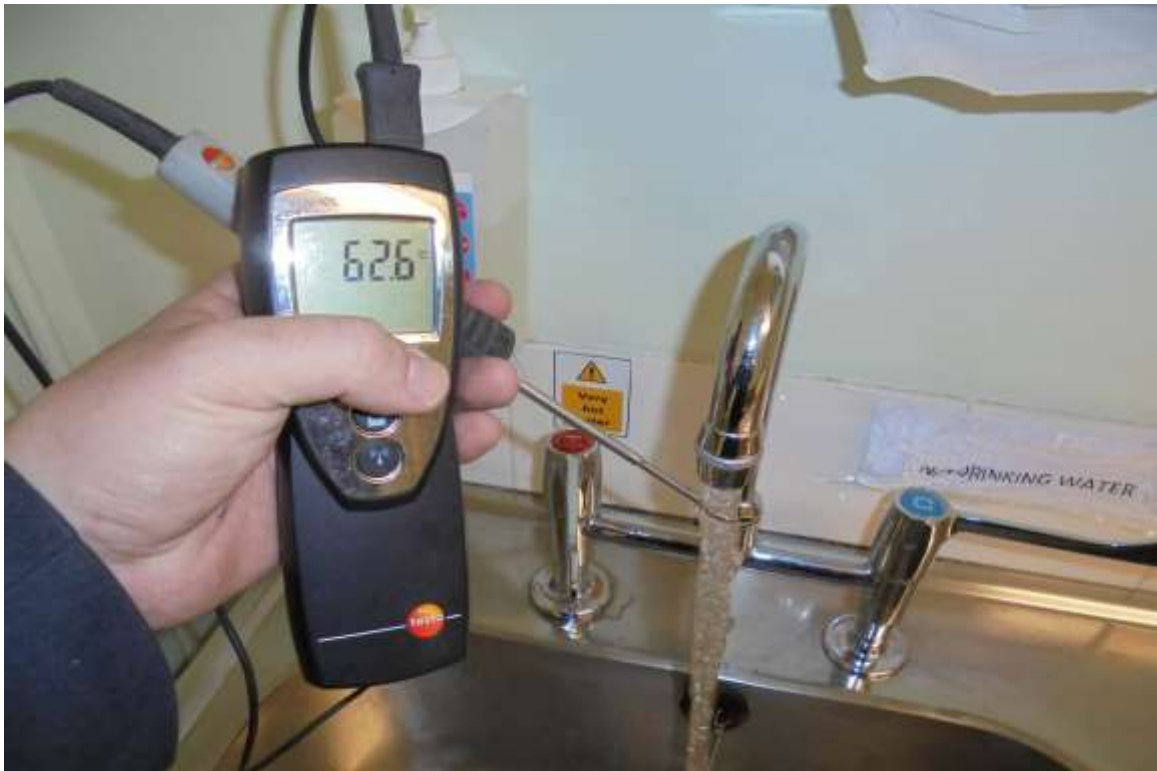
### **Consultant Room 8 Sink - Hot Water Outlet Temperature Satisfactory**

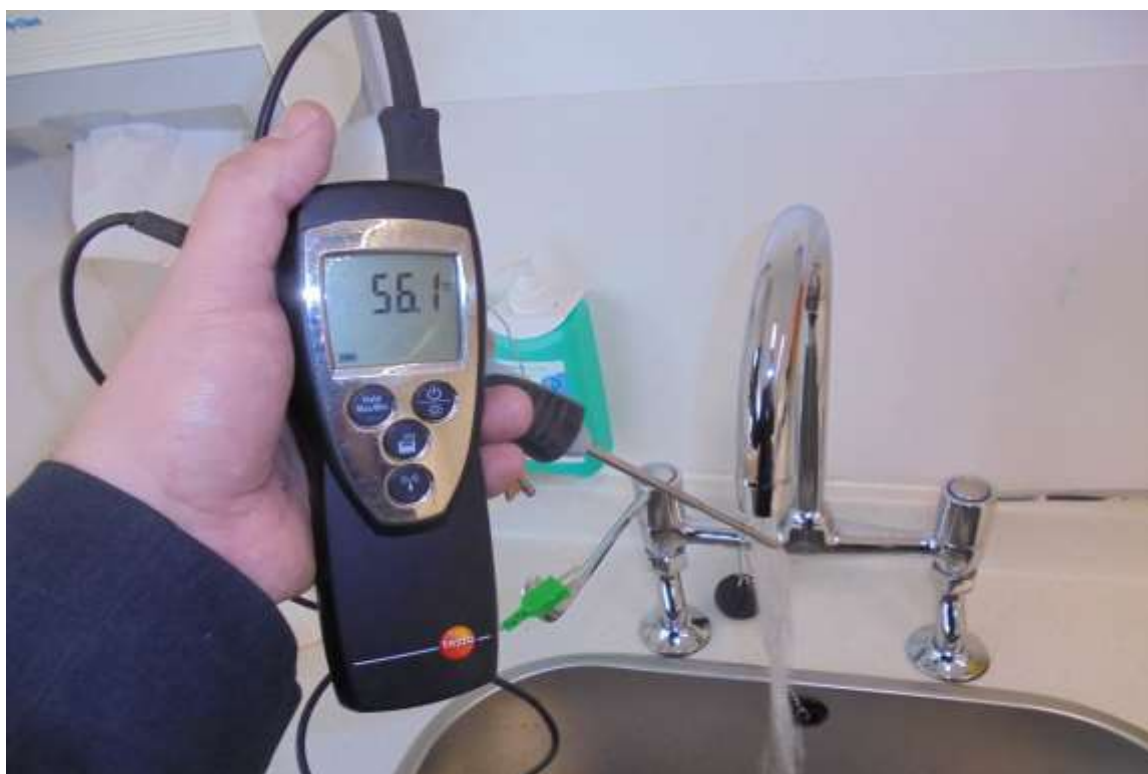
Mains fed, electric under-sink points of use water heater are provided in each of the Consulting Rooms within the extension wing. Where these are used, a minimum temperature of 55°C is required in healthcare premises. The temperature recorded at the extension Consultant Room 2 sink was satisfactory although monthly temperature monitoring should be used to ensure all three water heaters operate within the desired temperature range and determine the need for adjustment of the thermostatic controls.

**Extension Consultant Room 2 Sink - Hot Water Outlet Temperature Satisfactory**

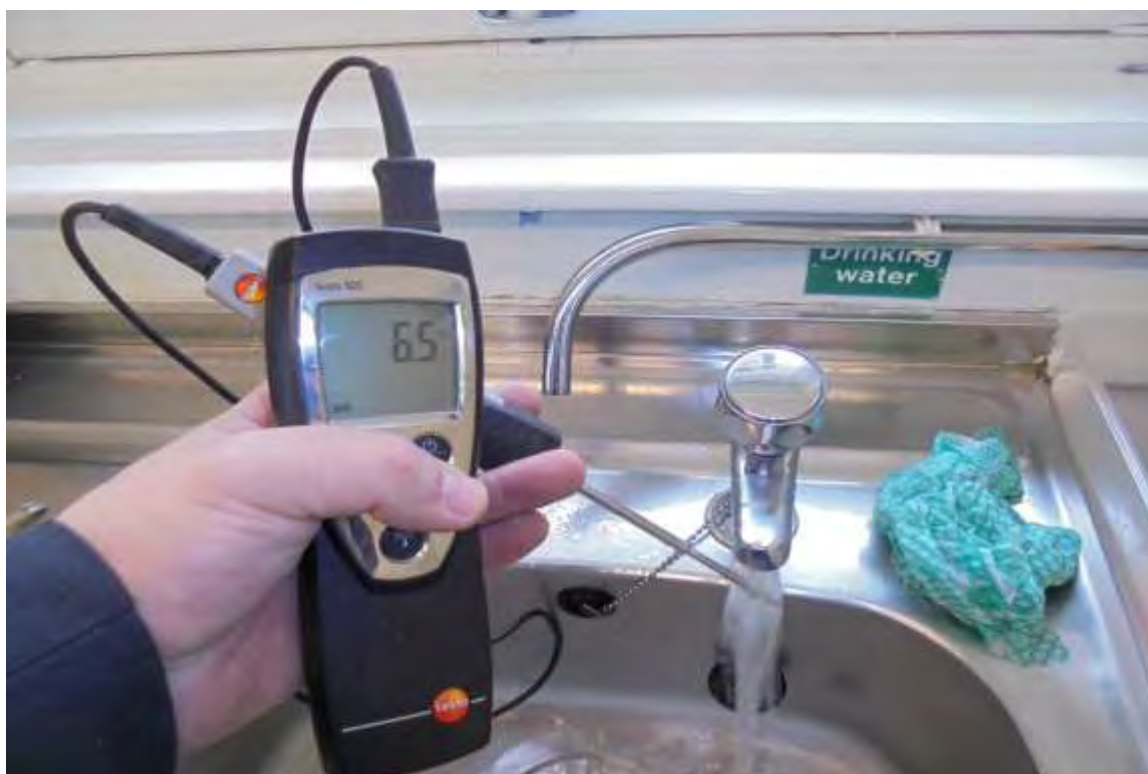
**1<sup>st</sup> Floor Staff Room Sink – Cold Water Outlet Temperature Satisfactory**

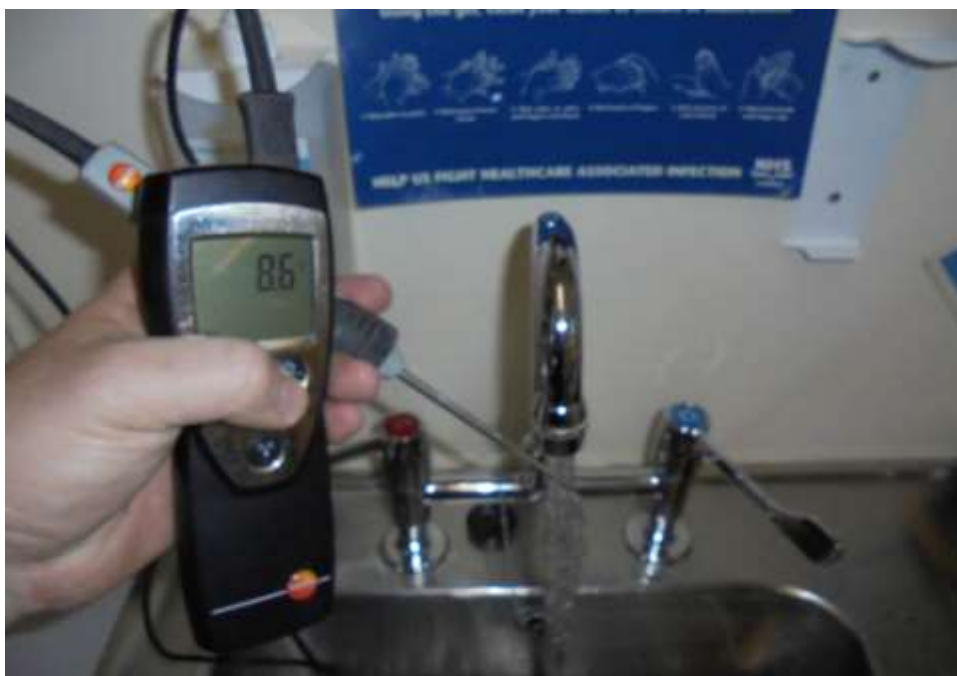
<b>Source Description</b>	: Health Education/ Physio Room (359/G/36)	High	>22
	Sink Cold	High Med.	20-22
		Low Med.	17-19
		Low	<17
<b>Assessment Justification</b>	: Sentinel Point		
<b>Assessor</b>	: Mr C Mitchell	<b>Client:</b>	NHS Lothian
<b>Date</b>	: 4 <sup>th</sup> March 2021		
<b>Date of Previous</b>	: 19 <sup>th</sup> December 2017	<b>Site:</b>	East Calder Health Centre East Calder
<b>pH</b>	: 7.6		
<b>FRC</b>	: <0.1 ppm	<b>Reference:</b>	5261/07
<b>Temp 1</b>	: 8.6°C		
<b>Temp 2</b>	:

Aspect	Cur.	Prev.	Rec.	Remarks
<b>A</b>	<b>Supply Water</b>	2	-	2	Supplied from CWS Tank Ref. 5261/01.
<b>B</b>	<b>Supply System</b>	1	-	1	
<b>C</b>	<b>Point Condition</b>	1	-	1	
<b>D</b>	<b>Turnover</b>	2	-	2	Daily.
<b>E</b>	<b>Incubation</b>	3	-	3	Temperature <20°C.
<b>F</b>	<b>Acidity</b>	3	-	3	
<b>G</b>	<b>Exposed Populace</b>	2	-	2	
<b>H</b>	<b>Infection Risk</b>	1	-	1	
<b>TOTALS</b>		<b>15</b>	<b>-</b>	<b>15</b>

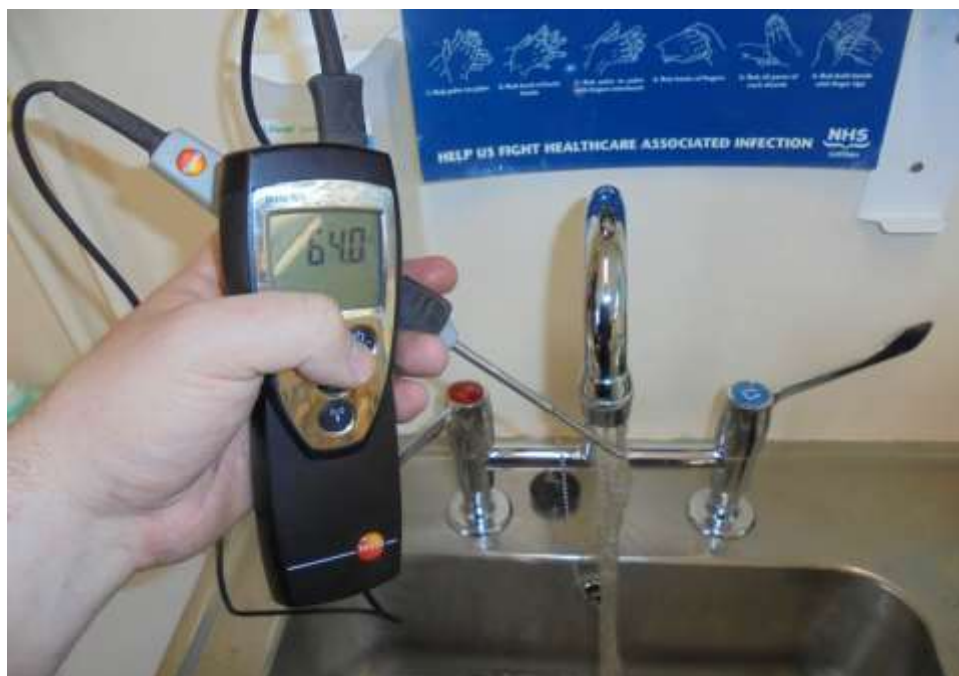
<b>Source Description</b>	: Health Education/ Physio Room (359/G/36) Sink Hot	High >22 High Med. 20-22 Low Med. 17-19 Low <17
<b>Assessment Justification</b>	: Sentinel Point	
<b>Assessor</b>	: Mr C Mitchell	<b>Client:</b> NHS Lothian
<b>Date</b>	: 4 <sup>th</sup> March 2021	
<b>Date of Previous</b>	: 19 <sup>th</sup> December 2017	<b>Site:</b> East Calder Health Centre East Calder
<b>pH</b>	: 7.6	
<b>FRC</b>	: <0.1 ppm	<b>Reference:</b> 5261/08
<b>Temp 1</b>	: 64.0°C	
<b>Temp 2</b>	:

Aspect	Cur.	Prev.	Rec.	Remarks
<b>A</b>	<b>Supply Water</b>	2	-	2	Supplied from DGFWH Ref. 5261/03.
<b>B</b>	<b>Supply System</b>	3	-	1	Poor Circulation
<b>C</b>	<b>Point Condition</b>	1	-	1	
<b>D</b>	<b>Turnover</b>	2	-	2	Daily
<b>E</b>	<b>Incubation</b>	1	-	1	Temperature >60°C - Scald hazard.. Scald hazard.
<b>F</b>	<b>Acidity</b>	3	-	3	
<b>G</b>	<b>Exposed Populace</b>	2	-	2	
<b>H</b>	<b>Infection Risk</b>	1	-	1	
<b>TOTALS</b>		<b>15</b>	<b>-</b>	<b>13</b>

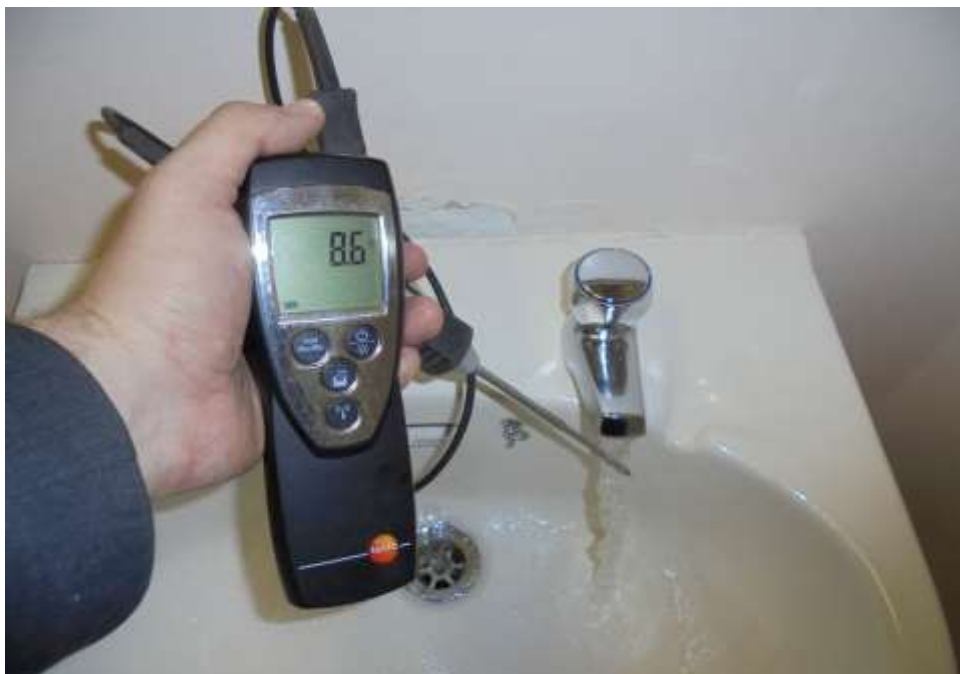
<b>Source Description</b>	: Public Toilet (359/G/38) WHB Cold	High	>22
<b>Assessment Justification</b>	:	High Med.	20-22
<b>Assessor</b>	: Mr C Mitchell	Low Med.	17-19
<b>Date</b>	: 19 <sup>th</sup> December 2017	Low	<17
<b>Date of Previous</b>	: 25 <sup>th</sup> February 2016	<b>Client:</b>	NHS Lothian
<b>pH</b>	: 7.4	<b>Site:</b>	East Calder Health Centre East Calder
<b>FRC</b>	: <0.1 ppm	<b>Reference:</b>	5261/09
<b>Temp 1</b>	: 8.6°C		
<b>Temp 2</b>	:

Aspect	Cur.	Prev.	Rec.	Remarks
<b>A</b>	<b>Supply Water</b>	<b>2</b>	<b>-</b>	<b>2</b>	Supplied from CWS Tank Ref. 5261/01. And DGFWH Ref. 5261/03
<b>B</b>	<b>Supply System</b>	<b>1</b>	<b>-</b>	<b>1</b>	
<b>C</b>	<b>Point Condition</b>	<b>1</b>	<b>-</b>	<b>1</b>	
<b>D</b>	<b>Turnover</b>	<b>2</b>	<b>-</b>	<b>2</b>	Daily.
<b>E</b>	<b>Incubation</b>	<b>3</b>	<b>-</b>	<b>3</b>	Temperature <20°C.
<b>F</b>	<b>Acidity</b>	<b>3</b>	<b>-</b>	<b>3</b>	
<b>G</b>	<b>Exposed Populace</b>	<b>2</b>	<b>-</b>	<b>2</b>	
<b>H</b>	<b>Infection Risk</b>	<b>3</b>	<b>-</b>	<b>3</b>	Potentially Susceptible Users
<b>TOTALS</b>		<b>17</b>	<b>-</b>	<b>17</b>

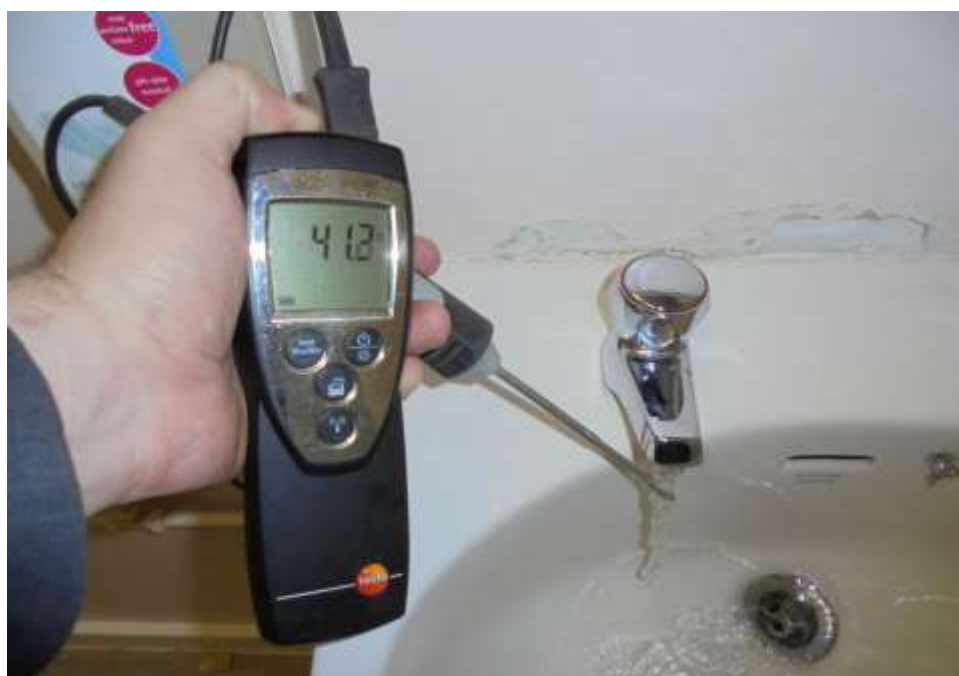
**Source Description** : Public Toilet (359/G/38) WHB Cold  
**Assessment Justification** :  
**Assessor** : Mr C Mitchell  
**Date** : 19<sup>th</sup> December 2017  
**Date of Previous** : 25<sup>th</sup> February 2016  
**pH** : 7.4  
**FRC** : <0.1 ppm  
**Temp 1** : 41.2°C  
**Temp 2** : 62.0°C Inlet to TMV

Aspect	Cur.	Prev.	Rec.	Remarks
<b>A</b>	<b>Supply Water</b>	<b>2</b>	-	<b>2</b>	Supplied from CWS Tank Ref. 5261/01. And DGFWH Ref. 5261/03
<b>B</b>	<b>Supply System</b>	<b>1</b>	-	<b>1</b>	
<b>C</b>	<b>Point Condition</b>	<b>1</b>	-	<b>1</b>	
<b>D</b>	<b>Turnover</b>	<b>2</b>	-	<b>2</b>	Daily.
<b>E</b>	<b>Incubation</b>	<b>5</b>	-	<b>5</b>	Temperature <50°C and >20°C. Thermostatic Control
<b>F</b>	<b>Acidity</b>	<b>3</b>	-	<b>3</b>	
<b>G</b>	<b>Exposed Populace</b>	<b>2</b>	-	<b>2</b>	
<b>H</b>	<b>Infection Risk</b>	<b>3</b>	-	<b>3</b>	Potentially Susceptible Users
<b>TOTALS</b>		<b>19</b>	-	<b>19</b>

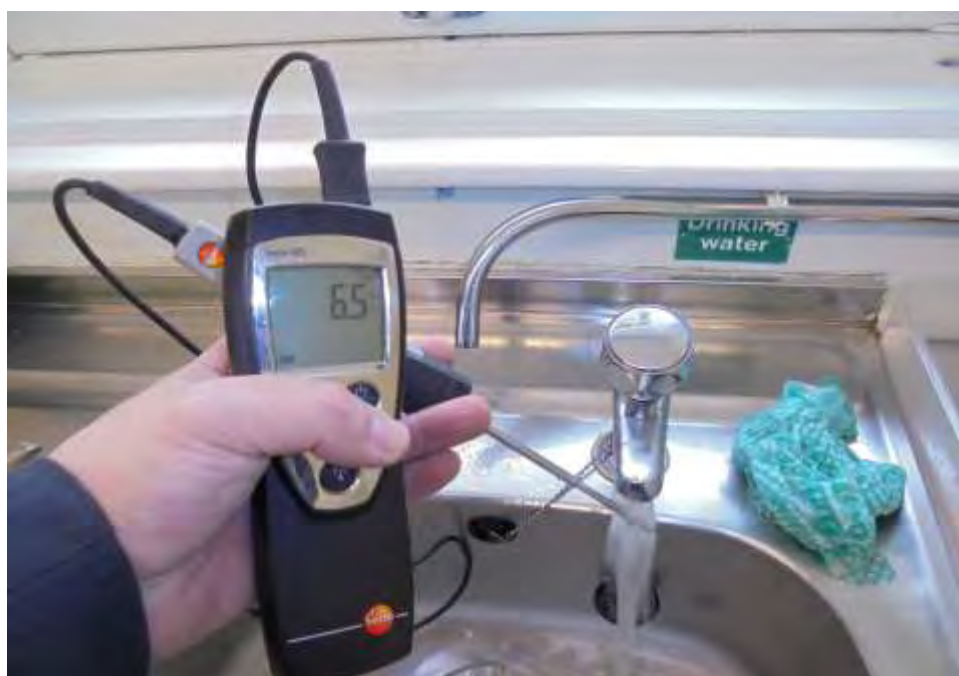
<b>Source Description</b>	: 1 <sup>st</sup> Floor Staff Room (359/1/15) Sink Cold	High >22 High Med. 20-22 Low Med. 17-19 Low <17
<b>Assessment Justification</b>	: Rarely Used Outlet	
<b>Assessor</b>	: Mr C Mitchell	<b>Client:</b> NHS Lothian
<b>Date</b>	: 4 <sup>th</sup> March 2021	
<b>Date of Previous</b>	: 19 <sup>th</sup> December 2017	<b>Site:</b> East Calder Health Centre East Calder
<b>pH</b>	: 7.6	
<b>FRC</b>	: <0.1 ppm	<b>Reference:</b> 5261/11
<b>Temp 1</b>	: 6.5	
<b>Temp 2</b>	:

Aspect	Cur.	Prev.	Rec.	Remarks
<b>A</b>	<b>Supply Water</b>	2	2	2	Supplied from Mains water service.
<b>B</b>	<b>Supply System</b>	1	1	1	
<b>C</b>	<b>Point Condition</b>	1	1	1	
<b>D</b>	<b>Turnover</b>	2	2	2	Daily.
<b>E</b>	<b>Incubation</b>	3	3	3	Temperature <20°C.
<b>F</b>	<b>Acidity</b>	3	3	3	
<b>G</b>	<b>Exposed Populace</b>	2	2	2	
<b>H</b>	<b>Infection Risk</b>	5	5	5	Drinking Water/. Culinary Use
<b>TOTALS</b>		<b>19</b>	<b>22</b>	<b>19</b>

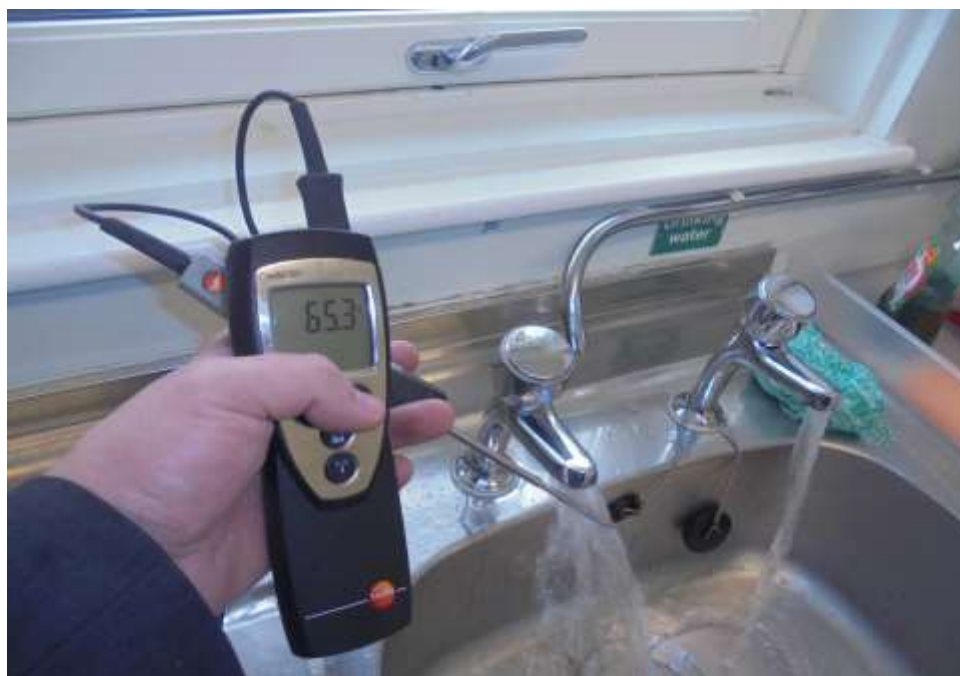
<b>Source Description</b>	: 1 <sup>st</sup> Floor Staff Room (359/1/15) Sink Hot	High	>22	
<b>Assessment Justification</b>	: Sentinel Point	High Med.	20-22	
<b>Assessor</b>	: Mr C Mitchell	Low Med.	17-19	
<b>Date</b>	: 4 <sup>th</sup> March 2021	Low	<17	<b>Client:</b> NHS Lothian
<b>Date of Previous</b>	: 19 <sup>th</sup> December 2017			<b>Site:</b> East Calder Health Centre East Calder
<b>pH</b>	: 7.6			<b>Reference:</b> 5261/12
<b>FRC</b>	: <0.1 ppm			
<b>Temp 1</b>	: 65.7°C			
<b>Temp 2</b>	:

Aspect	Cur.	Prev.	Rec.	Remarks
A	Supply Water	2	2	2	Supplied from DGFWH Ref. 5261/03.
B	Supply System	1	3	1	
C	Point Condition	1	1	1	
D	Turnover	2	2	2	Daily.
E	Incubation	1	1	1	Temperature >60°C - Scald hazard..
F	Acidity	3	3	3	
G	Exposed Populace	2	2	2	
H	Infection Risk	1	5	1	
<b>TOTALS</b>		<b>13</b>	<b>19</b>	<b>13</b>

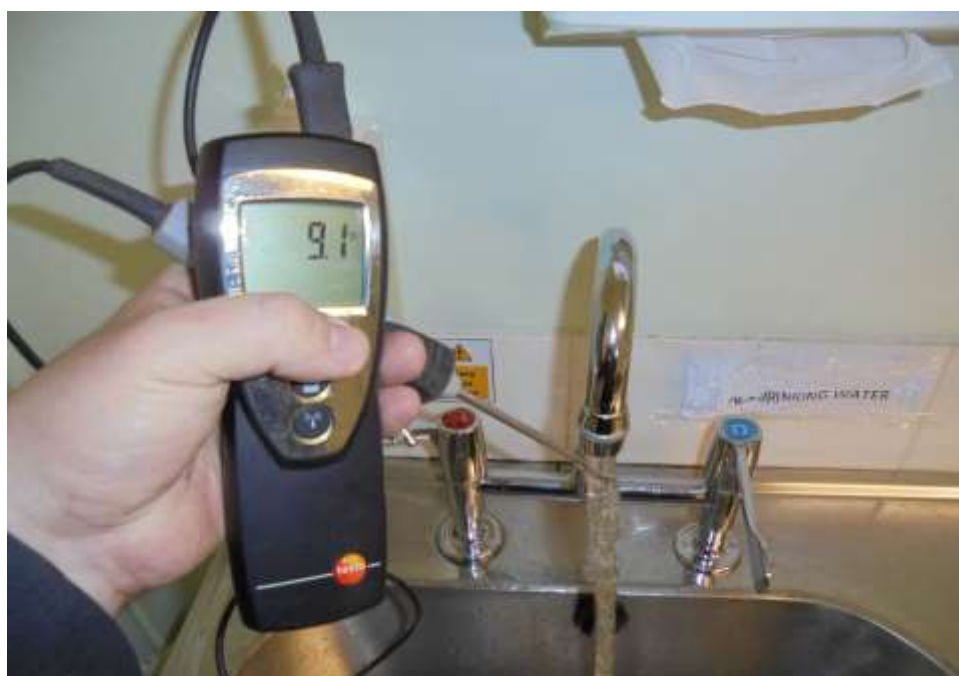
<b>Source Description</b>	: Consultant Room 8 (359/G/05) Sink Cold	High	>22
<b>Assessment Justification</b>	: Sentinel Point	High Med.	20-22
<b>Assessor</b>	: Mr C Mitchell	Low Med.	17-19
<b>Date</b>	: 4 <sup>th</sup> March 2021	Low	<17
<b>Date of Previous</b>	: 19 <sup>th</sup> December 2017	<b>Client:</b>	NHS Lothian
<b>pH</b>	: 7.6	<b>Site:</b>	East Calder Health Centre East Calder
<b>FRC</b>	: <0.1 ppm	<b>Reference:</b>	5261/13
<b>Temp 1</b>	: 9.1°C		
<b>Temp 2</b>	:

Aspect	Cur.	Prev.	Rec.	Remarks
<b>A</b>	<b>Supply Water</b>	2	2	2	Supplied from CWS Tank Ref. 5261/01. And DGFWH Ref. 5261/03
<b>B</b>	<b>Supply System</b>	1	2	1	
<b>C</b>	<b>Point Condition</b>	1	1	1	
<b>D</b>	<b>Turnover</b>	2	3	2	Daily.
<b>E</b>	<b>Incubation</b>	3	4	3	Temperature <20°C.
<b>F</b>	<b>Acidity</b>	3	3	3	
<b>G</b>	<b>Exposed Populace</b>	2	2	2	
<b>H</b>	<b>Infection Risk</b>	1	1	1	
<b>TOTALS</b>		<b>15</b>	<b>18</b>	<b>15</b>

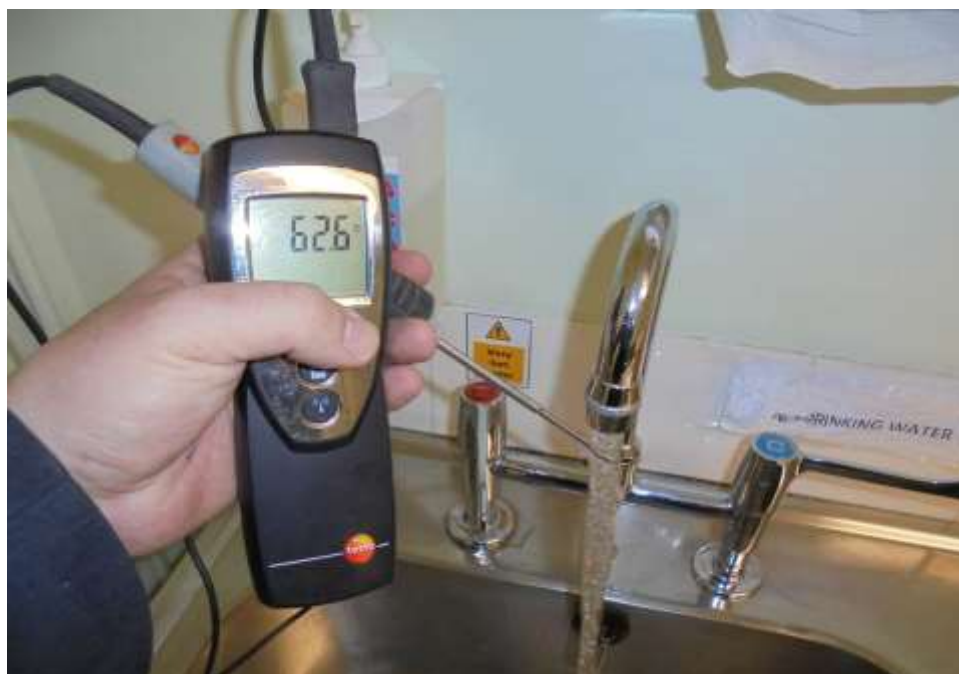
<b>Source Description</b>	: Consultant Room 8 (359/G/05) Sink Hot	High	>22
<b>Assessment Justification</b>	:	High Med.	20-22
<b>Assessor</b>	: Mr C Mitchell	Low Med.	17-19
<b>Date</b>	: 4 <sup>th</sup> March 2021	Low	<17
<b>Date of Previous</b>	: 19 <sup>th</sup> December 2017	<b>Client:</b>	NHS Lothian
<b>pH</b>	: 7.6	<b>Site:</b>	East Calder Health Centre East Calder
<b>FRC</b>	: <0.1 ppm	<b>Reference:</b>	5261/14
<b>Temp 1</b>	: 62.6°C		
<b>Temp 2</b>	:

Aspect	Cur.	Prev.	Rec.	Remarks
<b>A</b>	<b>Supply Water</b>	2	2	2	Supplied from DGFWH Ref. 5261/03.
<b>B</b>	<b>Supply System</b>	1	2	1	Poor Circulation
<b>C</b>	<b>Point Condition</b>	1	1	1	
<b>D</b>	<b>Turnover</b>	2	3	2	Daily.
<b>E</b>	<b>Incubation</b>	1	5	1	Temperature >60°C - Scald hazard..
<b>F</b>	<b>Acidity</b>	3	3	3	
<b>G</b>	<b>Exposed Populace</b>	2	2	2	
<b>H</b>	<b>Infection Risk</b>	1	1	1	
<b>TOTALS</b>		<b>13</b>	<b>19</b>	<b>13</b>

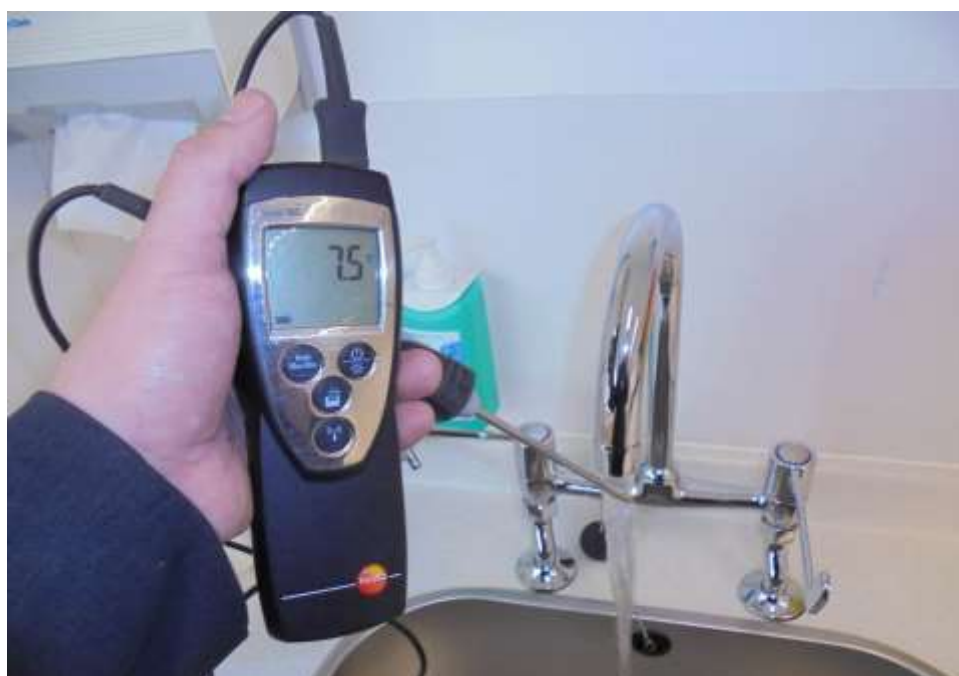
<b>Source Description</b>	: Extension Consultant Room 2 Sink Cold	High	>22
<b>Assessment Justification</b>	: Sentinel Point	High Med.	20-22
<b>Assessor</b>	: Mr C Mitchell	Low Med.	17-19
<b>Date</b>	: 4 <sup>th</sup> March 2021	Low	<17
<b>Date of Previous</b>	: 19 <sup>th</sup> December 2017	<b>Client:</b>	NHS Lothian
<b>pH</b>	: 7.6	<b>Site:</b>	East Calder Health Centre East Calder
<b>FRC</b>	: <0.1 ppm	<b>Reference:</b>	5261/15
<b>Temp 1</b>	: 7.5°C		
<b>Temp 2</b>	:

Aspect	Cur.	Prev.	Rec.	Remarks
<b>A</b>	<b>Supply Water</b>	2	2	2	POUH via MWS
<b>B</b>	<b>Supply System</b>	1	3	1	Effective dead leg.
<b>C</b>	<b>Point Condition</b>	1	1	1	
<b>D</b>	<b>Turnover</b>	2	2	2	Daily.
<b>E</b>	<b>Incubation</b>	3	5	3	Temperature <20°C.
<b>F</b>	<b>Acidity</b>	3	3	3	
<b>G</b>	<b>Exposed Populace</b>	2	2	2	Normal use.
<b>H</b>	<b>Infection Risk</b>	1	1	1	
<b>TOTALS</b>		<b>15</b>	<b>19</b>	<b>15</b>

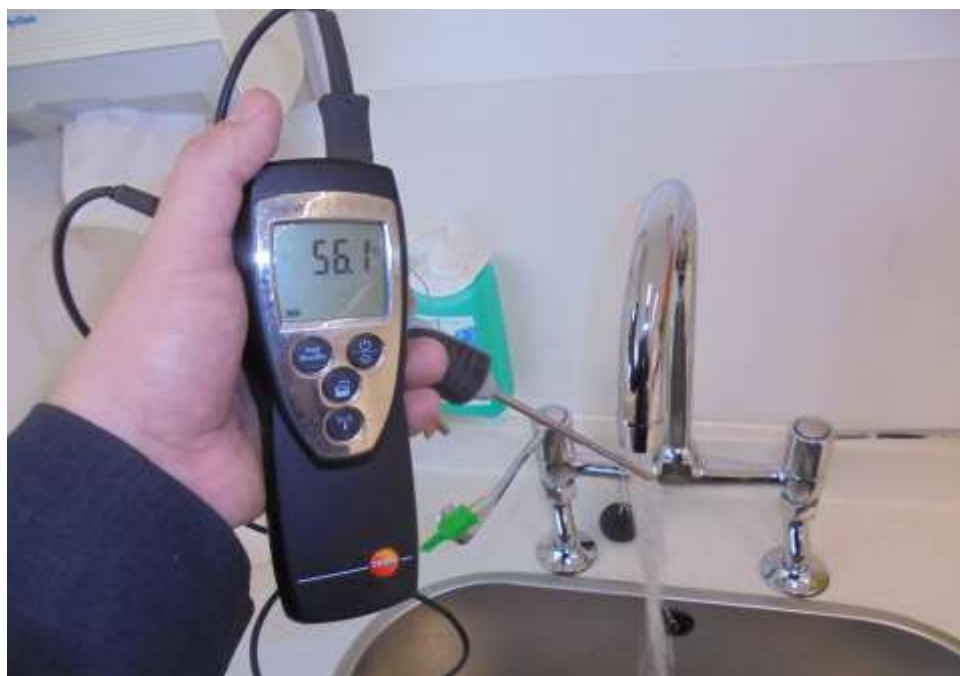
<b>Source Description</b>	: Extension Consultant Room 2 Sink Hot	High	>22
<b>Assessment Justification</b>	: Sentinel Point	High Med.	20-22
<b>Assessor</b>	: Mr C Mitchell	Low Med.	17-19
<b>Date</b>	: 4 <sup>th</sup> March 2021	Low	<17
<b>Date of Previous</b>	: 19 <sup>th</sup> December 2017	<b>Client:</b>	NHS Lothian
<b>pH</b>	: 7.6	<b>Site:</b>	East Calder Health Centre East Calder
<b>FRC</b>	: <0.1 ppm	<b>Reference:</b>	5261/16
<b>Temp 1</b>	: 56.1°C		
<b>Temp 2</b>	:

Aspect	Cur.	Prev.	Rec.	Remarks
A	Supply Water	2	2	2	POUH via MWS
B	Supply System	1	3	1	Effective dead leg.
C	Point Condition	1	1	1	
D	Turnover	2	2	2	Daily.
E	Incubation	1	5	1	Temperature >55°C.
F	Acidity	3	3	3	
G	Exposed Populace	2	2	2	Normal use.
H	Infection Risk	1	1	1	
<b>TOTALS</b>		<b>13</b>	<b>19</b>	<b>13</b>

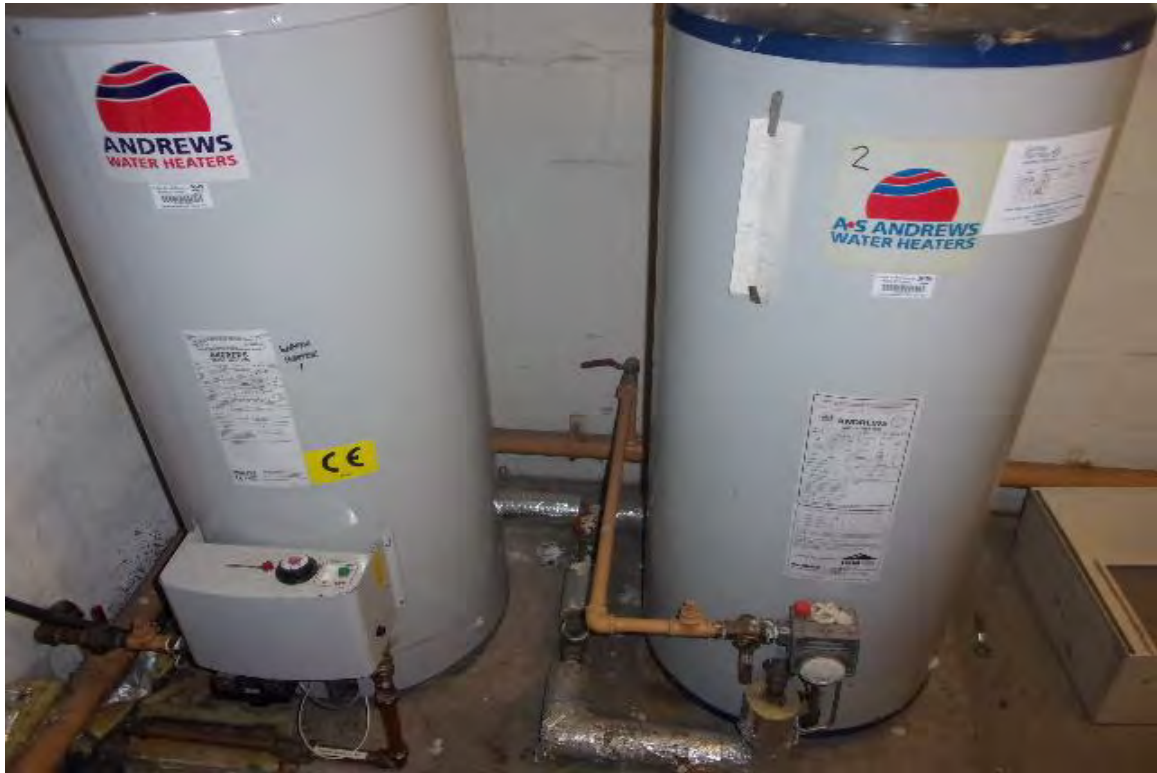
**Plantroom Gas Fired Water Heaters – General Arrangement**

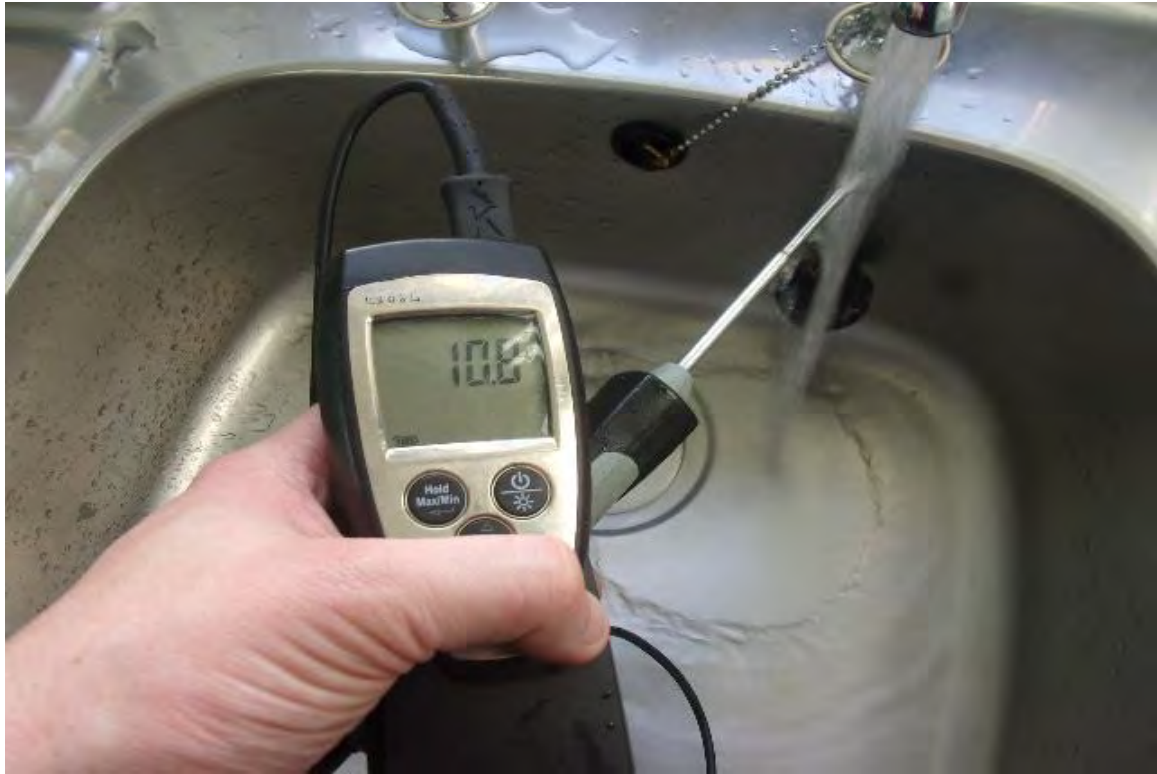
**1<sup>st</sup> Floor Staff Room Kitchen Sink - Cold Water Outlet Temperature Satisfactory**

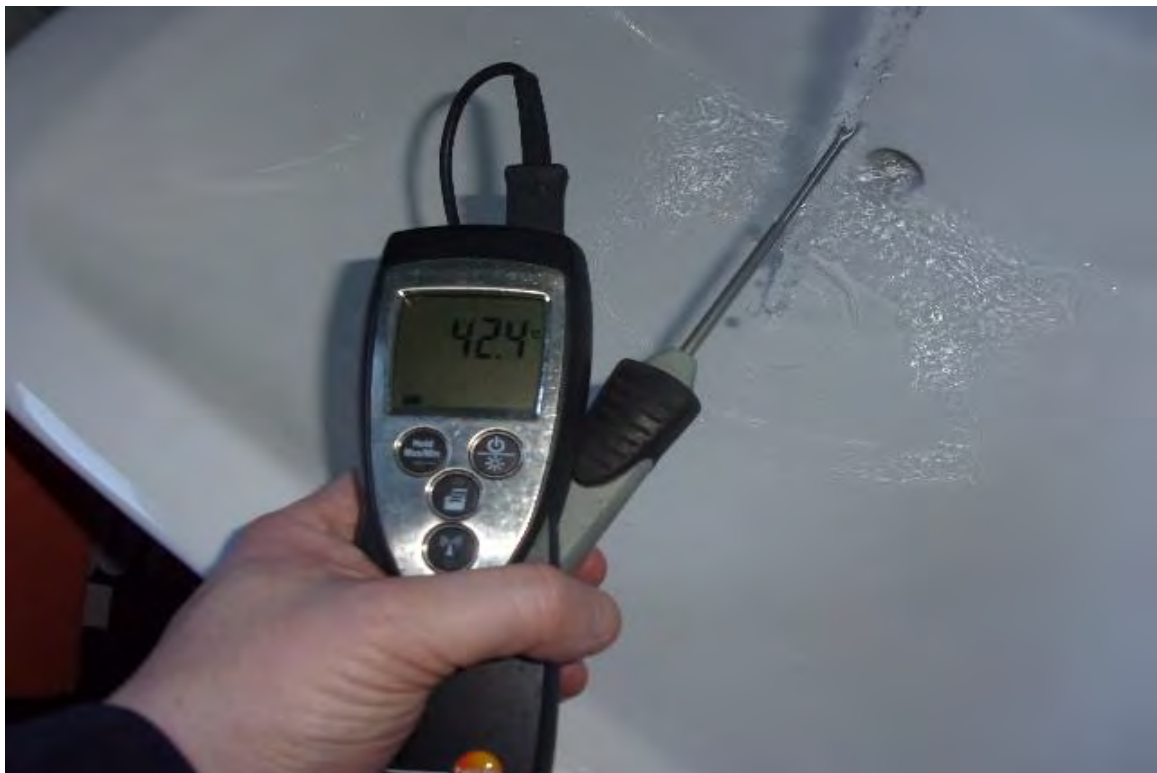
**Secretarial Office (G/09) WHB – Blended Outlet Temperature Satisfactory**

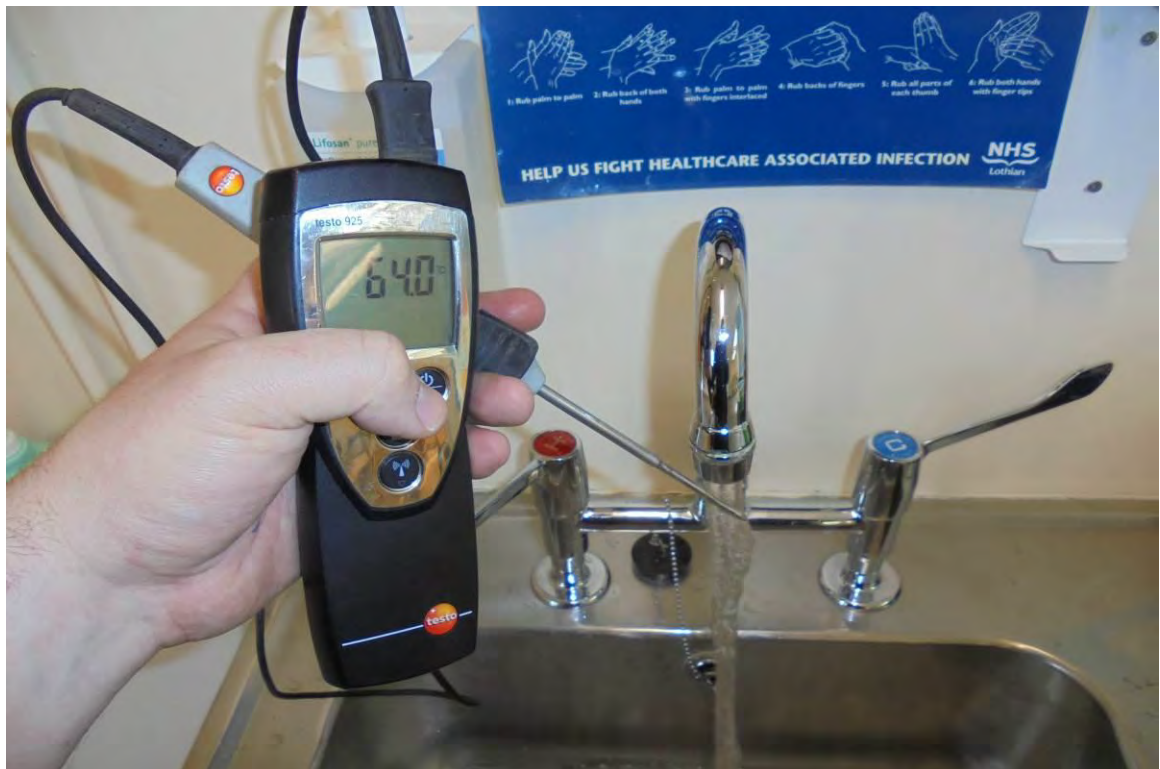
**Health Education/Physio Room Sink - Hot Water Outlet Temperature Satisfactory**

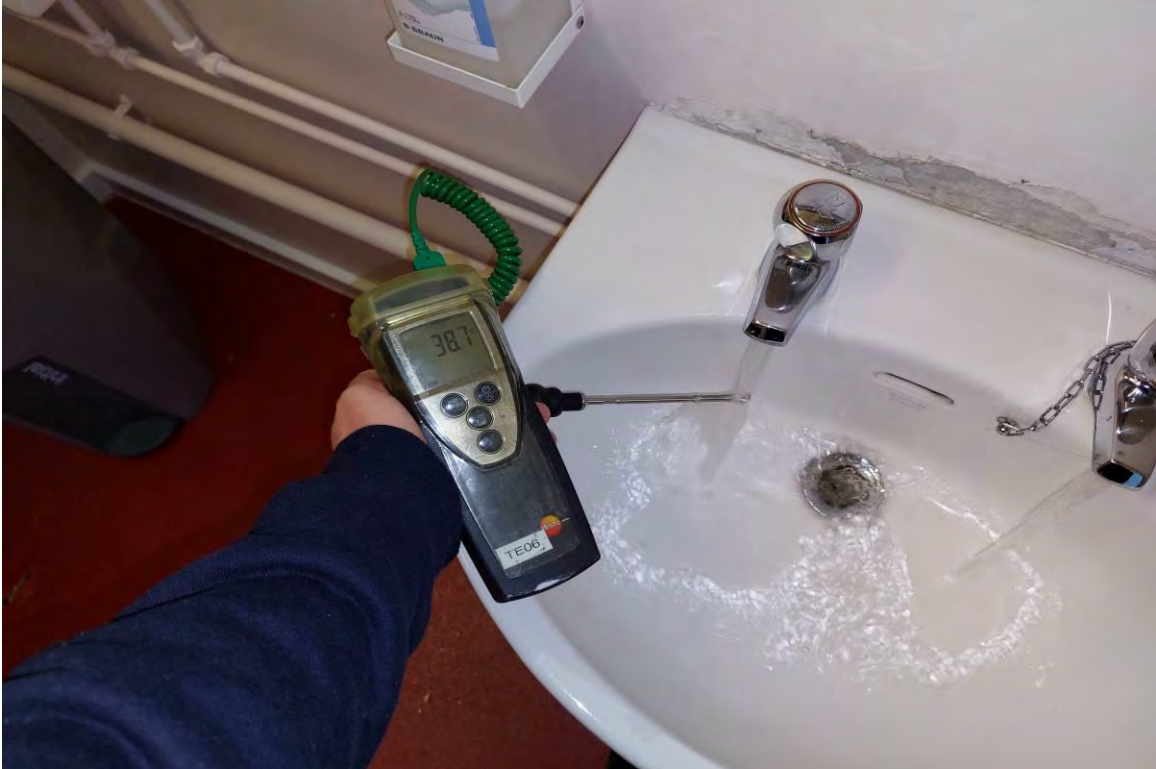
**Public Toilet WHB - Hot Water Outlet Temperature Satisfactory  
Thermostatic Control**
