## FREEDOM OF INFORMATION – LEGIONELLA

I write in response to your request for information in relation to Legionella in East Calder Health Centre.

This document relates to an ongoing programme of water quality monitoring at East Calder Health Centre, carried out by Westfield Caledonian during February 2016. As part of this visit, a review of the Water Quality Risk Assessment, relating to the domestic water systems contained within this building was carried out. This survey was carried out to satisfy the requirements of the Approved Code of Practice (L8) and guidance document HSG 274 and to determine aspects of the system design, condition and mode of operation which may compromise the quality of the water to which occupants are exposed and subsequent health risk. This assessment survey and control scheme review was carried out in a manner consistent with requirements with *BS8580:2010 Water Quality-Risk Assessment for Legionella control – code of practice*.

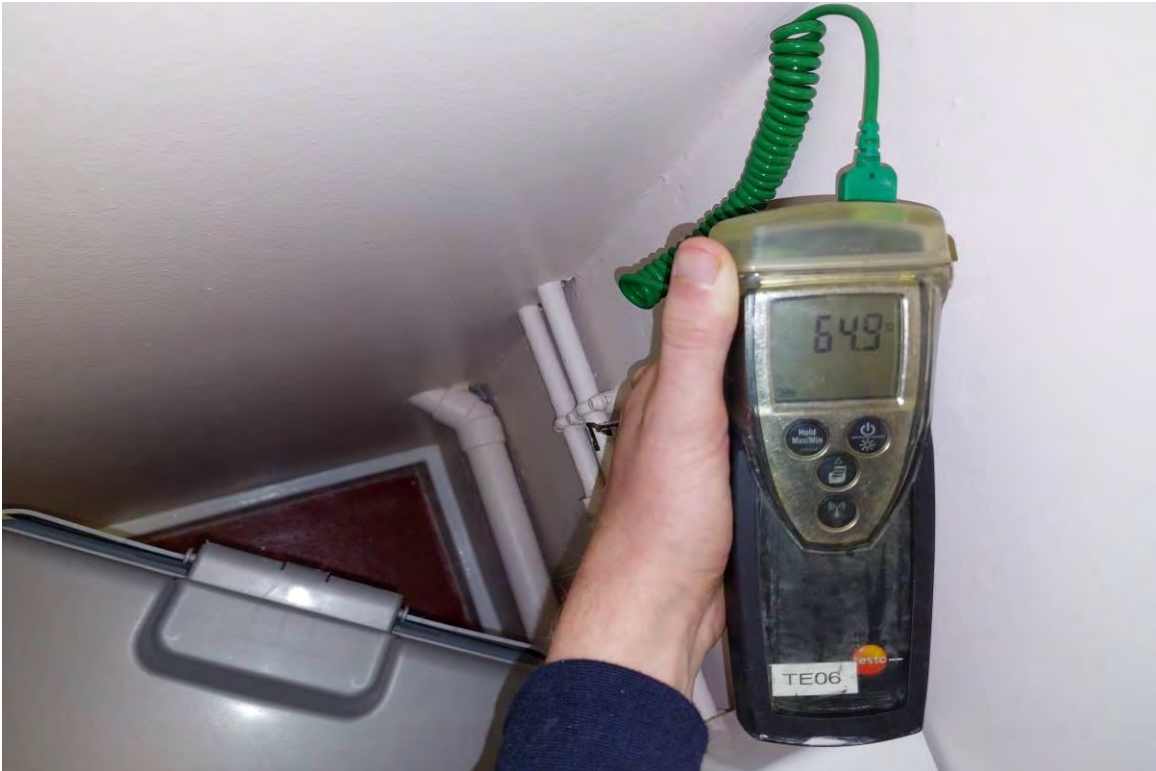
**Public Toilet WHB - Supply Temperature to TMV Satisfactory (>55°C)**

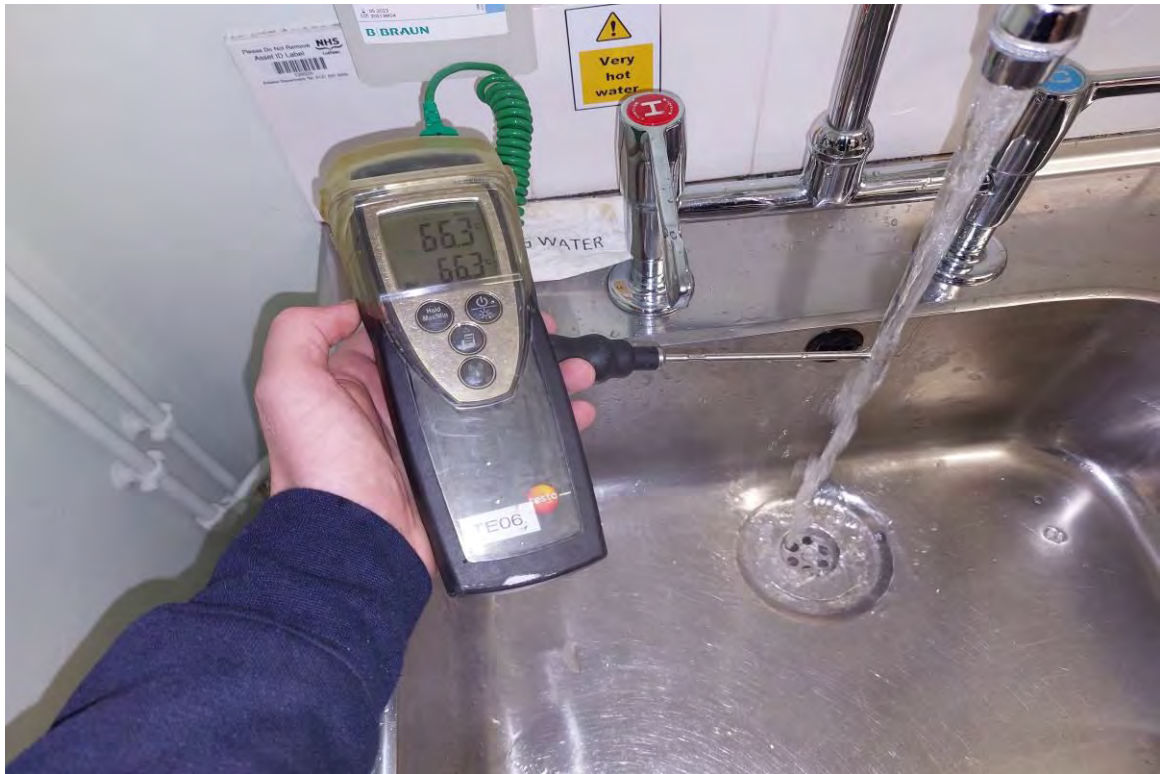
### **Consultant Room 8 Sink - Hot Water Outlet Temperature Satisfactory**

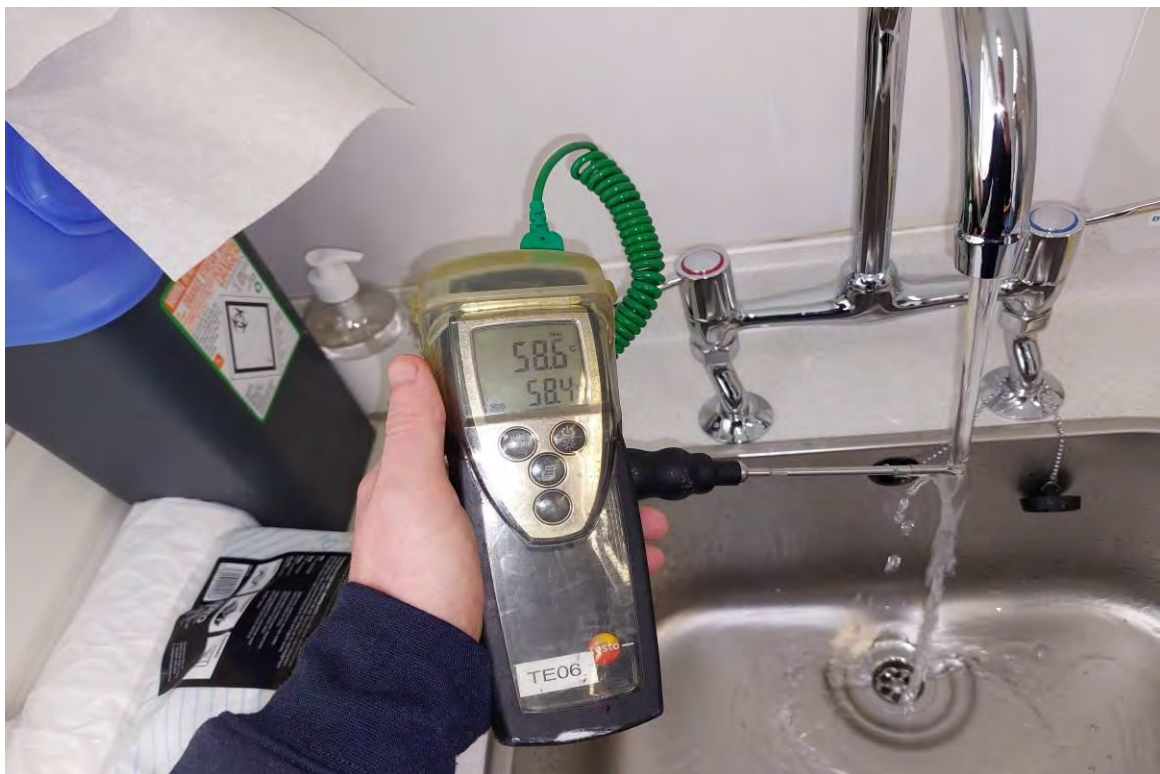
**Extension Consultant Room 3 Sink - Hot Water Outlet Temperature Satisfactory**

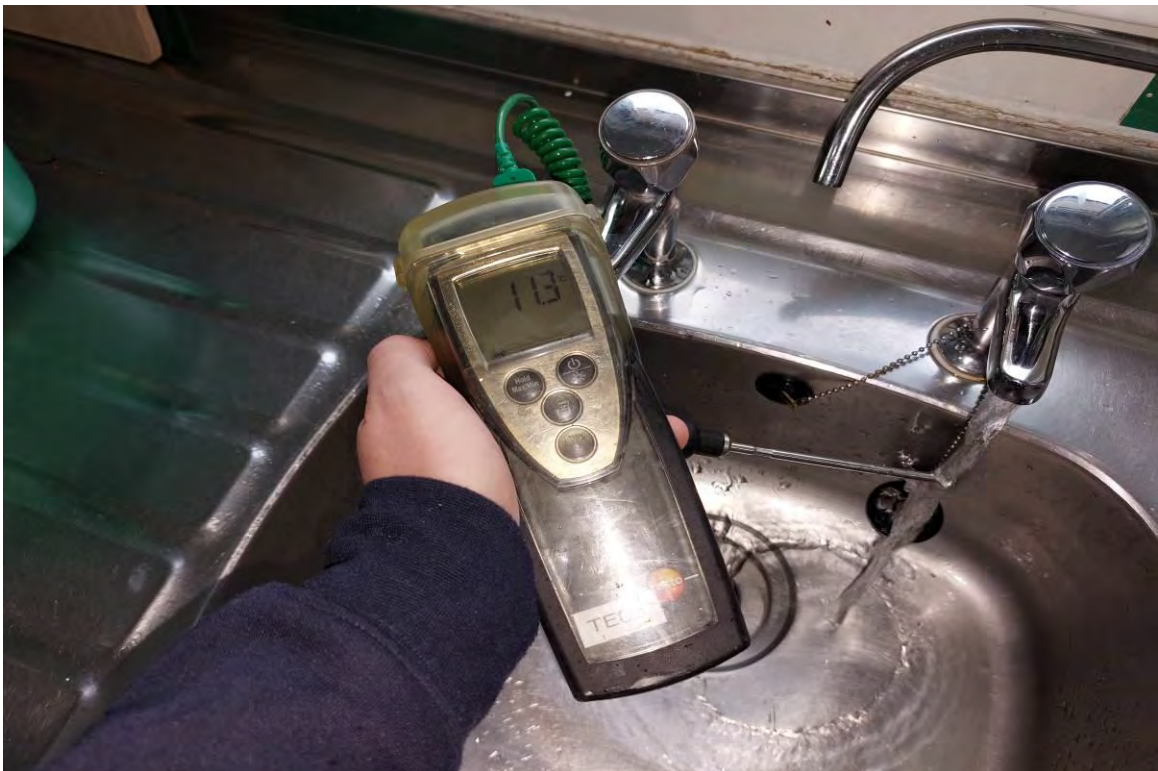
**1st Floor Staff Room Sink – Cold Water Outlet Temperature Satisfactory**

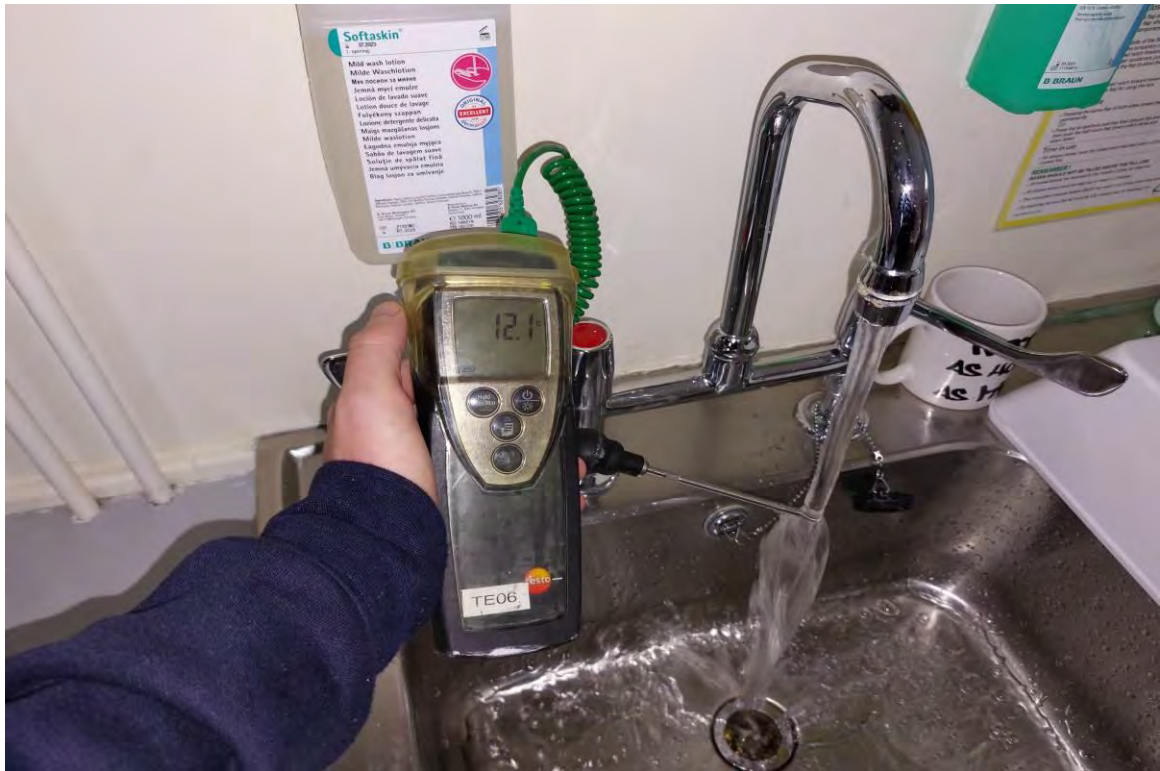
**Health Education/Physio Room Sink – Cold Water Outlet Temperature Satisfactory**

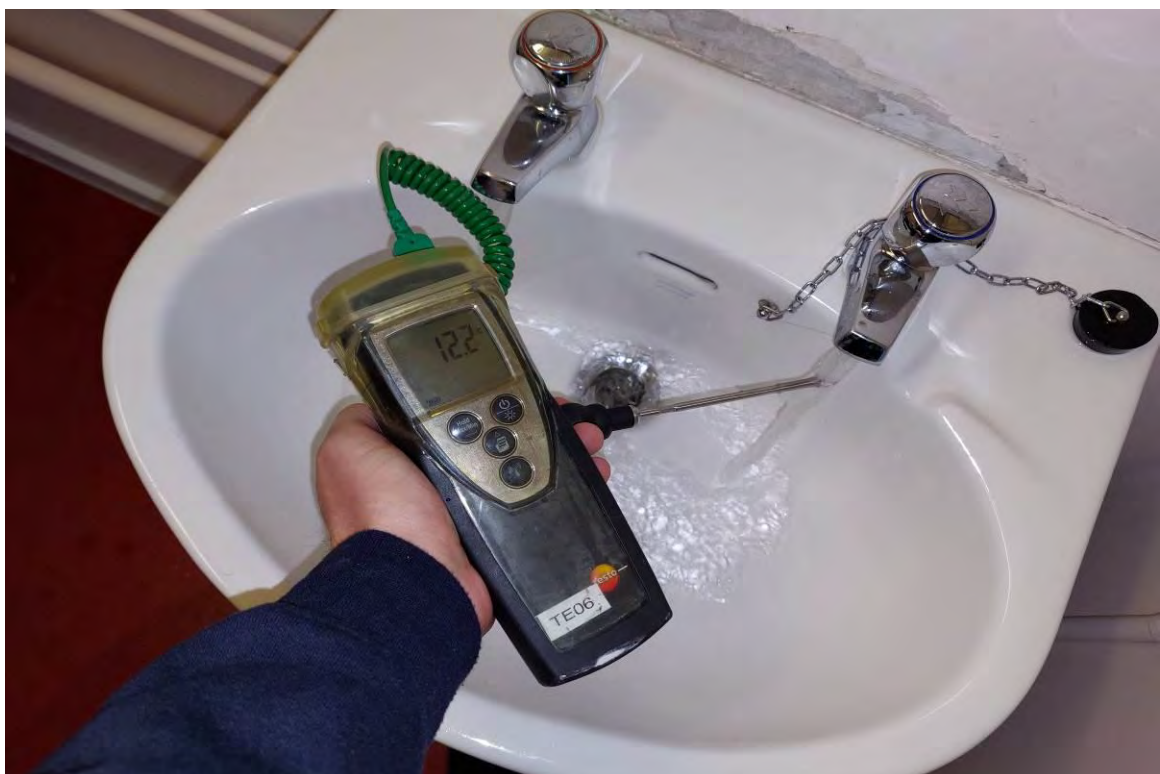
**Public Toilet WHB - Cold Water Outlet Temperature Satisfactory**

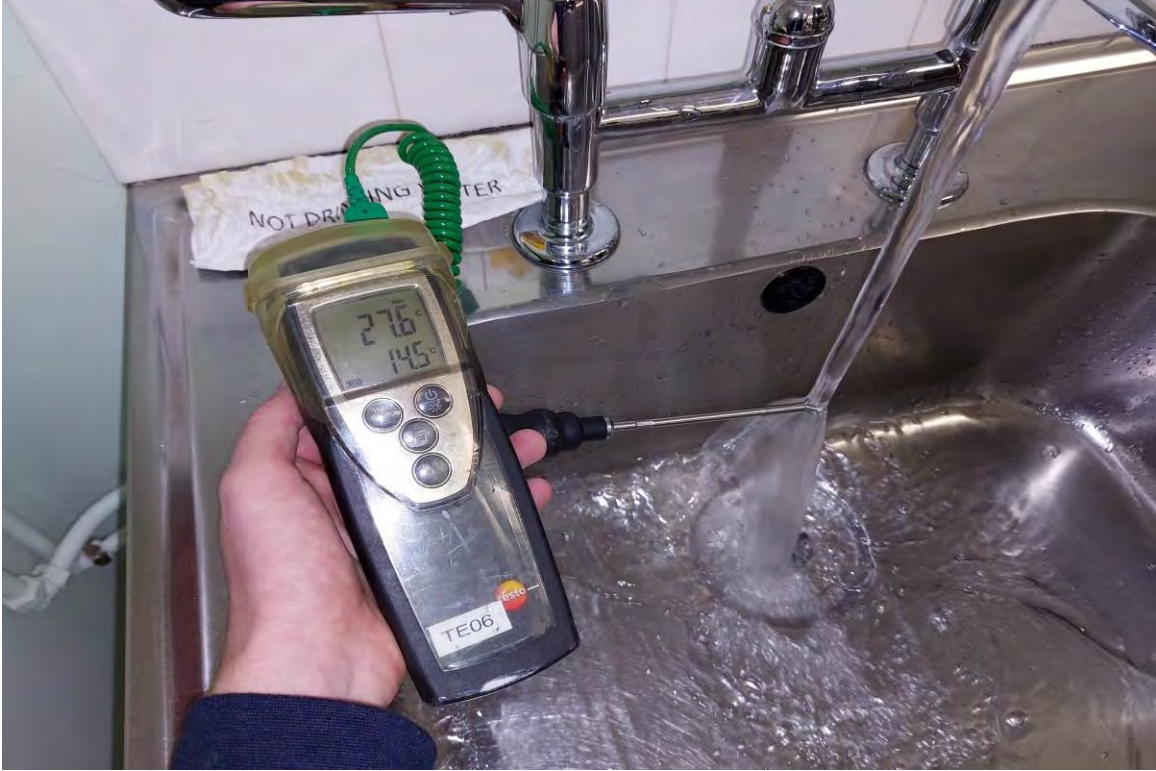
**Consultant Room 8 Sink - Cold Water Outlet Temperature Satisfactory**
